The re-alignment afloat of a ship's main engine crankshaft using liquid nitrogen: The original repair re-visited

The Re-alignment Afloat of a Ship's Main Engine Crankshaft Using Liquid Nitrogen: The Original Repair Re-visited.

Using four tonnes of liquid nitrogen, the author recounts how the crankshaft of the MV Eastern Rover was successfully restored to operational alignment afloat. The bearing damage was also repaired and realigned afloat, with full cargo intact, at Moji, Japan, where the casualty occurred.

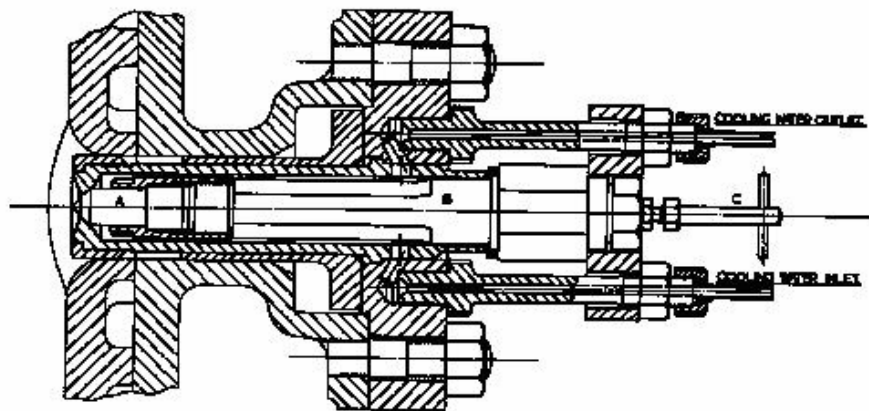
Figure 4. Fuel valve/cylinder liner arrangement

The author discusses the failure in service of the crankshaft of a 670mm bore Doxford LBD4 marine diesel main engine caused by cooling water leakage through minute cracks in a cylinder liner, adjacent a fuel valve. The water passed into the cylinder combustion space formed by two opposing pistons, in one of the cylinders. The hydraulic shock caused crankshaft journal slippage and major axial misalignment, with consequential main bearing and other damage. This occurred when the engine was wrongly tested using starting compressed air without first checking the main machinery by slowly rotating it once or twice, using the electric driven mechanical crankshaft turning gear.

The cause of the damage was self evident to the ship's engineers. Notification of the casualty was received at our Hong Kong head office immediately after it happened. Repairs and dry dockings were the author's responsibility so the author was instructed to fly to the ship immediately and arrived aboard next day. It was a feature of Doxford engines to employ two fuel valves in each cylinder. These fuel valves are positioned one on each side of each cylinder and are cooled by the fresh water that also circulates the main engine cylinder liners and top pistons. The valves themselves are secured in a removable carrier such that both the carrier and the nozzle are in a cooling water space outside the liner. Failure of the nozzle cone to make a watertight seal with its carrier can enable water to leak into the cylinder past the nozzle cone, to thereby accumulate on the concave crown of the bottom piston. Another possibility known from a few cases, was that Doxford liners had developed small cracks in way of their fuel valve pockets. Figure 4 depicts the fuel valve and cylinder liner arrangement. Subsequent inspection showed minor cracks were the cause of the casualty. The combustion space of No 4 cylinder had become slightly filled with water. Contrary to company requirements, the engine had not been given one or two slow test turns by means of the electric driven mechanical turning gear with the cylinder indicator cocks open, as precaution demands before starting the engine. It will be clear by reference to Figure 3 that when starting air at 600psi was applied in one of the other cylinders to turn the engine, the top and bottom pistons in No 4 cylinder made their compressive inward strokes. This was done with such force that the hydraulic shock in the cylinder caused the dislocation of the crankshaft. The forward main crankshaft web slipped its shrink and rotated 9.5mm around the

side rod crank pin, in an astern direction. The length of shafting forward of No 4 unit had continued to travel ahead of the after section, to produce the

slippage. Before its rotation stopped, no longer in axial alignment, the crankshaft journals on either side of No 4 cylinder proceeded to badly damage their respective bottom half white-metal bearings.

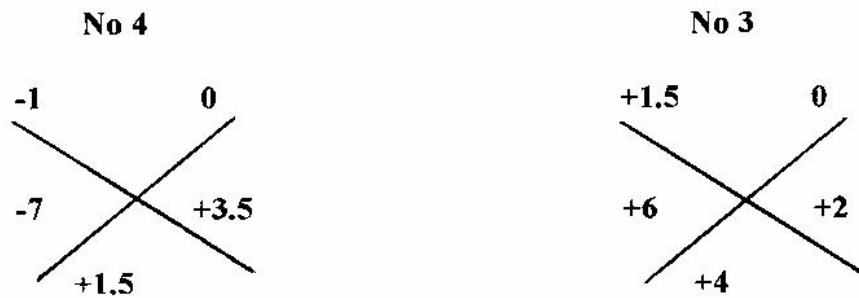
Figure 9 portrays the deflexions of No's 4 and 3 crankwebs after completion of the work, including the adjustment of main bearing heights, prior to Moji departure.

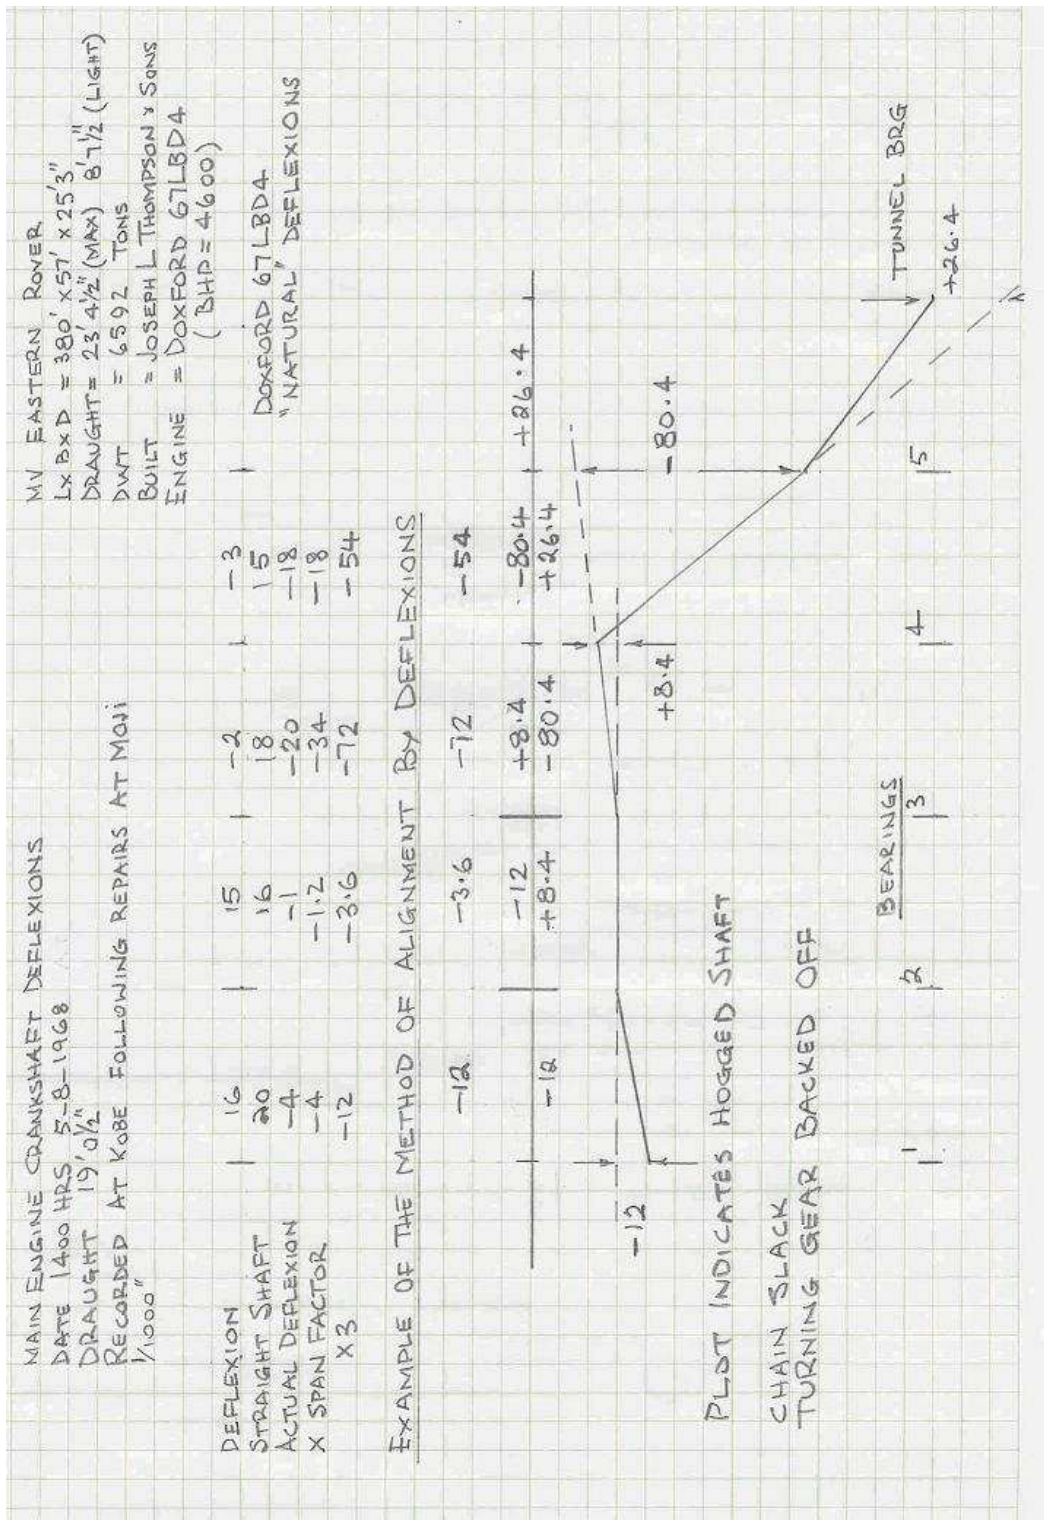
Figure 10 Main engine shaft alignment. Deflexions recorded arrival Kobe 5-8-68

Figures 10 and 11 portray the alignment of the crankshaft from web deflexions taken at ports succeeding the repair. Adjustments were made to the main bearing heights as shown. The plots indicated that being new, No 4 main bearing was high relative to the other main bearings. This could be expected.

However it was judged that the thrust bearing was being influential in the deflexion readings and so to test this opinion the bearing was raised by 0.030 inch shims and the deflexions retaken. A plot of these deflexions resulted in the further addition of 0.030 inch shims beneath the thrust bearing accompanied by the removal of 0.019 inch from No4 main bearing. The final acceptable position of the crankshaft is shown in Figure 11. Doxford engine builders require that their engines operate with positive deflexions within the range of +0.005 to +0.035 inch (0.125 to 0.9mm). Confirmation of the acceptable alignment can be seen from the later deflexion gauge readings recorded at Bangkok by the ship's engineers. Care must always be taken to factor into the work the alignment of the loaded hull, and therefore the distortion of the bedplate that occurs with changes of ship loading. This change of hull alignment corresponds to the changes in the vessels draught. Doxford LBD4 engine main bearings are uniquely designed, being mounted in spherical housings. This design enables the bearings to change their positions in the bedplate, to suit changes in bedplate alignment, thereby warranting special consideration. It will be seen from the above that alignment of a ship's main engine crankshaft by adjustment of the thickness of the white-metal bearings is considerably complicated. Nevertheless the author hopes that the deflexion graphing technique used by the author and depicted here, to realign the crankshaft and the bearings, has been explained or is otherwise sufficiently self explanatory to be readily understood and perhaps utilised by those whose job it is to continually monitor the main and auxiliary diesel engines of ships both big and small.
