# Marine Accident Investigation Branch (MAIB) - Safety Digest 02/1999

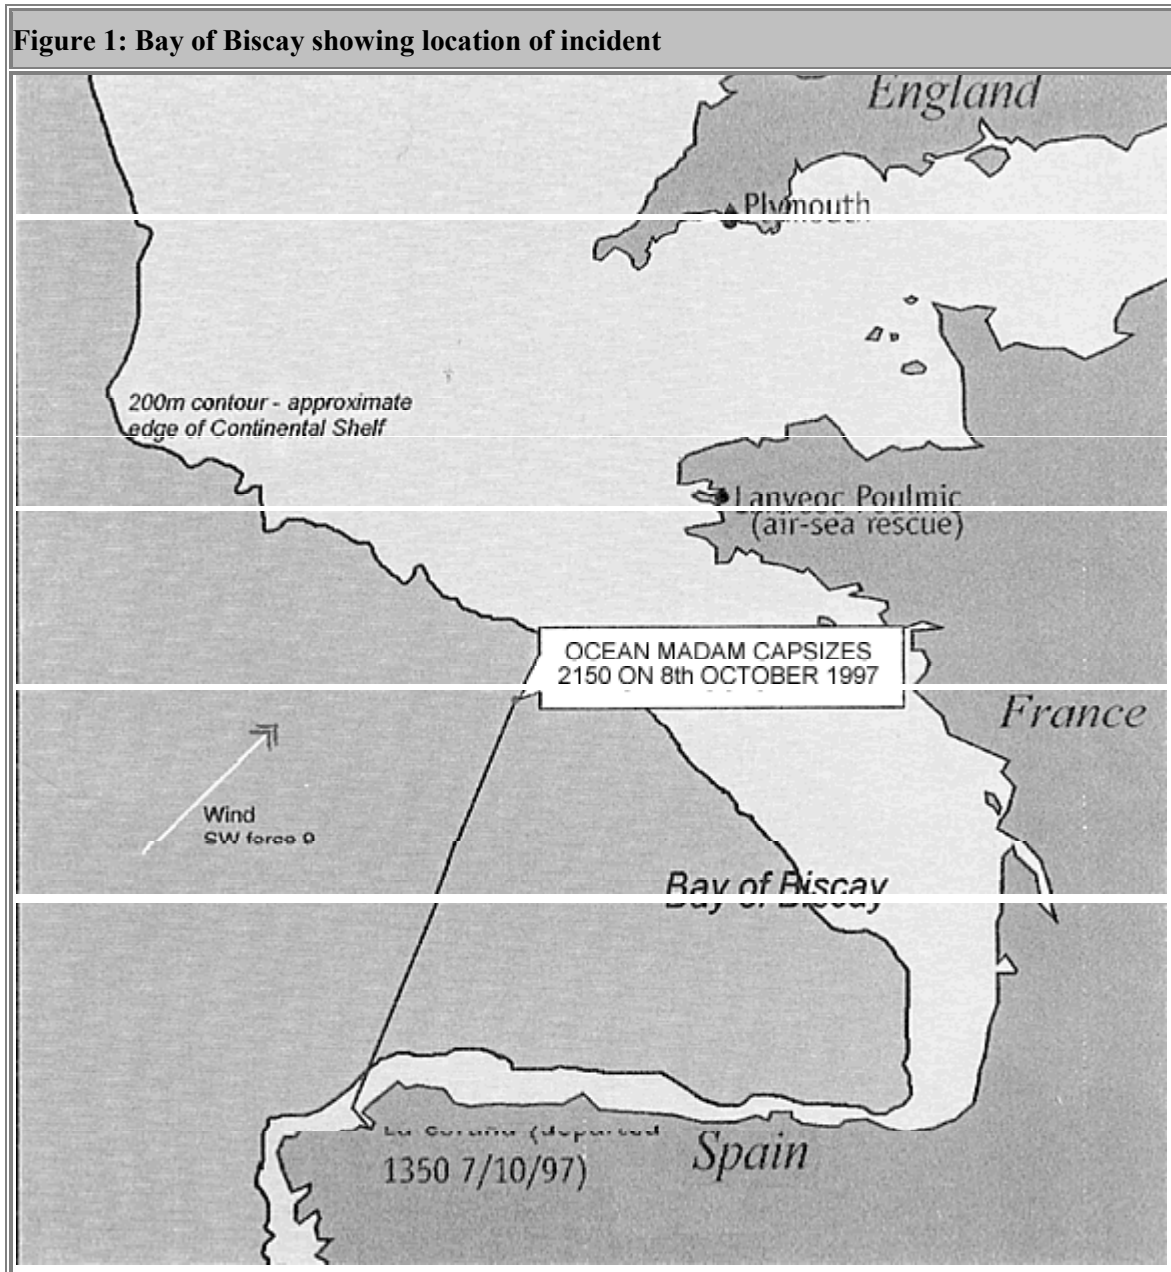
With one of the crew at the helm, and under shortened sail in the dark, the yacht was laid flat by a wave. She righted immediately but the event alarmed both skipper and crew. The skipper took over the helm and retained one of the crew on deck to help him. An hour later the yacht was knocked down again but this time she inverted and failed to recover. Once he realised she was not going to right itself, the skipper extricated himself from the submerged cockpit and found his way to the surface where he managed to cling to the transom-mounted boarding ladder.

After an indeterminate period the yacht righted herself and this enabled the skipper to climb back on board. On regaining the cockpit he discovered that the yacht had been dismasted and that he was alone. There was no sign of the crewman who had been on watch with him. When last seen he been wearing a lifejacket and safety harness and had been clipped on. There was no indication of harness failure so it is assumed he had unclipped himself when trapped under water.

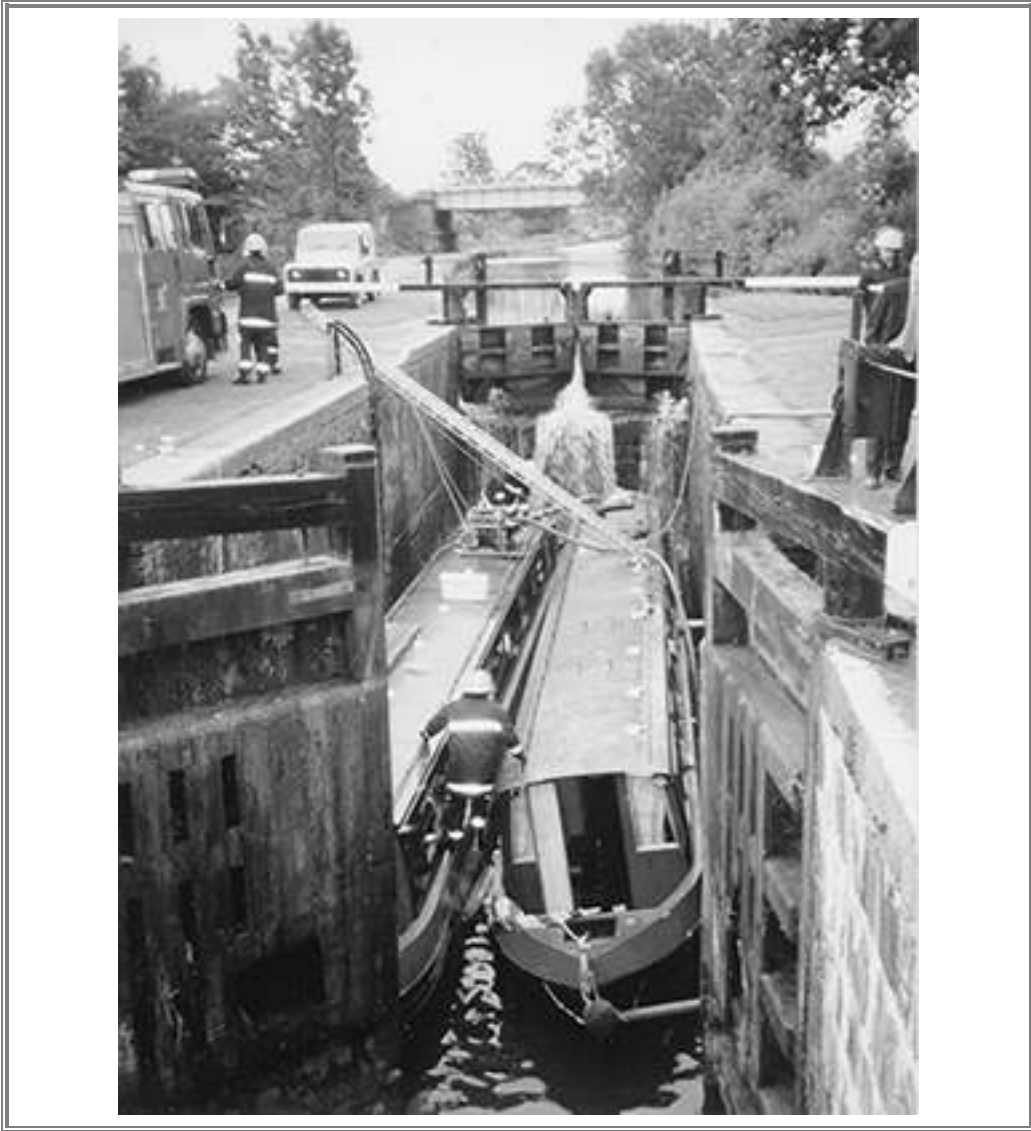
**Drum Major in Steg Neck Lock**

Both paddles were opened to release water from the lock and the level started to go down. Shortly afterwards it was realised *Drum Major's* bow fender (commonly known as a turks head) had caught in the narrow gap between the balance beam and the top of the gate. As the water level continued to be lowered, frantic efforts were made to release the fender. They failed and she became suspended by the bow. She assumed an increasing bow up angle until the stern was sufficiently depressed to allow water to start pouring in over the stern and into the accommodation.

- 2. This accident draws particular attention to the need to check that the bow fender is clear of the adjacent gate and cannot be caught as the level is lowered. Before any paddle is opened to empty a lock, a positive check must be made that it is clear before, and immediately after, they are fully opened. If there is a problem, the paddles must be shut as fast as possible.**

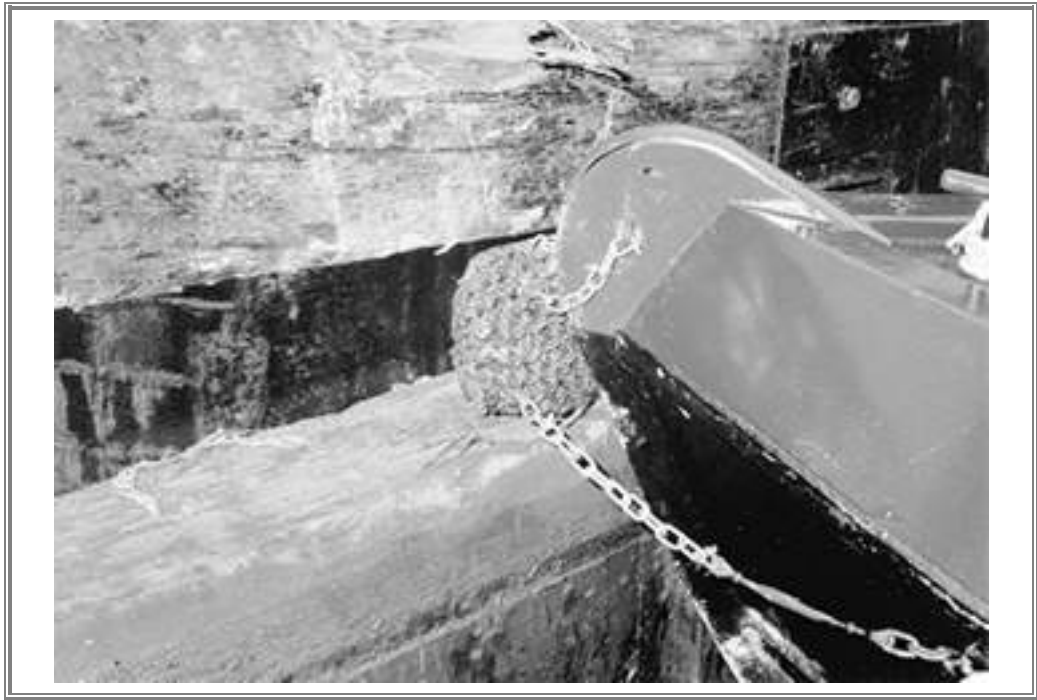
**Drum Major fender caught on the lock gate**
