## MARINE INVESTIGATION REPORT

M09C0029

EXPLOSION

TANKER *ALGOCANADA*

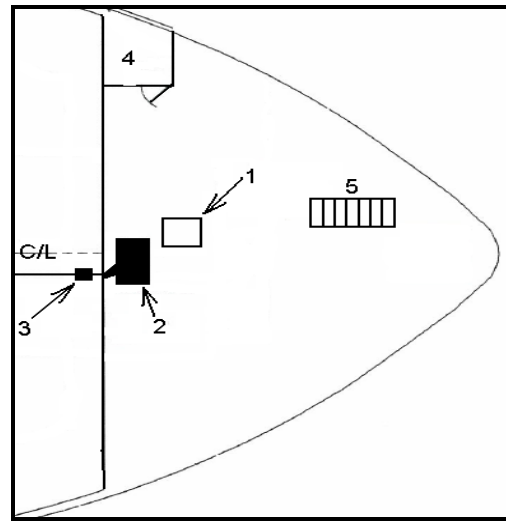
The vessel was initially equipped with an approved tank-drying system<sup>2</sup>, as well as portable water-driven air fans for ventilating. The tank-drying system includes a fan unit located in the forecastle adjacent to the aft bulkhead. This fan unit was connected to piping, which penetrates the bulkhead and was in turn affixed to a double, non-return valve situated in the deck trunk (see Figure 1).<sup>3</sup>

**Figure 1.** Arrangement of tank-drying unit and forecastle

- On the *AlgoCanada*, a blank flange was fitted to the fixed tank-drying system between the fan unit and the distribution system.

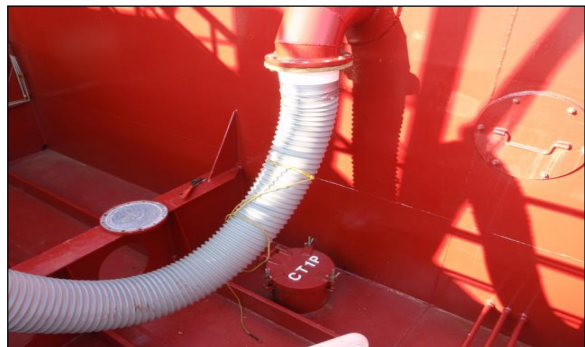
At about 0930, the GPs removed the tank-drying flange covers and hooked one end of the flexible hoses to the tank-drying system (see Photo 2). At 0944, the other ends of the flexible hoses were inserted through the tank-cleaning hatches close to the bottom of tanks No. 1 port and starboard. The GPs then proceeded aft to assist with the pilot transfer.

**Photo 2.** Flex hose to the tank-drying system

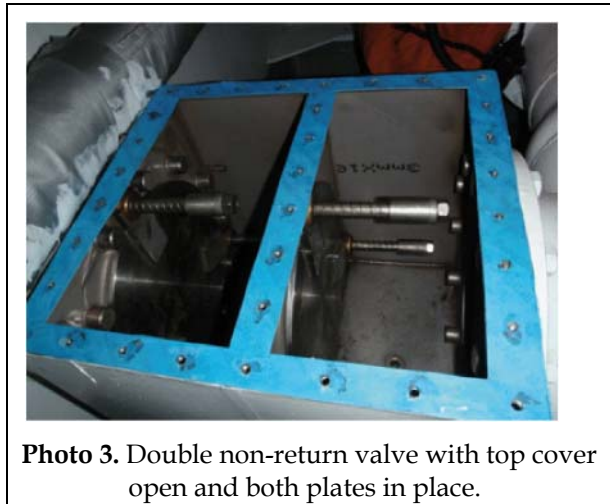
**Photo 3.** Double non-return valve with top cover open and both plates in place.

Prior to this voyage, a modification on the tank-drying system was performed by the vessel's crew in order to speed up venting times.<sup>11</sup> The company was aware of the modification and had provided instructions for the removal of 1 of the 2 baffle plates in order to improve the air flow of the tank-drying system (see Photo 3). However, neither the valve's manufacturer nor the classification society was consulted.

It was the practice on the *AlgoCanada* to use the tank-drying system to vent and gas-free the cargo tanks. However, the air flow of the tank-drying unit was found to be inadequate for this purpose. Modifications to the double non-return valve were subsequently performed, which included the removal of 1 of the 2 valve plates. This improved air flow and shortened ventilation times.

Neither the valve's manufacturer nor the classification society was consulted regarding the valve's modification, which had effectively rendered it a single, non-return valve. Given that the

vapours were subsequently able to migrate into the forecastle and bow thruster compartment, the remaining single valve plate was not an effective seal.

- The *AlgoCanada*'s fixed tank-drying system was switched off and fitted with a lock so that it could not be operated. The master posted a notice indicating that the system was not to be used.
- Blanks were fitted to each of the tank-drying system's outlet covers on both *AlgoCanada* and *AlgoNova*. These blanks are fitted with locks, preventing connection of the cargo tanks to the tank-drying system and forecandle space.
- On the *AlgoCanada* and *AlgoNova*, both double non-return valve plates were reinstalled.

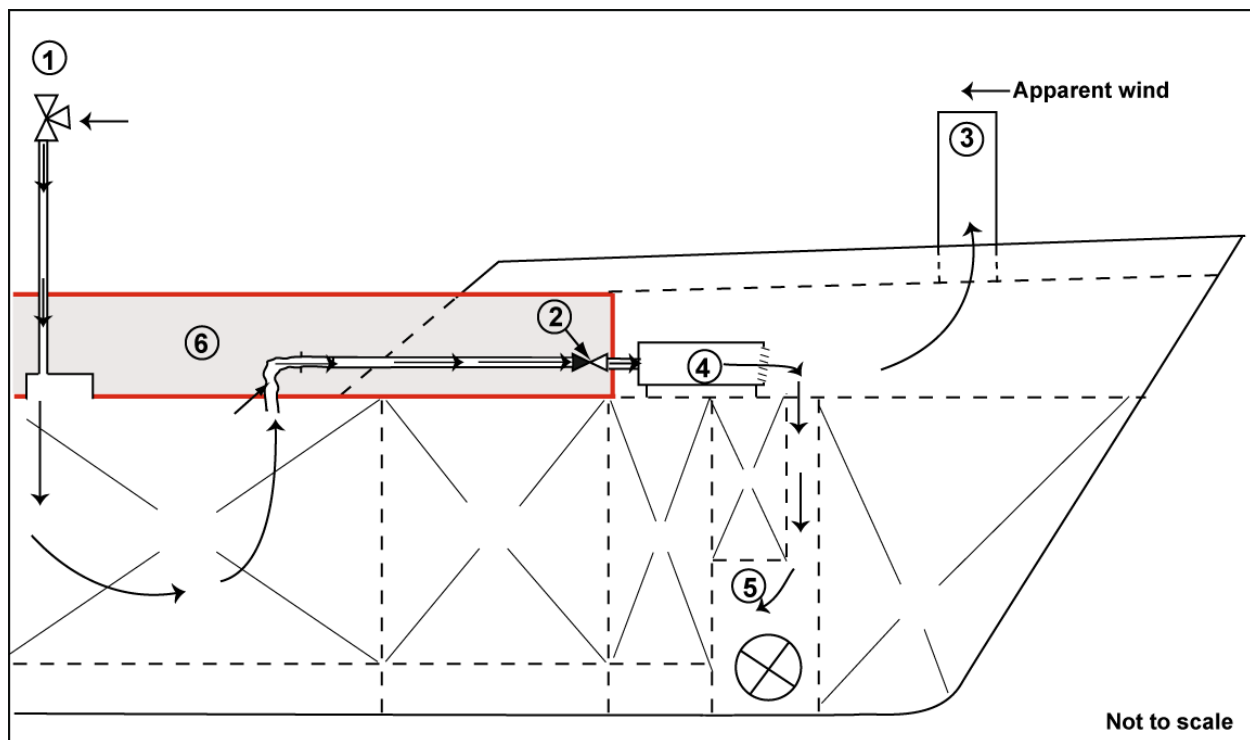
In this occurrence, given that the forecastle door was open, the apparent wind across the vessel's bow created an area of lower pressure in the forecastle. This, coupled with the open PV valves, induced a flow of gasoline vapours from the cargo tank into the forecastle through the drying unit and the modified non-return valve. Once the heavier-than-air vapours passed through the tank-drying unit, they settled downward and into the bow thruster compartment (see Figure 3).

This compartment contained a heater unit that was automatically controlled by a thermostat, along with electrical lighting fixtures and a ventilation fan, none of which were explosion-proof. Smoke and burn patterns on the electric heater indicated that it was likely the ignition source.

Figure 3. Migration of flammable vapours from cargo tank to bow thruster compartment
