MARINE INVESTIGATION REPORT

M17A0004

Grounding

Bunkering tanker *Arca 1*
Little Pond, Nova Scotia
08 January 2017

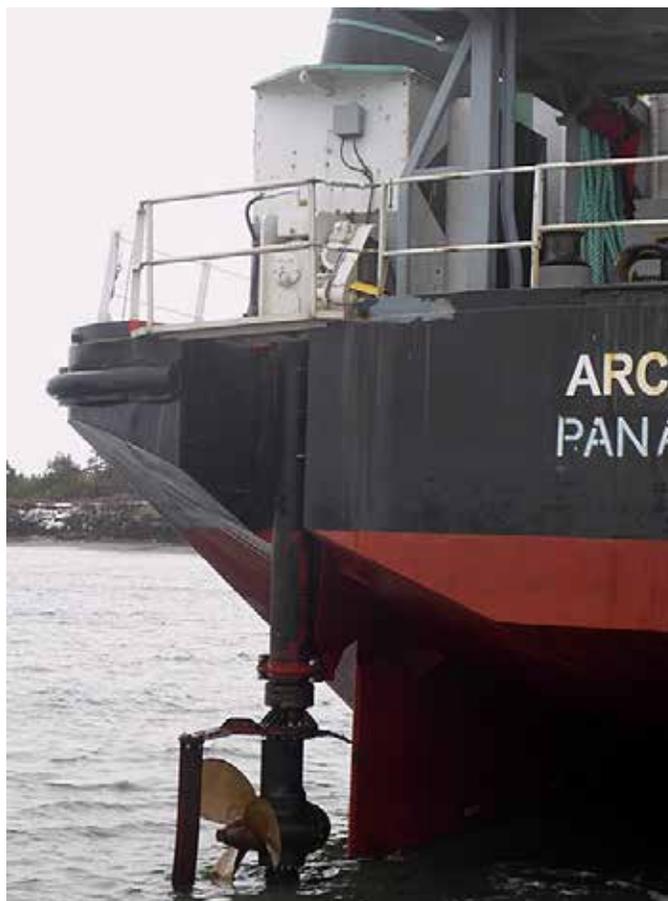
Figure 2. Port Z-drive

During the occurrence, the friction plate on the port propulsion clutch arrangement slipped, which caused overheating and led to the failure of the clutch.

The starboard Z-drive separated from the mounting arrangement when the vessel contacted the bottom, causing the destruction of the starboard transmission. The outer hull was indented, and several transverse members sustained damage.

The crew was not aware of previous maintenance carried out on the vessel, and the vessel had been out of service for 2 years. The clutch had been visually inspected, and its operation was verified before departure; however, the tension on the main propulsion clutch was not checked and adjusted before or during the voyage as per the original equipment manufacturer's recommendation. Clutch slippage occurred and caused the loss of port propulsion.

1. The tension on the main propulsion clutch was not checked and adjusted before or during the voyage as per the original equipment manufacturer's recommendation. As a result, clutch slippage occurred and caused the loss of port propulsion.
