National Transportation Safety Board

Marine Accident Brief

Diesel Generator Failure aboard Offshore Supply Vessel *Red Dawn*

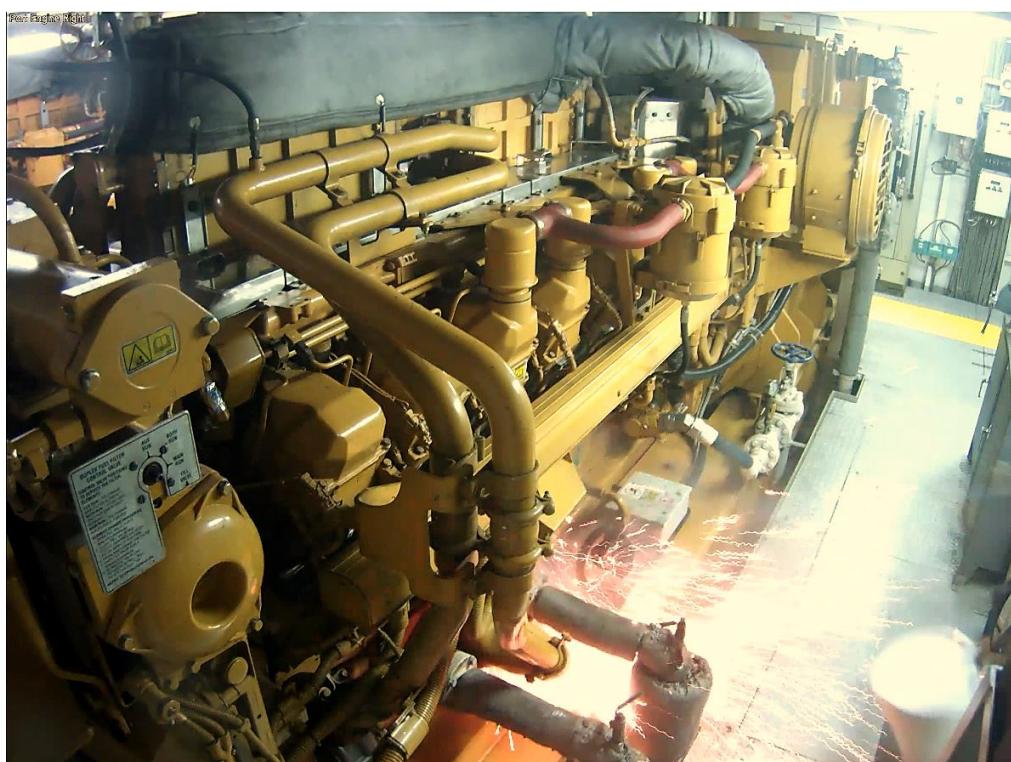
Screenshot from closed-circuit television at the time of the failure, looking aft from the inboard side of MDG no. 2.

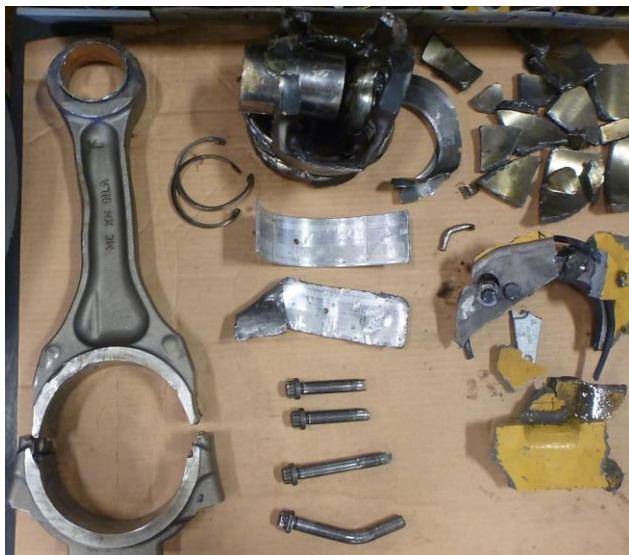
- Cylinder no. 8's connecting rods, caps, bearing halves, and bolts were also collected and analyzed. Three of the four connecting rod bolts sheared at the threaded end of the bolt. The fourth connecting rod bolt was bent at a 45-degree angle, but the threaded end was intact.

Connecting rod, cap, bolts, and bearing halves of cylinder no. 8. (Photo by Coast Guard)

Based on the forensic analysis and teardown of MDG no. 2 and the appearance of cylinder no. 8's connection rod bolts and cap and bearing assembly, investigators determined that one of the four connecting rod bolts on cylinder no. 8 backed out of the internal thread of the connecting rod. Once this bolt backed out, the remaining three bolts became overloaded. It appeared that repetitive impact occurred as the connecting rod cap loosened, resulting in the remaining three bolts shearing off.

The two Caterpillar technicians who conducted the overhaul on MDG no. 2 the previous month stated that they followed company procedures and that they tightened the connecting rod bolts using a company-issued and calibrated torque wrench in accordance with the manufacturer's specifications. However, based on the findings of the circumstances pertaining to the rod assembly's failure, the bolts were likely under-torqued during the overhaul.
