**CRANKCASE EXPLOSION
CASUALTY INVESTIGATION**

BRITISH VALOUR - OFFSHORE BERMUDA

23.03hrs (GMT) 18 MARCH 2001

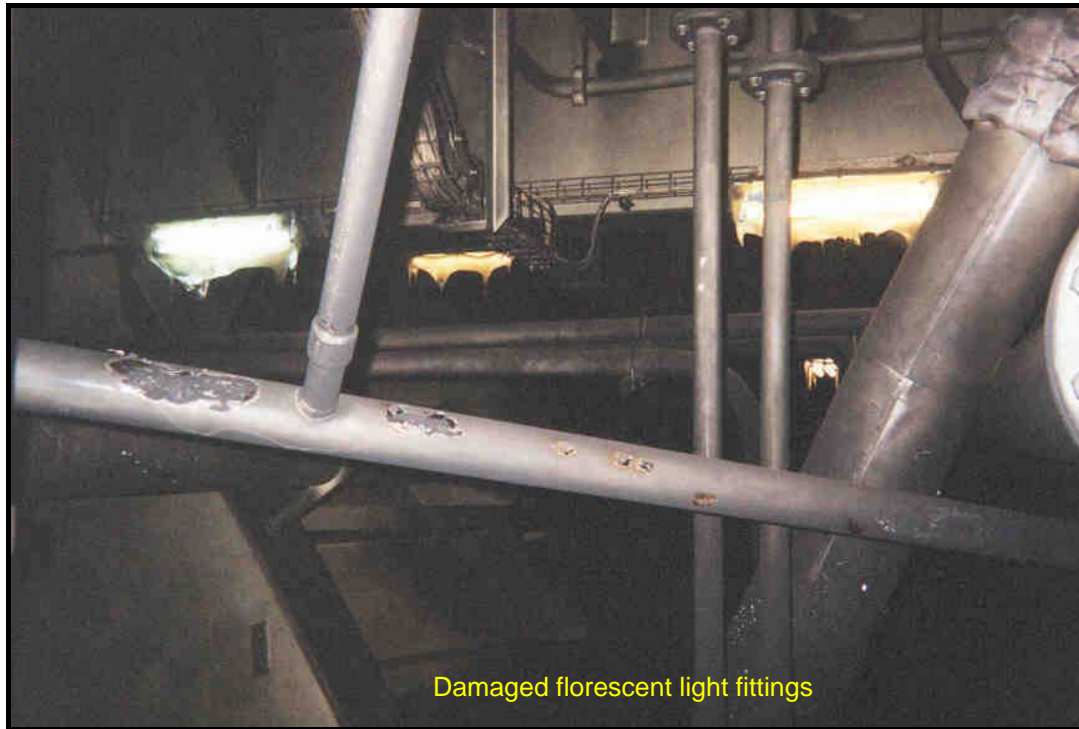
- 2.9 Significant soot and smoke damage on the starboard ships side, plates, walkways, pipes and ducts was apparent.
- 2.10 A number of fluorescent light diffusers had largely melted away, the area from the bottom plates level right up to cylinder head level on the starboard side of the engine room was affected

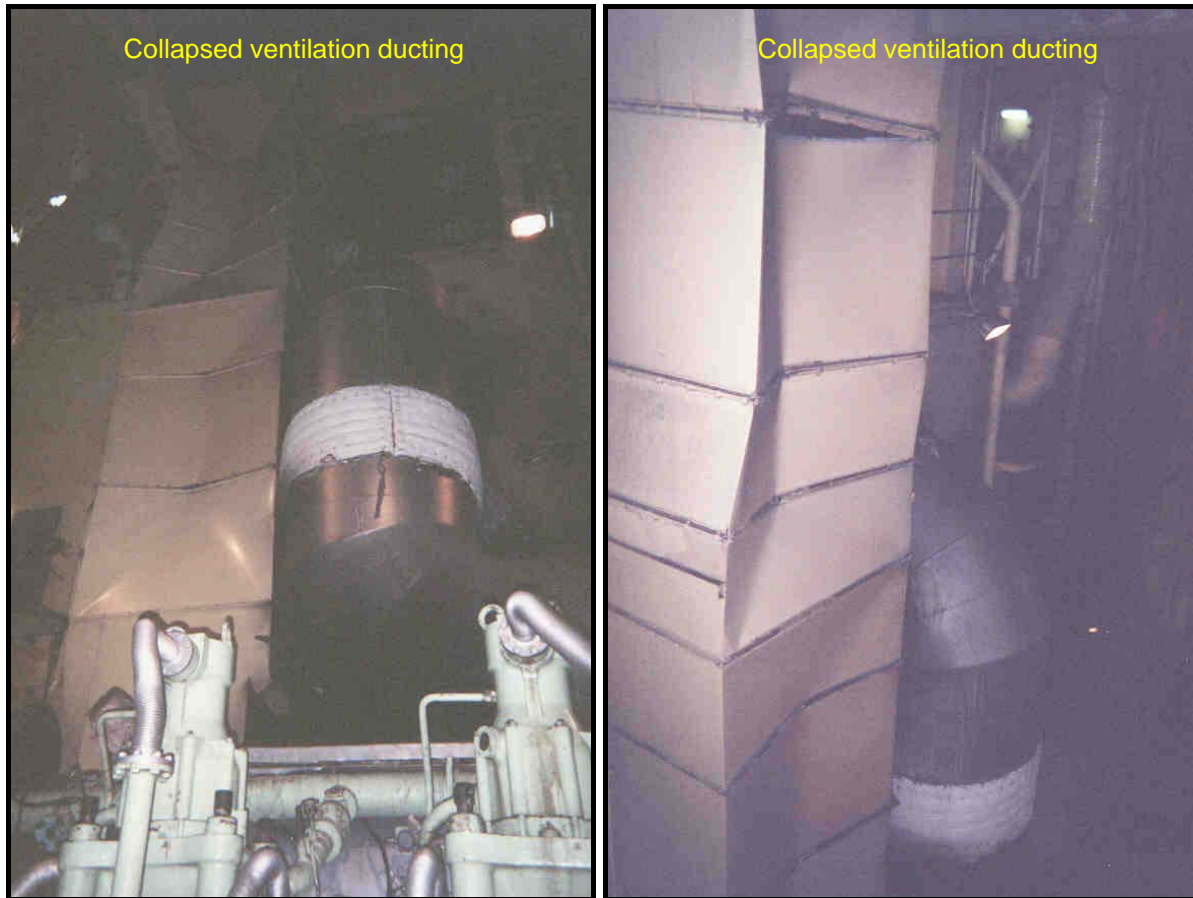
2.13 Engineroom ventilation ducting was significantly deformed, dislodged or collapsed and acoustic insulation was found littered over the after deck .

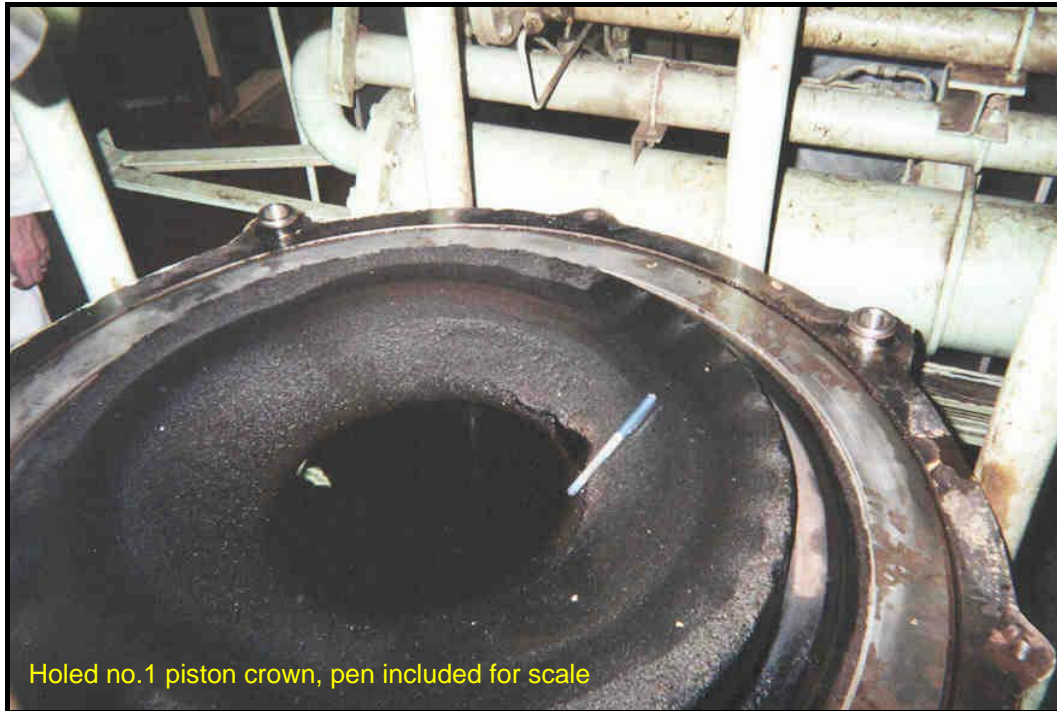
- 2.16 No.1 Piston crown was found to be cracked and holed which penetrated to the oil cooling space thereby allowing direct communication of the combustion space with the crankcase via the cooling oil passages and would indicate a probable initiation site.

- 4.3 Unusually large piston crown wear had occurred since overhaul in dry-dock in October 2000, the evidence gained indicates fuel impingement from poor atomisation which caused localised overheating and cooling oil breakdown on the internal surfaces of the crown and in turn increased the high temperature erosion in the areas of failure, ultimately leading to the mechanical failure of no.1 and no.6 piston crowns.
