MARINE INVESTIGATION REPORT

M99L0011

COMPRESSOR BURSTING

ON THE CONTAINER SHIP "CANMAR SPIRIT"

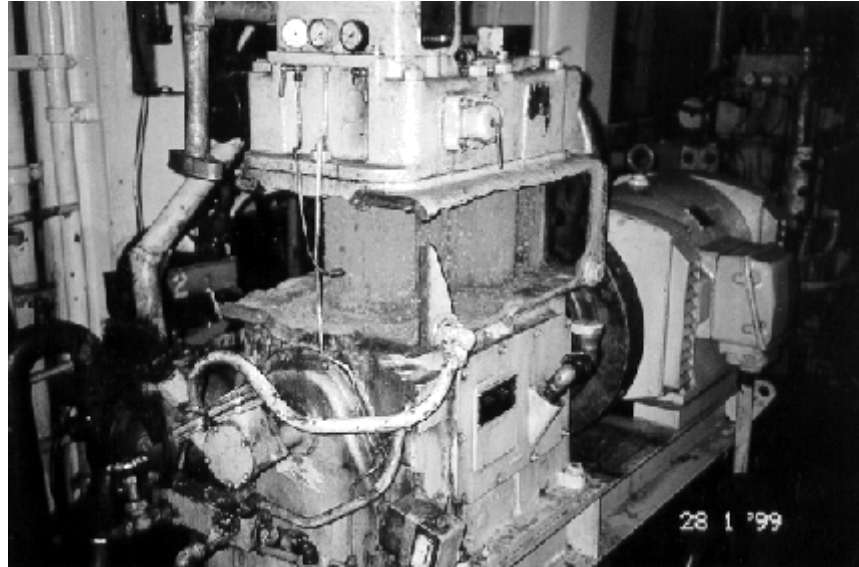
12. The cooler tubes revealed corrosion pitting attributable to the less-than-adequate use of anti-oxidant additives in the cooling water. This does not seem to be a significant factor in this accident.
13. The compressor casing burst open in way of the cooling water chamber due to a severe and near instantaneous over-pressurization. The cooling water relief valve seems to have been operable but in all likelihood could not handle the rate of expansion associated with the complete and near instantaneous failure of the high-pressure cooler tubes at pressures at or above 4,000 psi.
14. The majority of the engine-room crew and the master were experienced mariners but this was their first tour of duty on board the "CANMAR SPIRIT".
15. Some of the crew members reported being under pressure and stress following the accident but relief and assistance were neither requested nor offered.

Photo 1. Fractured compressor water jacket casing after removal of coolers.

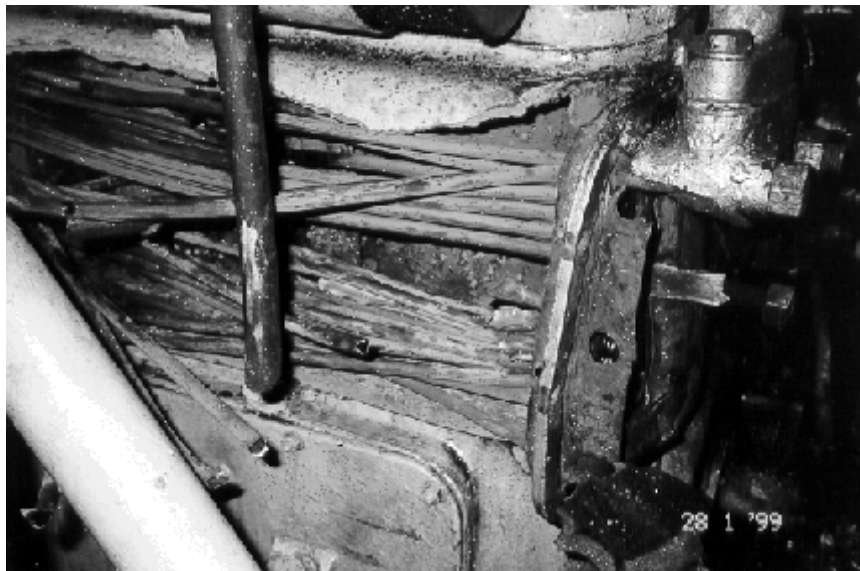
While none of the first-stage cooler tubes had failed, 18 of the 33 tubes that make up the second-stage tube nest failed in a manner consistent with an over-pressurization. Microscopic examination revealed no evidence of pre-cracking on the fracture surfaces of the tubes. Also, there was no indication of overheating or any evidence of combustion as would be expected subsequent to an explosion-type occurrence. The evidence therefore points to a bursting-type occurrence.

Close examination and testing of both first-stage and second-stage air cooler tubes indicate that the first-stage tubes met manufacturer's specifications but the second-stage tubes did not. Specifically, the manufacturer specifies copper tube BS2871 which contains a minimum of 99.85 per cent copper and a wall thickness of 0.91 mm for both first- and second-stage tubes. The composition of the second-stage tubes installed on the compressor was found to be consistent with a UNS C68700 aluminum brass alloy, with wall thicknesses on average only half that of manufacturer's specifications.

9. Of the 33 second-stage cooler tubes, 18 failed during the over-pressurization of the compressor.
10. The second-stage cooler tubes did not meet manufacturer's specifications with respect to material, outside diameter and wall thickness. Wall thickness was found to be, on average, half that of manufacturer's specifications.

Photo 2. Burst high pressure air cooler tubes and fractured casing.

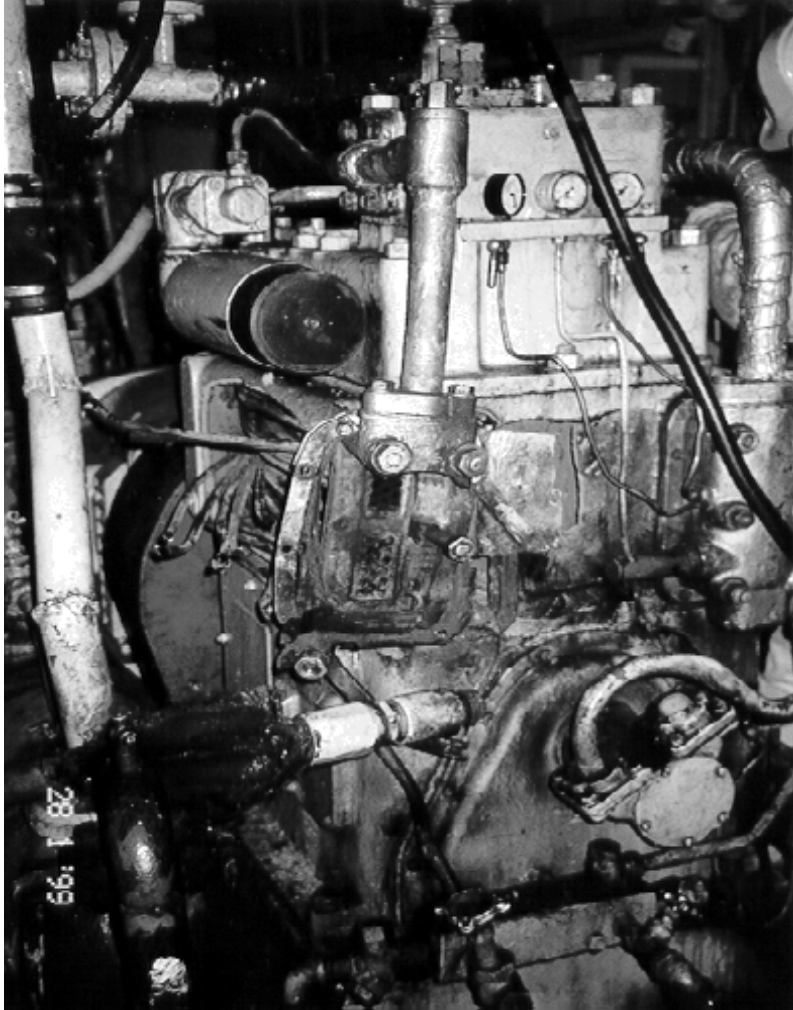
The second-stage air cooler cover contains a drain valve, a fusible plug and the high-pressure relief valve. At the time of the failure, this cover fractured into many pieces that were projected outward at high velocity. An optical microscope examination revealed fracture surfaces consistent with a brittle mode of failure such as would be present in an instantaneous overstress. No evidence of pre-cracking was observed.

6. The fracture surfaces on the second-stage outlet cover were consistent with an instantaneous failure with no evidence of pre-cracking or previous repair. The cover fractured into many fragments that were projected outward at high velocity.

Photo 3. Damaged compressor showing burst air cooler and cover.
