MARINE SAFETY ALERT

Safety Alert 07-19

For want of a watchman the ship was lost. Invest to protect your assets.

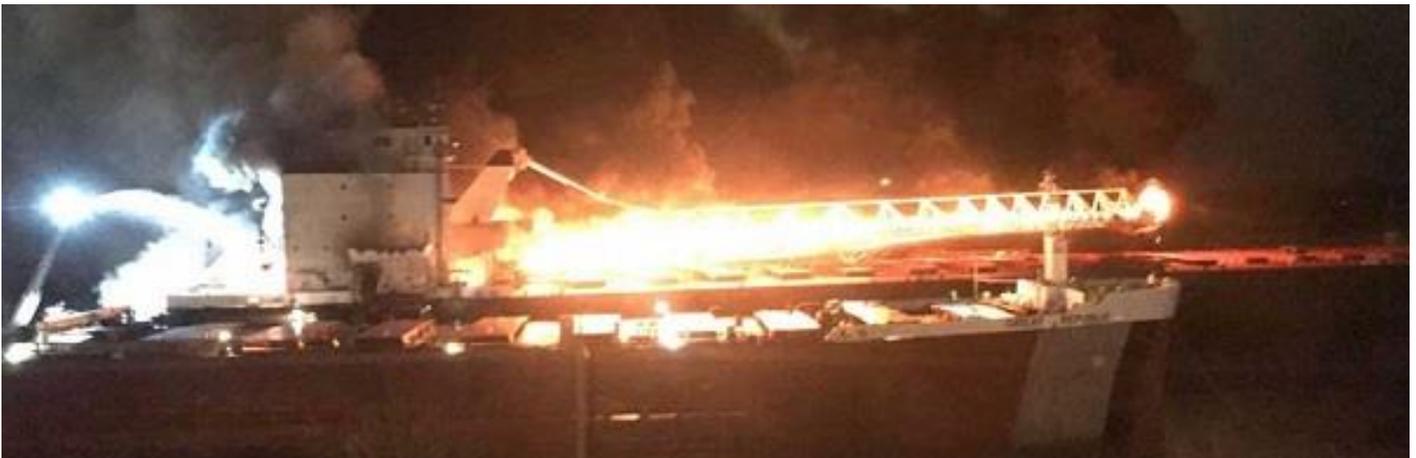
A U.S. inspected Great Lakes bulker that was laid up for the winter suffered a catastrophic fire that caused major cosmetic, machinery, and structural damage. The vessel was unmanned and vacant at the time the fire was discovered although there was normally a ship watchman onboard. On the day of the fire a working crew had been onboard and welding had taken place in the ballast tanks and conveyor tunnel areas. The last worker from the welding crew departed the vessel at 1800. The fire was first observed at 2000 by a ship watchman on a nearby ship. The ship watchman assigned to the vessel that suffered the casualty, who normally stays on board during the lay-up period, went home for the weekend earlier on the day of the fire.

The fire appeared to have originated in the machine shop on the gangway deck, above the lower main engine room space. Numerous possible sources of ignition were identified; propane heaters, electric heaters, and heat lamps were being used in the machinery space. Evidence revealed that the work crew used the machine shop and steering gear rooms to warm-up during their work breaks. The electric heaters in those spaces were left energized prior to the fire. All of the other vessel machinery was shut down.

Investigators were not able to access the vessel for 11 days following the incident. When they did they were unable to identify a specific source of the fire, but they ultimately concluded that the fire started in the machine shop area where numerous electric heaters had been energized for weeks.

As a result of this casualty the Coast Guard **strongly recommends** that vessel owners and operators of all merchant vessels in lay-up status, particularly those utilizing shore power and on which work is being performed;

- Ensure that continuous fire, safety, and security watches are maintained and that the watchmen are provided specific written instructions regarding their duties in the event of a fire or other emergency situation; and
- That persons with vessel engineering experience and knowledge of engine room systems are used during lay-up preparations to prevent unintended circumstances such as the flooding of the machinery space in this instance.

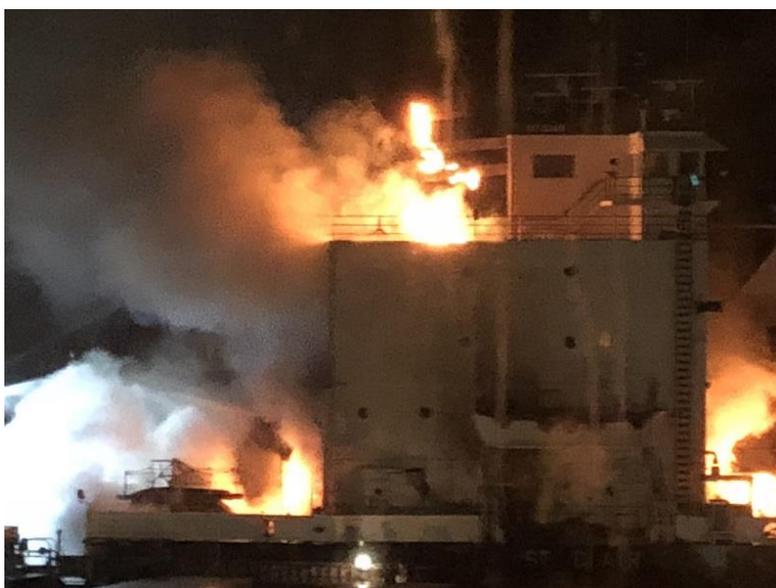
During the fire and due to the power loss, the bubbling system used to prevent freezing around the machinery space area of the hull failed. As a result and because of the several days of freezing weather, various piping systems failed and allowed water to flood the machinery space. The flooding continued until divers were able to secure the flow from the sea chest.
