Marine Accident Investigation Branch (MAIB) - Safety Digest 02/1999

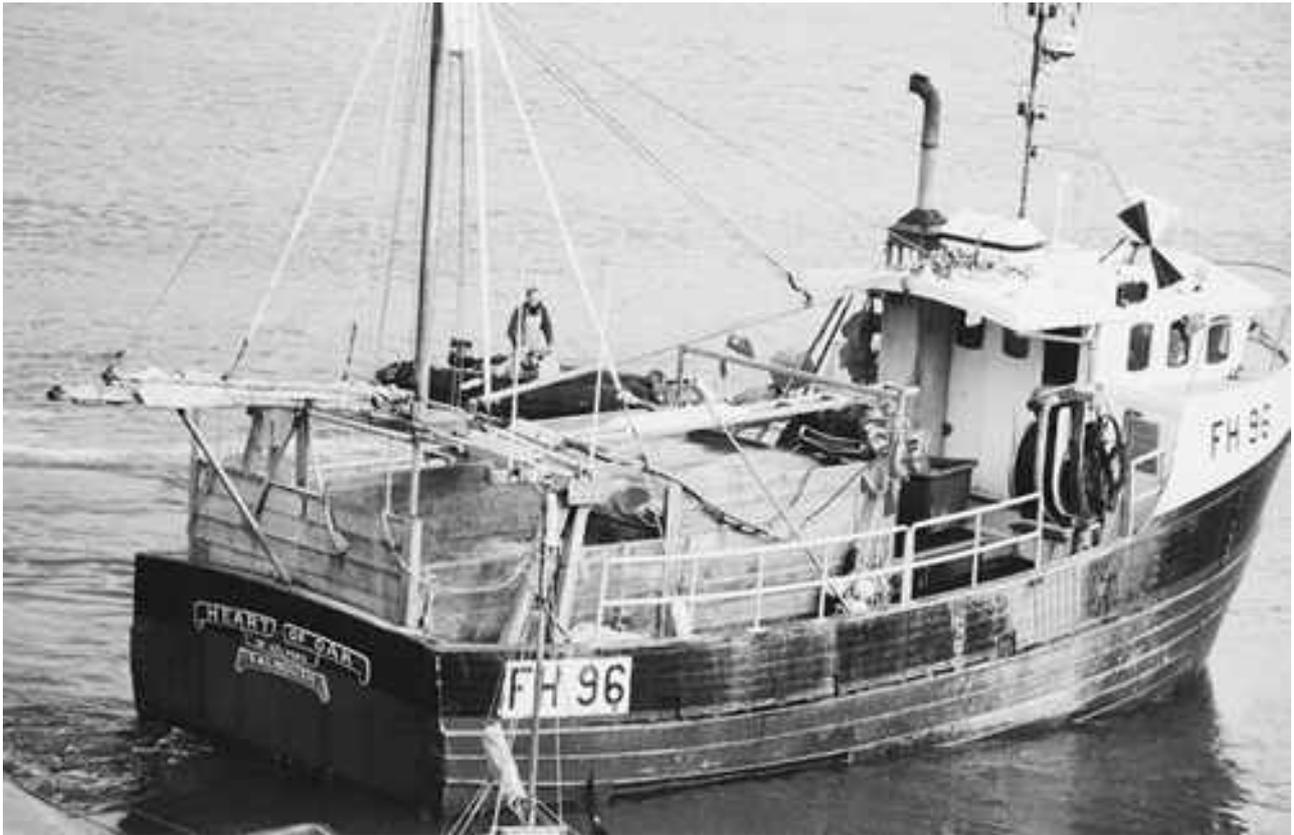
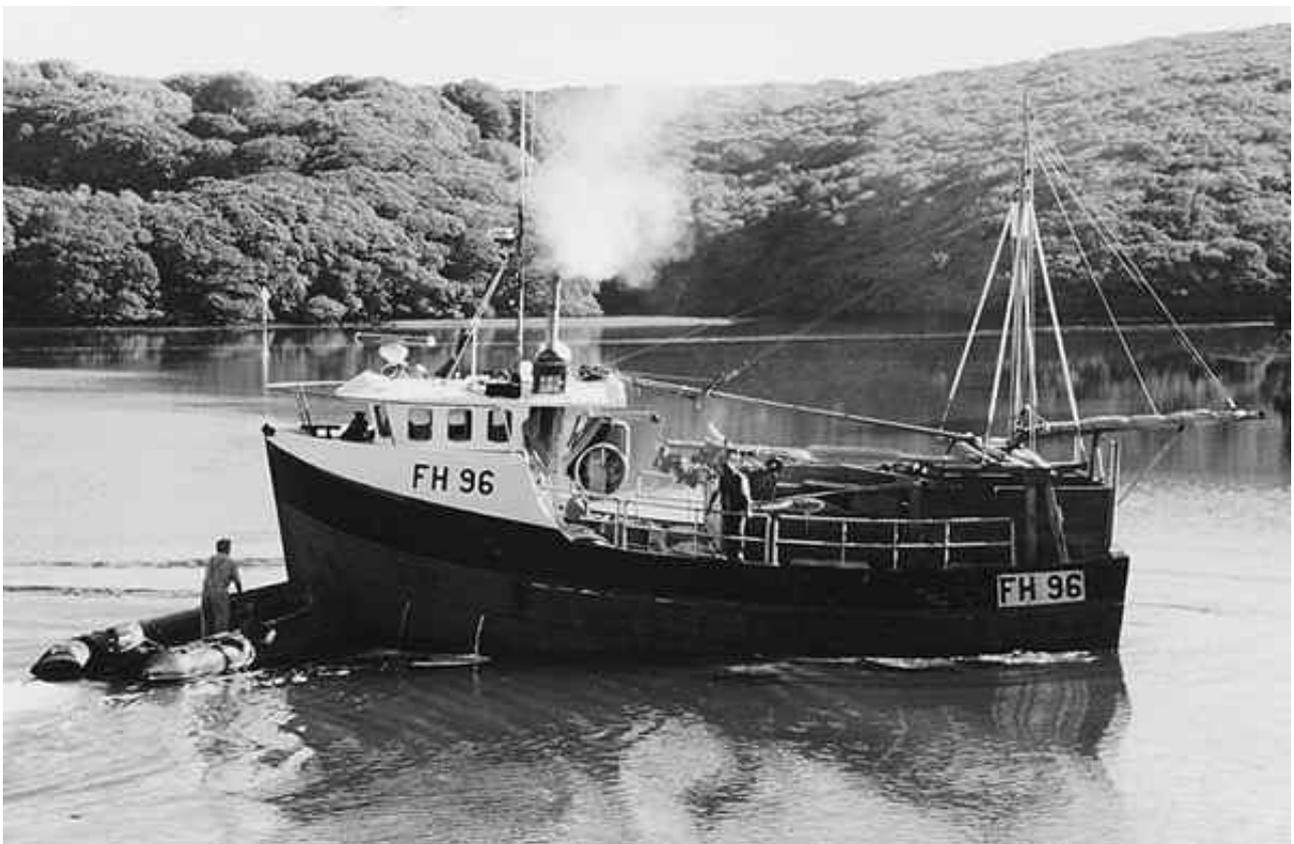
Heart of Oak of Helford

While making way in the heavy swell the vessel started to roll heavily and the partially full net bin slid from where it was stowed, starboard of amidships, to where the deckhand was working. He raised himself up to try and fend it off but was caught by the bin and lost his balance. He fell overboard.

Since this unfortunate accident, the owners of the vessel have fitted aluminium rails round the working deck and the crew now wear single chamber self-inflating lifejackets at all times when working on deck.

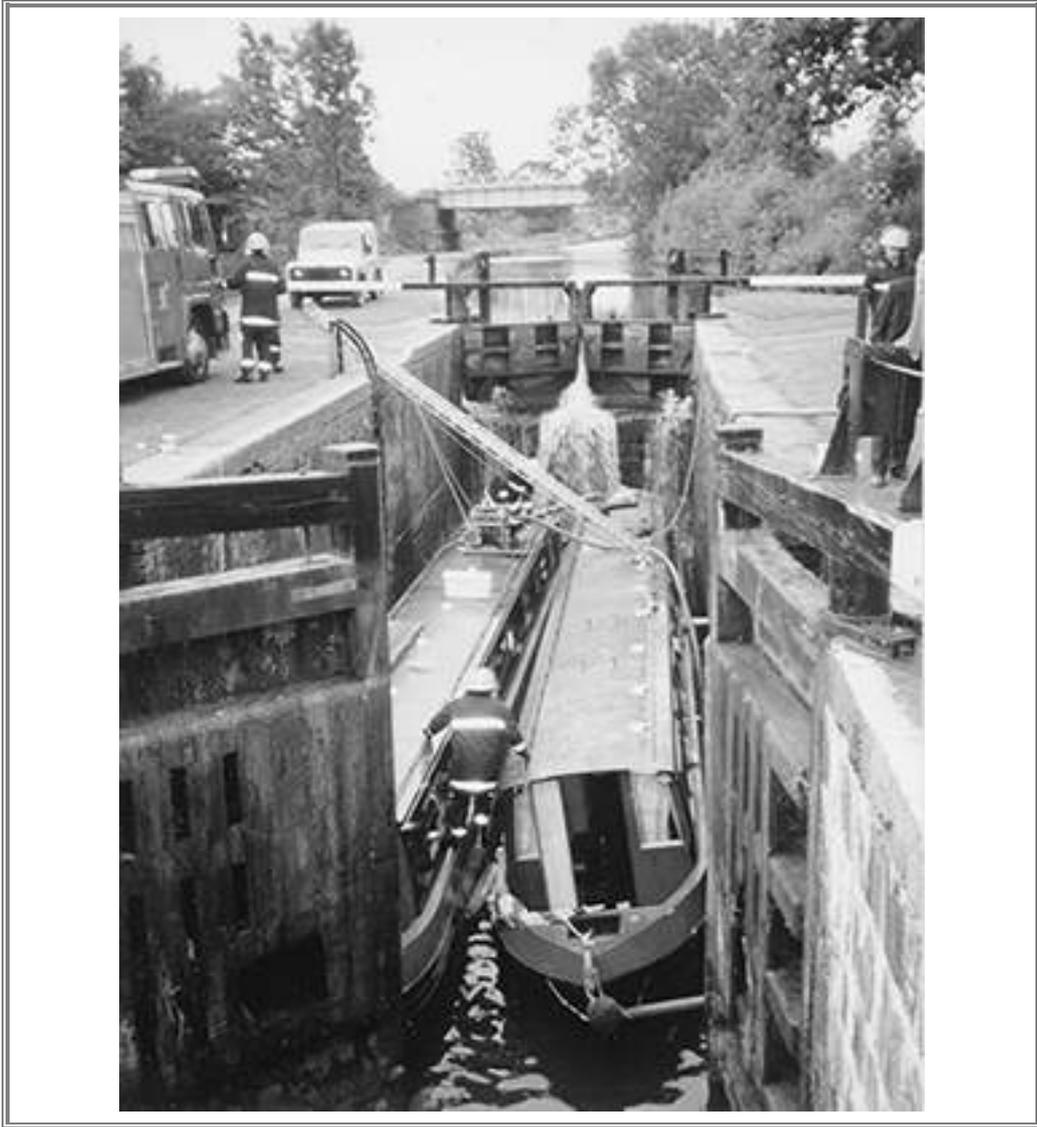
Drum Major in Steg Neck Lock

- 2. This accident draws particular attention to the need to check that the bow fender is clear of the adjacent gate and cannot be caught as the level is lowered. Before any paddle is opened to empty a lock, a positive check must be made that it is clear before, and immediately after, they are fully opened. If there is a problem, the paddles must be shut as fast as possible.**

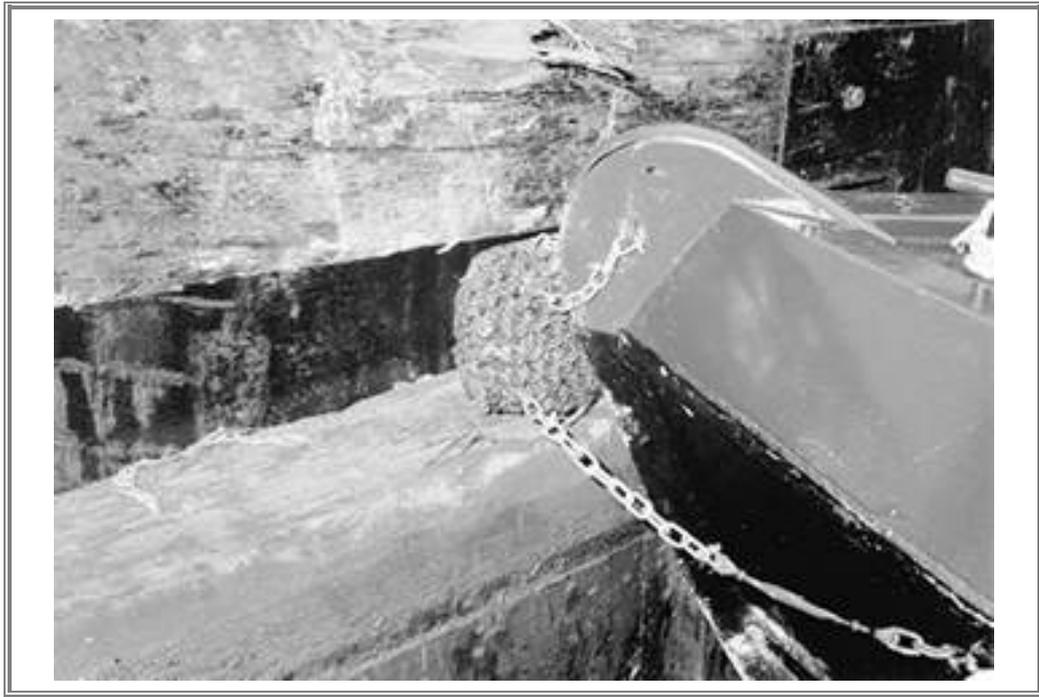
Drum Major fender caught on the lock gate
