**SAFETY STUDY 1/2001**

**REVIEW OF  
LIFEBOAT AND LAUNCHING SYSTEMS'  
ACCIDENTS**

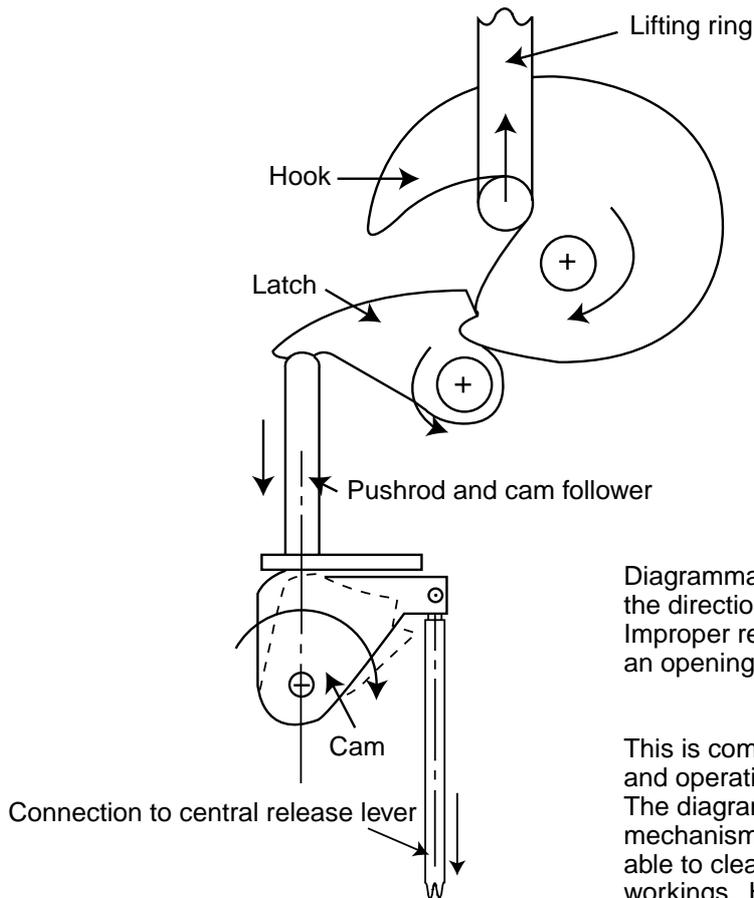
Figure 1

It has been found that crews generally have a poor understanding of the operating principles involved with release hooks, often because of inadequate training. This is not the only reason. Poor labelling, complex mechanisms and hard to follow operating instructions in some manufacturers' manuals have also featured as contributing factors **(see Figure 1)**.

Diagrammatic arrangement of hook release mechanism and the direction of movement of its components during release. Improper resetting of the cam, as shown dotted, can induce an opening moment leading to inadvertent release.

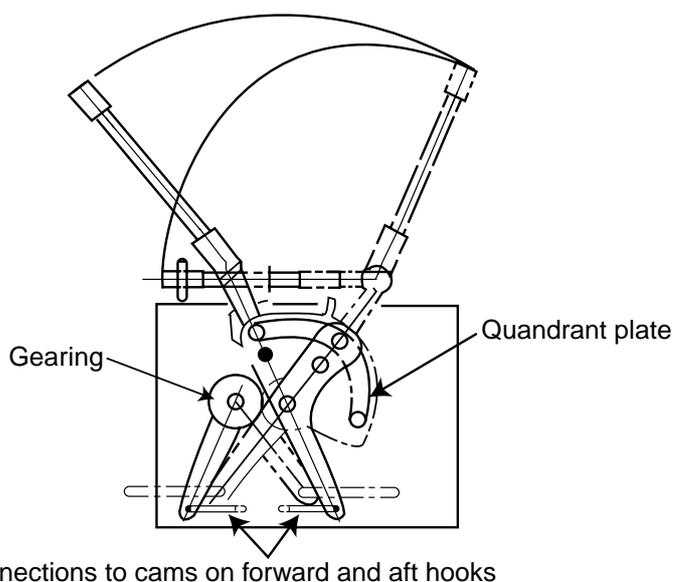
This is compounded by the complexity of the mechanism and operating instructions that are difficult to understand. The diagram, showing the important features of resetting the mechanism, is complicated and makes it necessary to be able to clearly see the actual mechanism to understand its workings. However, viewing the mechanism is difficult, making understanding of the diagram difficult. Other material in the manufacturer's instruction manual was of little help in this task.

The central operating lever is placed adjacent to the coxswain's position, often in such a fashion that the gearing, quadrant and very important safety pin cannot be viewed easily. Indeed it is often impossible for the user to obtain the same view of the mechanism as it is shown on the instruction panel, he can see it only from above, making the important components difficult to identify. This problem is aggravated by these parts being below the bottom boards of the boat in an area of darkness.

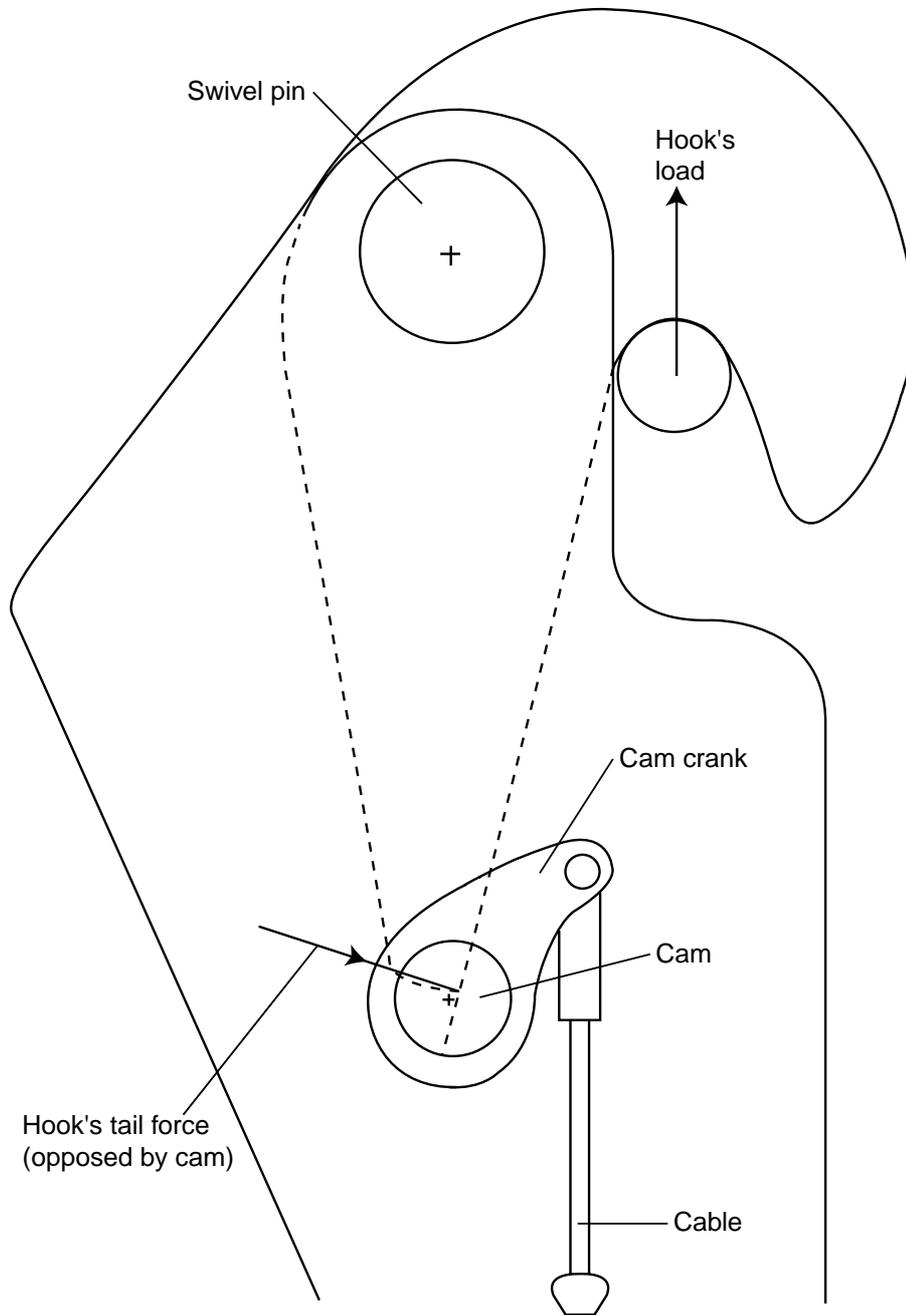
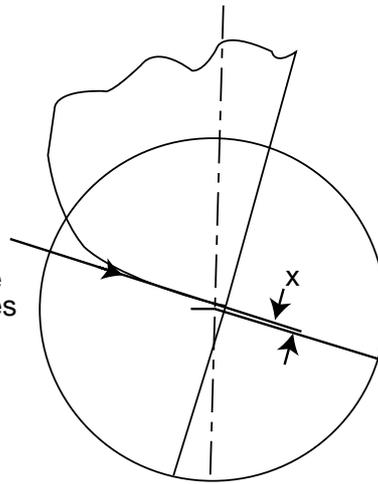
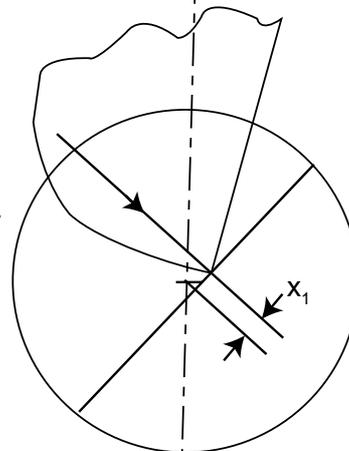
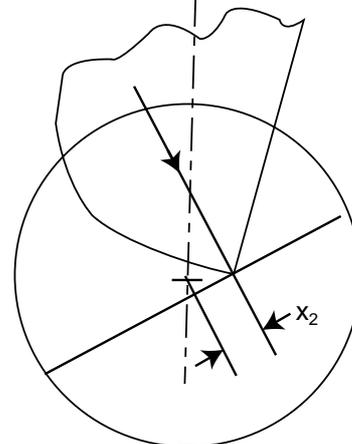
Figure 2

Analysis of a number of accidents reveals that premature hook release has often been caused by the failure to re-set it correctly when the lifeboat was being recovered from its previous launching. This shortcoming stems from a lack of understanding of the mechanism involved, inadequate training and poor maintenance. Once the hook has been incorrectly reset, spontaneous release is possible at any time before the lifeboat is next put in the water **(see Figures 2 and 3)**.

Hook and cam in fully closed position. Flat face of cam and tail of hook are in contact. This gives the minimum lever 'x' by which the force from the hook's tail generates an opening moment on the cam. This moment is resisted by the moment generated by the cable force.

Partially closed condition. Improper resetting of the cam when a boat is being recovered might generate this state. Can be aggravated by sticky cables. The size of the lever ' $x_1$ ' is much greater than that for the fully closed position ' $x$ '. This allows the force from the hook's tail to generate a much larger opening moment on the cam. It is possible for this moment to overcome that generated by the cable leading to rotation of the cam and spontaneous opening of the hook.

Further rotation of the cam leads to increase in the size of the lever to ' $x_2$ '. The moment generated on the cam is so large that it will almost certainly overcome the moment generated by the cable force. The hook is then able to fully open.

The above sequence shows the magnification in hook opening effects due only to the growth in lever of the force in the hook's tail. Other changes take place as the cam's face rotates, which result in an increase in magnitude of the hook's tail force and thus also the cam rotating moment. All of these effects indicate the importance of properly resetting the cam when recovering a boat.

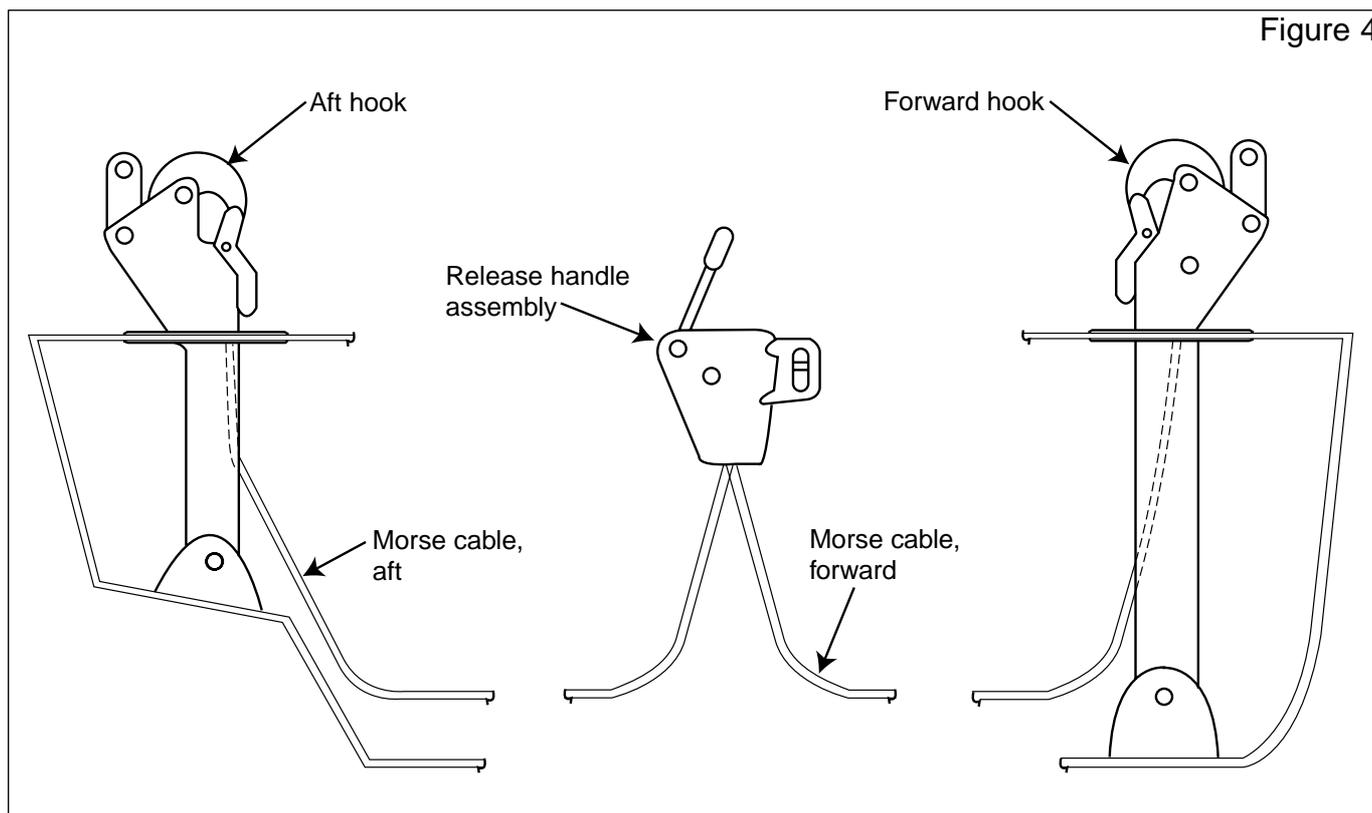
Figure 4

To comply with the requirement that both hooks are released simultaneously from a single control position, it is common for release mechanisms to include flexible cables to connect the control lever to the hook mechanisms (**see Figure 4**).

The MAIB has found, however, that these cables can seize if the stranded wire becomes corroded. This can result in the on-load release hook failing to close properly when being reset. This in turn has resulted in inadvertent release later. Once corroded these cables cannot be repaired effectively, and have to be replaced. The evidence shows that management and crews are often unaware that such replacement is necessary.

In response to one MAIB recommendation, a manufacturer amended its on-load release hook operation and maintenance manual to emphasise the importance of replacing damaged or corroded cables. It is not always the case. It is known that some other manufacturers do not draw attention to the inherent dangers of not replacing corroded cable.

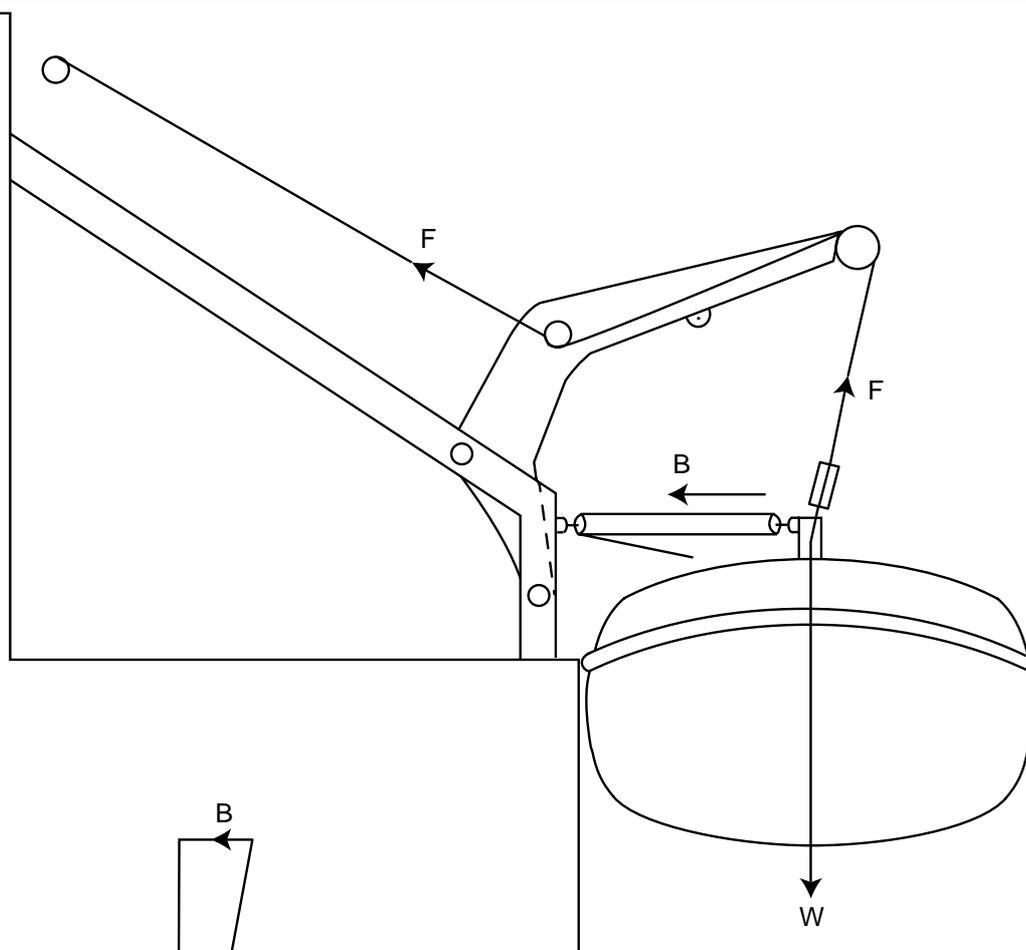
Figure 6

Lifeboat lowered to embarkation level, triced in and the bowsing tackles fitted. Once tricing pendants are slipped, properly tensioned bowsing tackles retain the lifeboat into the ship's side. Because the bowsing forces are virtually horizontal, only the falls load (F) supports weight (W), as intended. Also, F is acting in the back falls and contributes to the support of the davit arms.

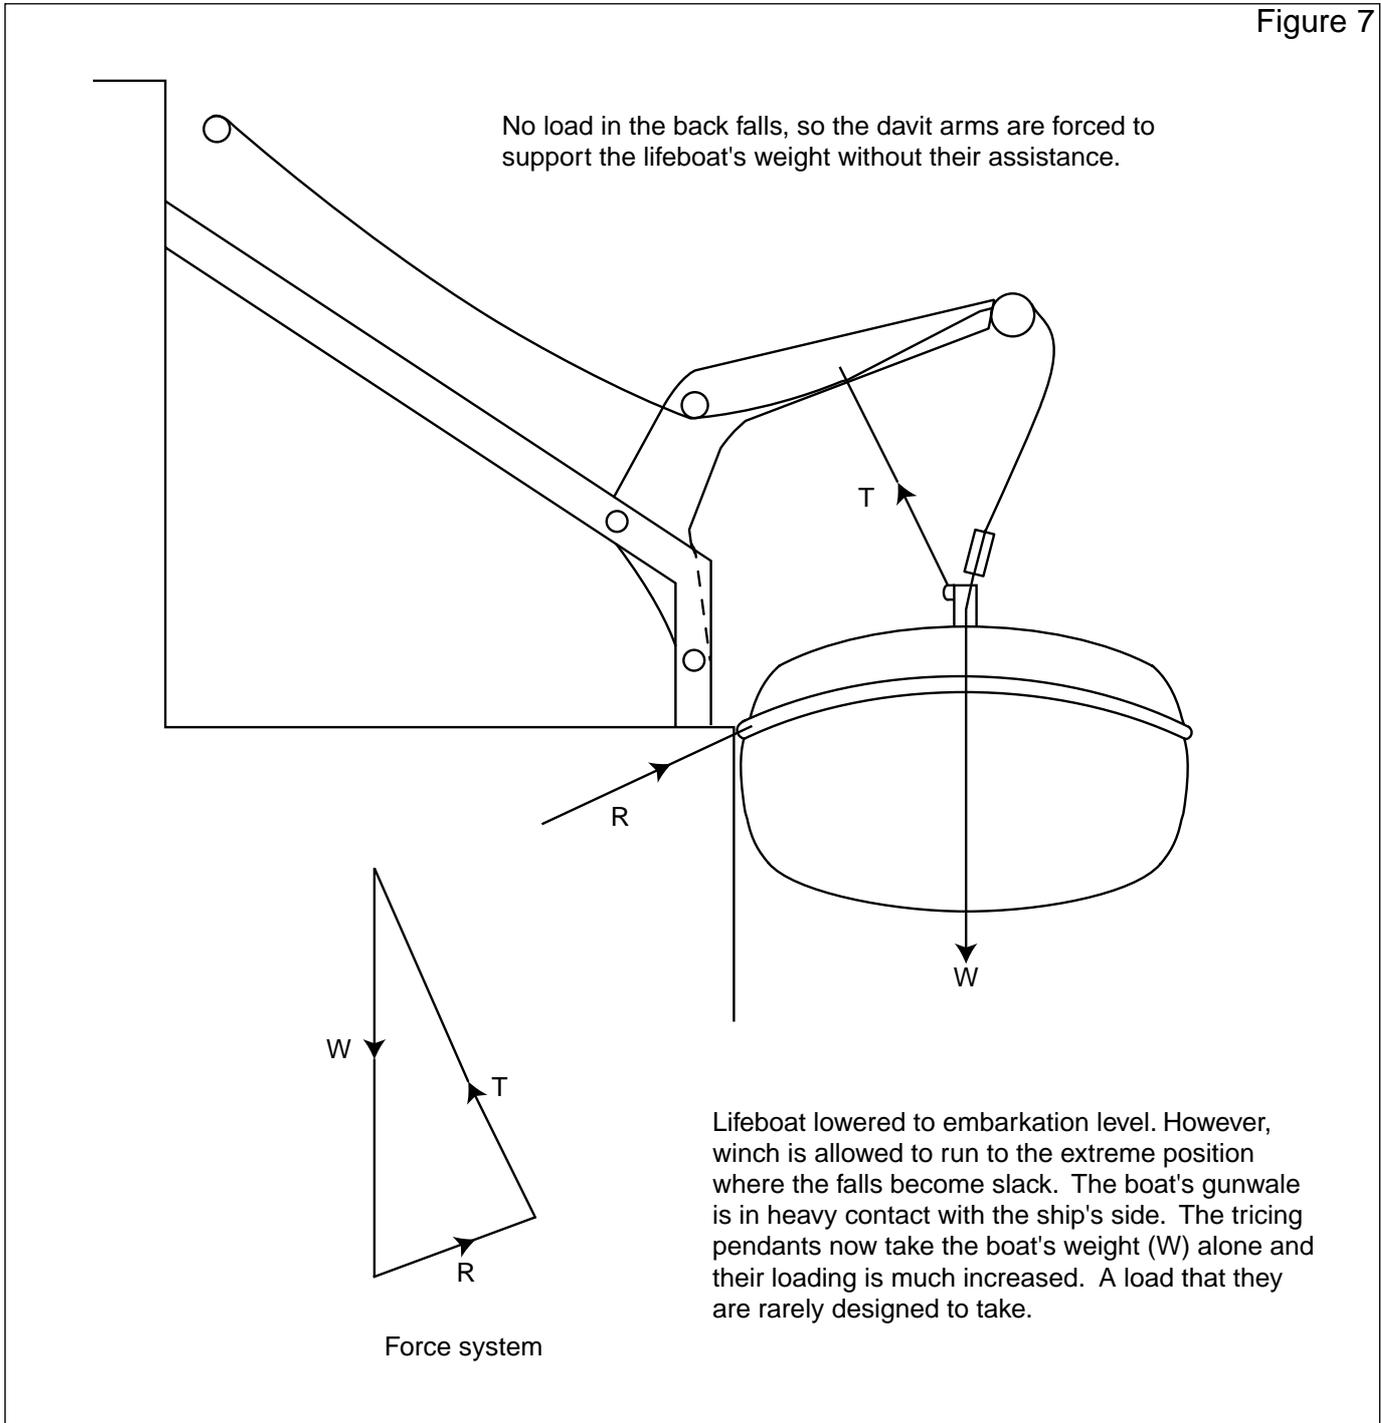
Figure 7

A second potential danger of not bowsing in a lifeboat is that a loaded lifeboat might overload the tricing pennants. If they fail (**see Figure 7**), the consequences can be serious. This is likely to occur if the lifeboat is brought hard against the ship's side. It can even lead to the falls going slack if the winch wire is paid out too far. Tricing pennant failure would again cause the boat to swing uncontrollably, endangering anyone who happened to be embarking at that particular moment.

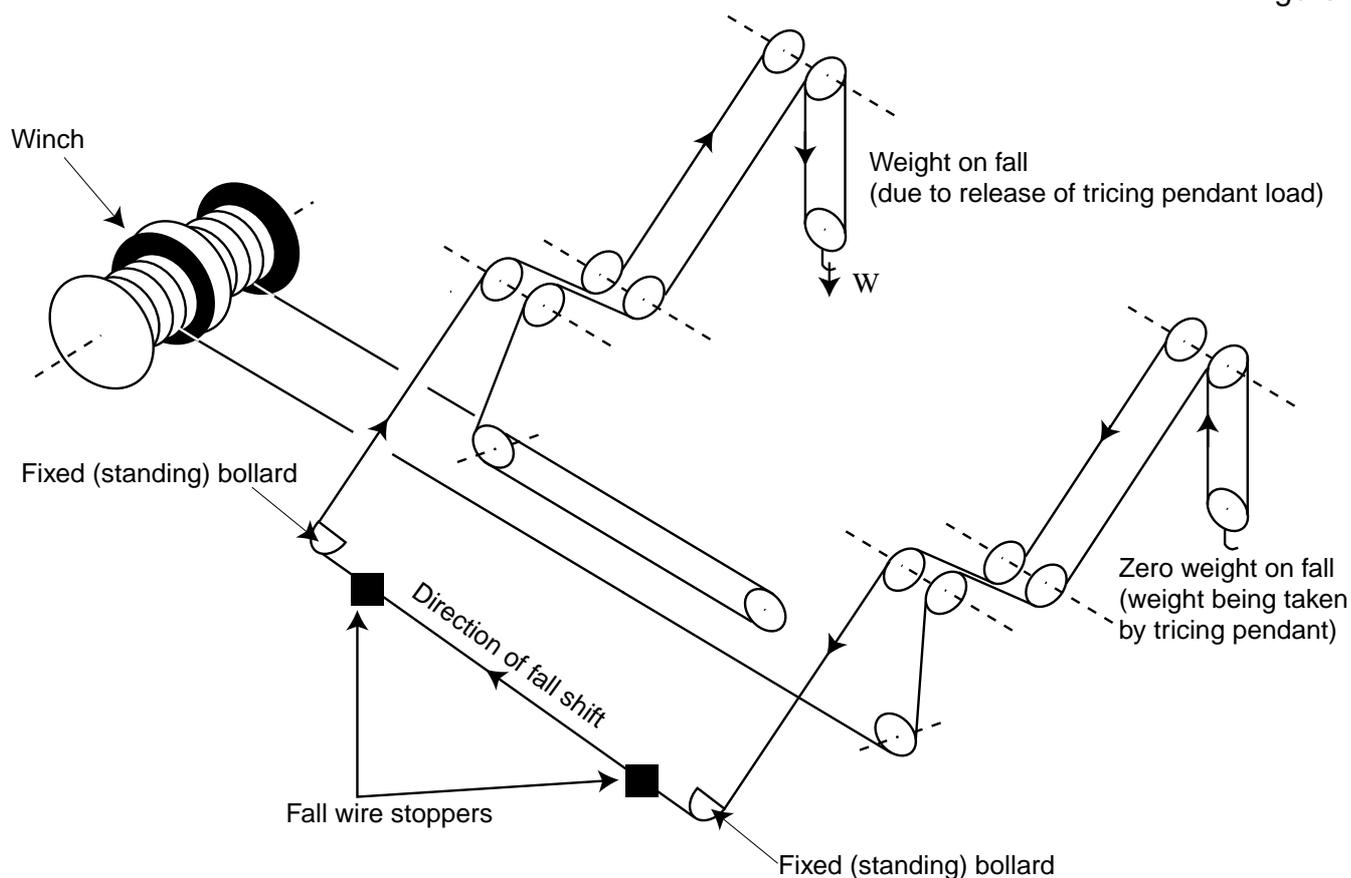
Figure 8

Failure of a single tricing pennant with slack falls has been known to have serious implications. When continuous falls are fitted, they will run out at the end where the failure has occurred. The lower block at the other end will simultaneously rise, sometimes sufficiently far and hard to hit the head of the davit arm. This imposes a dynamic overload on it and may lead to failure with the consequential repercussions for anyone in the lifeboat. This seemingly unlikely train of events has occurred in one boat where the crew was testing experimental tricing/bowsing gear (**see Figure 8**). It was a serious accident and people were killed.

When lowering the boat to embarkation level, the winch might be payed out so far that the falls go slack. Only the tricing pendants then take the boat's weight. Should one tricing pendant then fail, or is slipped, the weight at that end attempts to transfer to the falls. However, as there is no weight on the falls at the other end, because the remaining tricing pendant is still taking it, they can offer no balancing reaction. They then have a tendency to shift or slide towards the end where the tricing pendant has failed. This tendency is normally resisted by friction between the falls and the standing bollards. But, again, without load in the falls no significant friction force can be generated.

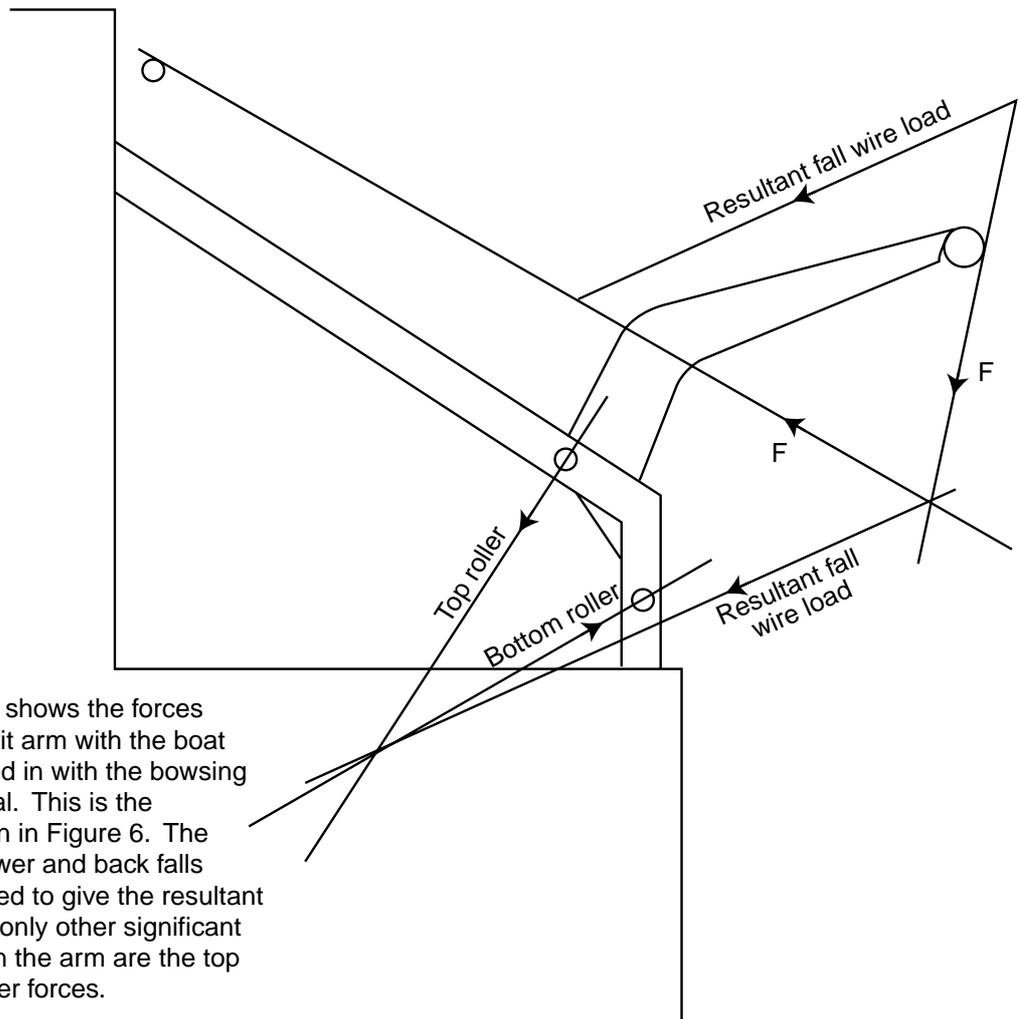
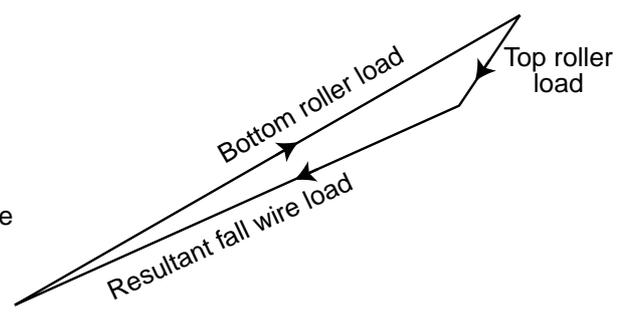
Figure 9

Above diagram shows the forces acting on a davit arm with the boat properly bowsed in with the bousing tackle horizontal. This is the condition shown in Figure 6. The forces in the lower and back falls have been added to give the resultant wire load. The only other significant forces acting on the arm are the top and bottom roller forces.

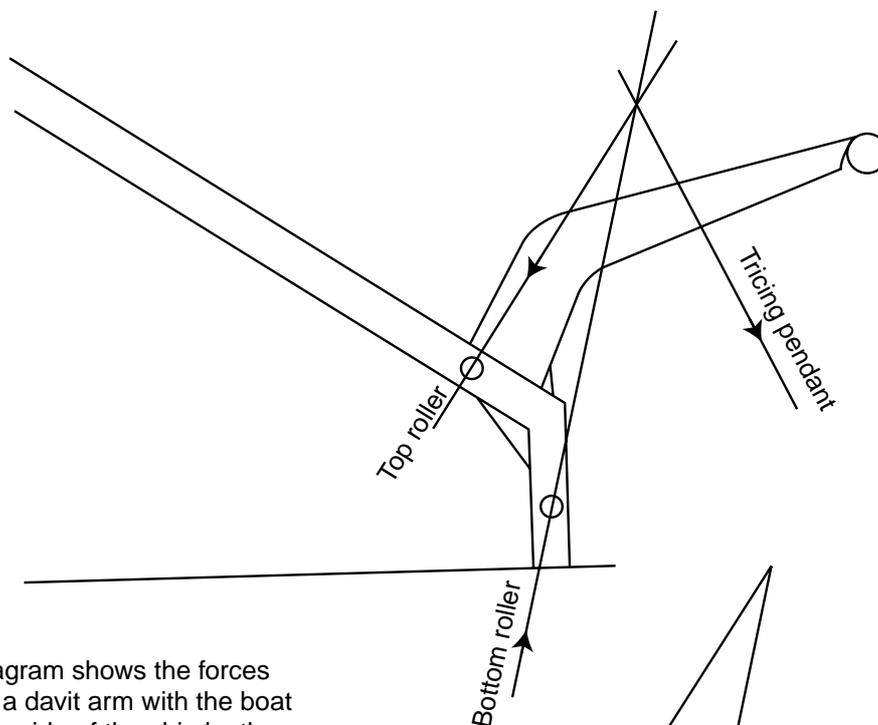
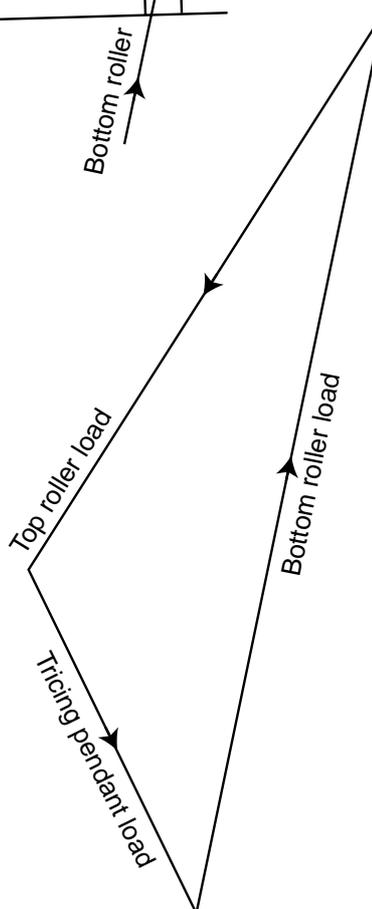
A further consequence of not properly bowing in a lifeboat can occur if the load bearing capacity of the davit arms is dependent on support offered by the back falls which lead inboard from the davit heads (**see Figure 9**). With the lifeboat at embarkation level, and supported by falls and tricing pennants, its weight is shared between them. The greater the proportion of weight taken by the tricing pennants, the less will be taken by the falls. This gives a corresponding reduction in the load on the back falls, which means that their contribution to supporting the davit arm is reduced. This results in an increased portion of the load being taken on the supporting structure of the davit arm and can, on some designs, overload it if the boat is fully laden (**see Figure 10**).

Above diagram shows the forces acting on a davit arm with the boat held to the side of the ship by the tricing pendants and with the falls slack. This is the condition shown in Figure 7. The only significant forces acting on the arm are the tricing pendant load, the top and bottom roller forces.

The diagram to the right is the above force system giving the relative magnitudes of the forces. Notice how much greater are the roller loads compared to the properly bowed in condition of Figure 9.

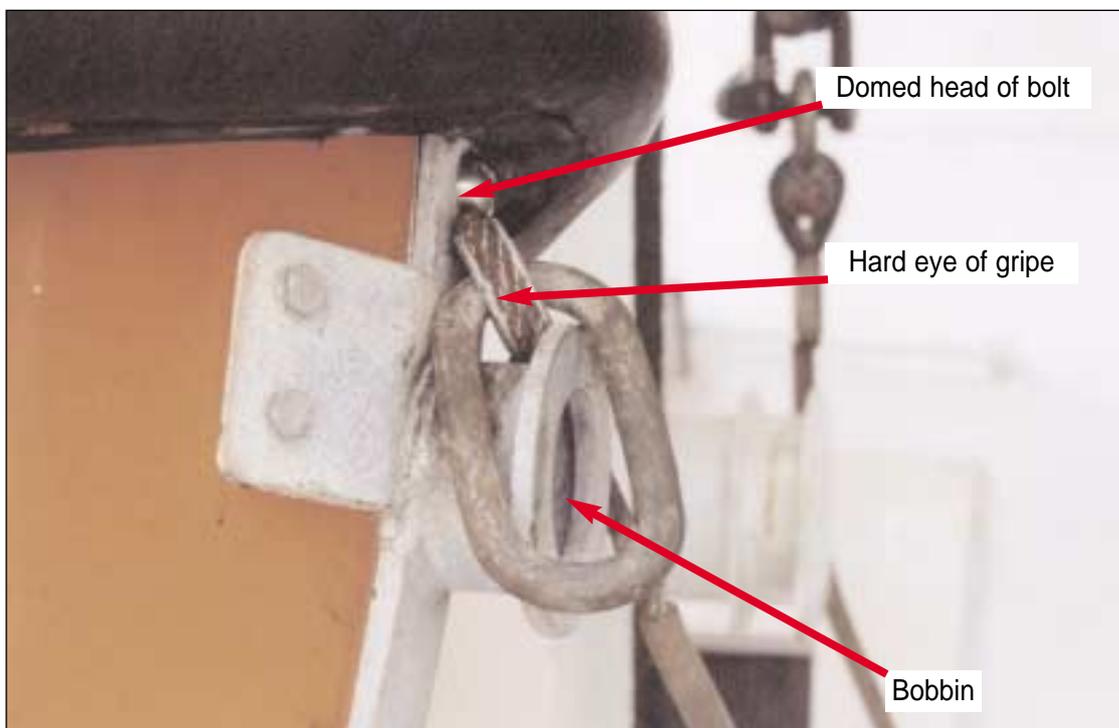
Figure 11

The MAIB received one report where the hard eye on the freed end of a gripe fouled the gripe's bobbin and the domed head of a mounting bolt (**see Figure 11**). This happened during the early stages of lowering. Fortunately it happened during an exercise where there was someone available on the vessel to free the gripe. Had this occurred in different circumstances, the lifeboat could have been loaded, lowered clear of its davits, and yet been prevented both from being lowered to the water and raised under control of the people in the lifeboat. Changing the size of the hard eye allowed the gripe to slide freely over the bobbin and cured the problem.

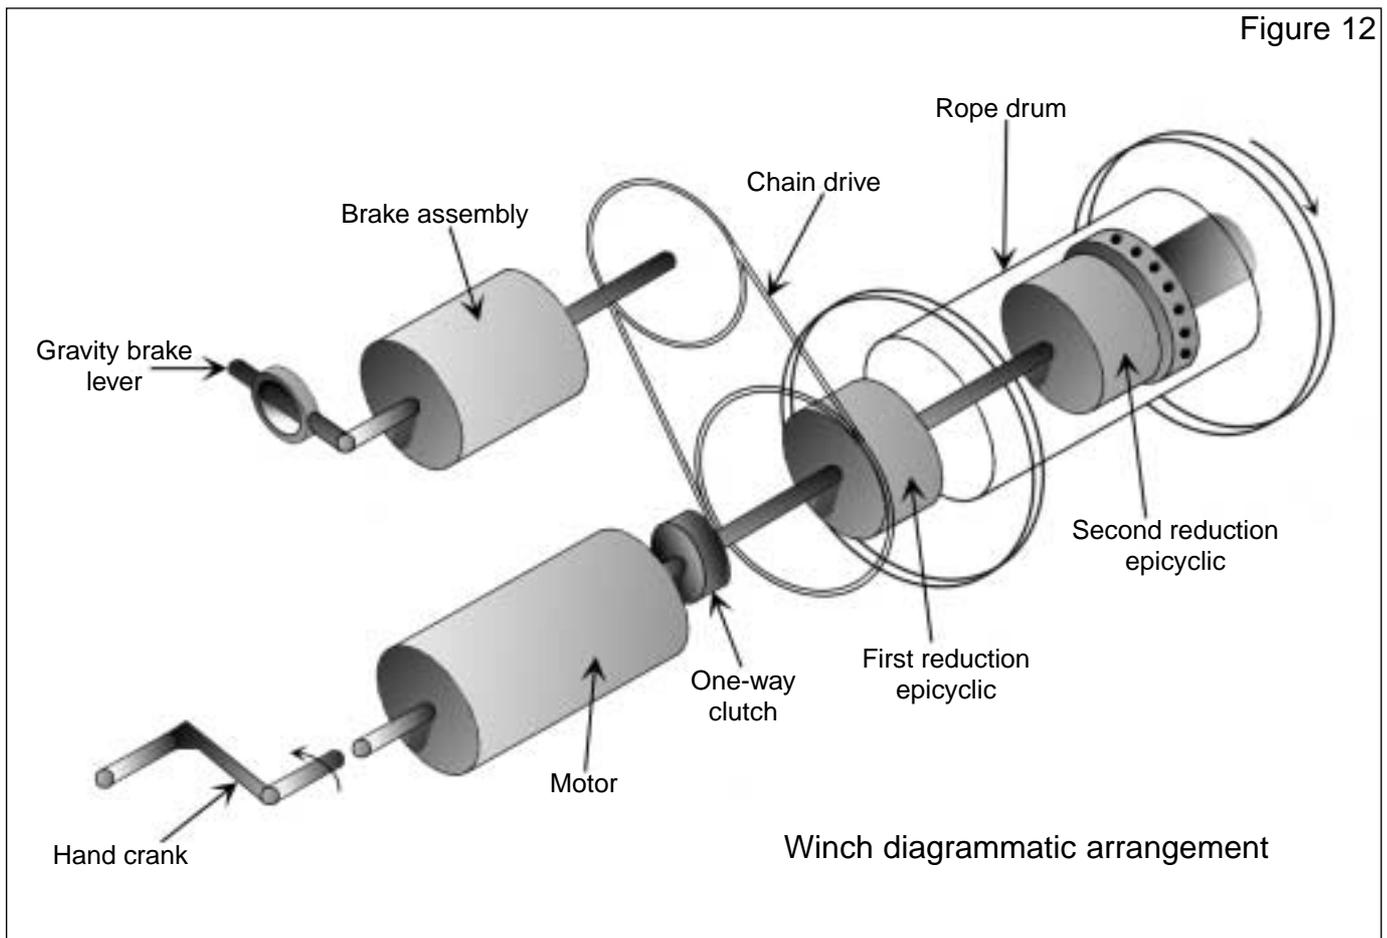
Figure 12

During the 1960s several new designs of winches were submitted to the UK Administration for approval. Some employed one-way sprag-type clutches. These used smooth inner and outer tracks, and relied entirely on friction forces to lock the unit. Carefully shaped spring-loaded sprags within the annular space between the tracks, generated the locking forces. These units ran free when one half of the unit turned, and locked when opposite rotation was applied.
