November 22, 2003

Report On the Current Status of the CO² System Onboard The M.V. Queen Of Nanaimo

Report compiled on behalf of the Ship's Officers Component, BCFMWU

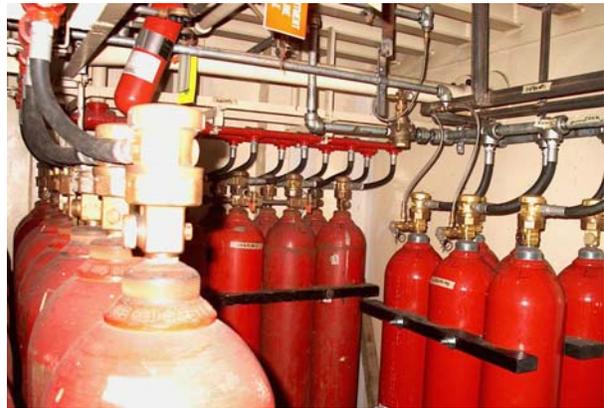
CO² Compartment onboard the M.V. Nanaimo.

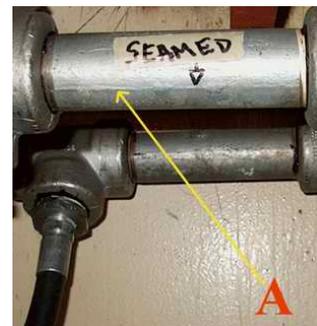
The use of Schedule 40-A53 seamed galvanized piping is inappropriate for this type of application. The pressure shock loading applied to the whole system coupled with the cryogenic shock of CO² being applied can cause this type of pipe to fail easily, thus rendering the system far less effective than intended. Further to this, rapid over-pressurization of the CO² compartment can cause unexpected injuries to unaware personnel that would likely be in the vicinity during system deployment. The seam in this particular pipe nipple is clearly visible as referenced by the arrow "A" in the picture at the right.

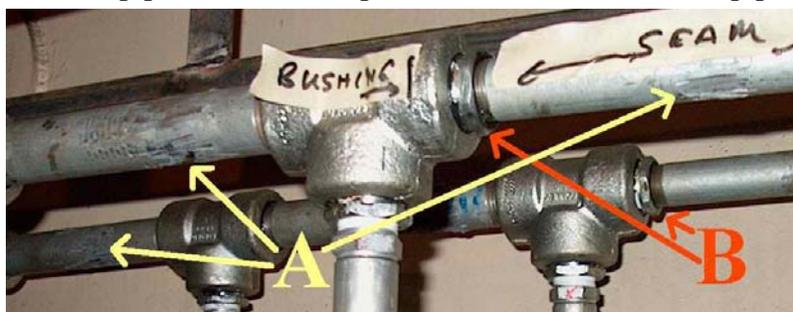
The amateurish installation of some of these nipples via excessive force has caused significant damage to them. These bite marks from the pipe wrench used, penetrate the sidewall of the pipe, and set up stress risers that can significantly reduce the safe working pressure. These are referenced by "A" in this picture. "B" is showing reducer bushings that are not properly rated for this type of service, as well as

the fact that reducer bushings shouldn't be used to begin with.

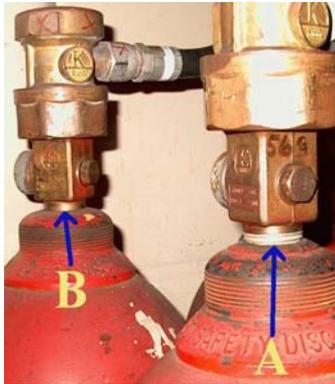
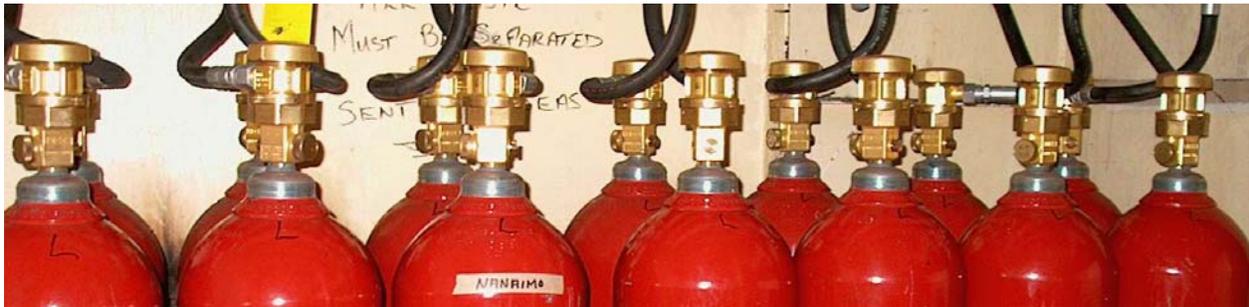
During one of the inspections, it was discovered that a significant number of valve bodies that are not properly installed into their respective CO² cylinders. This is evident by the fact that threads are visible. In the picture at the left, "A" indicates a valve head that is incorrectly installed, while "B" shows what a correct installation looks like. In the picture below, one can see that the majority of the cylinders are marked with an "L" in felt pen, presumably by one of the inspectors. This is to denote a loosely installed valve head. This particular bank is located in the paint locker, and if you look closely, you will notice that the majority of this bank of cylinders is marked in this fashion. Further to this, one can see that there are extreme bends in the flexible whip lines that connect each cylinder to the cascade system manifold.

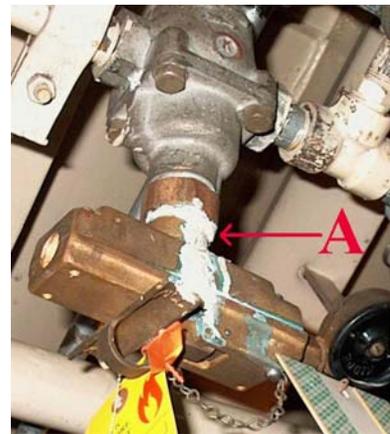
At one point during this inspection, it was discovered that there is corrosion on one of the release assemblies. The particular assembly in question is the "B" handle for the bow propeller compartment flooding system, and the corrosion is on the back side of the mechanism. It is unknown exactly why this corrosion is present, and to what extent it is present on the interior of the assembly. However it is noteworthy that several qualified people have performed inspections on this equipment, and apparently passed it as serviceable despite this seemingly glaring defect. The substance is depicted by the red arrow "A" in the picture at the right.

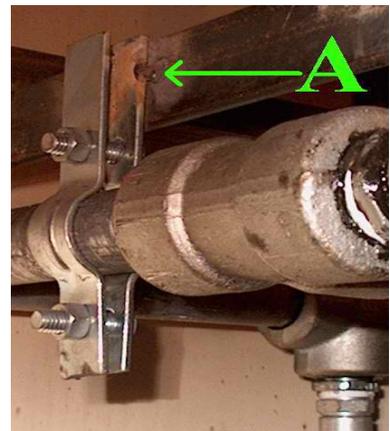
The bracketing used to support the new installation is rather lightweight given the magnitude of the shock loading that can occur upon deployment of the CO² gas. In the picture at the right, one can see that this particular bracket is only tacked on to the support steel as denoted by the green arrow "A". Failure is certain to occur at this location. These brackets should be replaced with units of heavier construction.

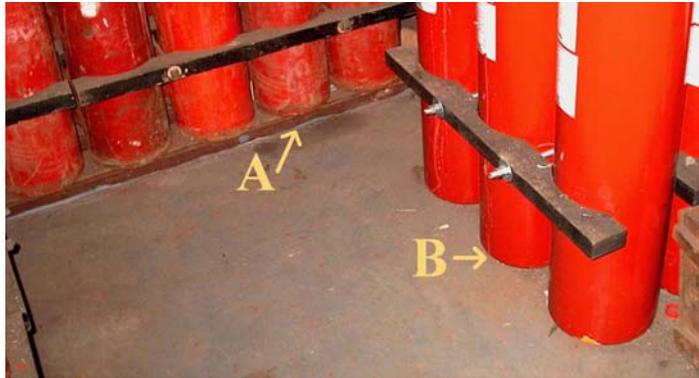
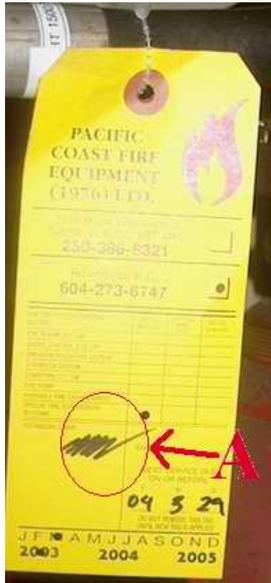
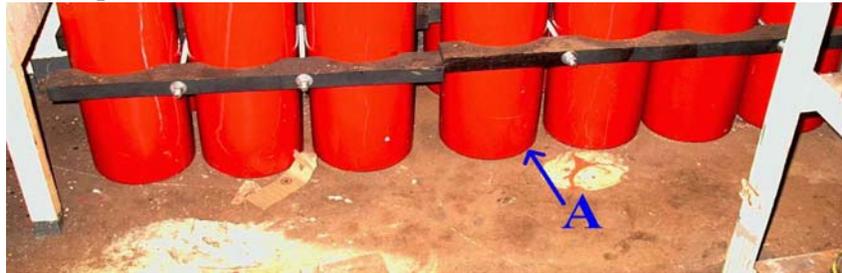
These pictures illustrate a shortcut taken in the installation of the extra cylinders. It is common practice to mount cylinders on a wooden base if a steel deck is present. This is to prevent fretting of the base of the cylinders induced by vibrations from normal ship operations, which can therefore weaken a cylinder, risking potential failure of said cylinder. The picture at the right shows the wooden base below cylinders as indicated by “A”, while “B” shows direct mounting on the steel deck. The lower picture shows the entire bank of new cylinders in the paint locker on the steel deck.

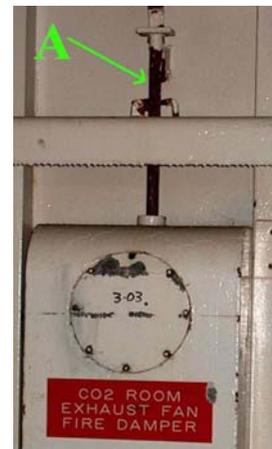
One of the findings in the BCFS investigation of the fire on board the Queen of Surrey was that at the previous refit, the ventilation damper for the CO₂ compartment had accidentally been left in the closed position. This fact contributed to the violent explosion that occurred when the compartment was over-pressurized due to the accumulation of leaking CO₂ from the system that failed upon deployment. Among other things, the closed 4 dog hatch was violently blown off due to this buildup of pressure. If anyone had been near the hatch at that time, they could have easily been seriously injured or even killed. For this reason, there was a directive issued to remove the dampers from the CO₂ compartments on affected vessels fleetwide in order to reduce the possibility of re-occurrence. As you can see referenced by “A” in the picture, the damper is

still in place on board the M.V. Nanaimo.
