**STATE OF TENNESSEE
DEPARTMENT OF LABOR AND WORKFORCE DEVELOPMENT
DIVISION OF BOILER AND ELEVATOR INSPECTION**

**Boiler Accident
Dana Corporation, Paris Extrusion Plant
Paris, Tennessee
June 18, 2007**

Report Date: July 9, 2007

**Report Prepared by:
Chief Boiler Inspector
Division of Boiler and Elevator Inspection
Tennessee Department of Labor and Workforce Development**

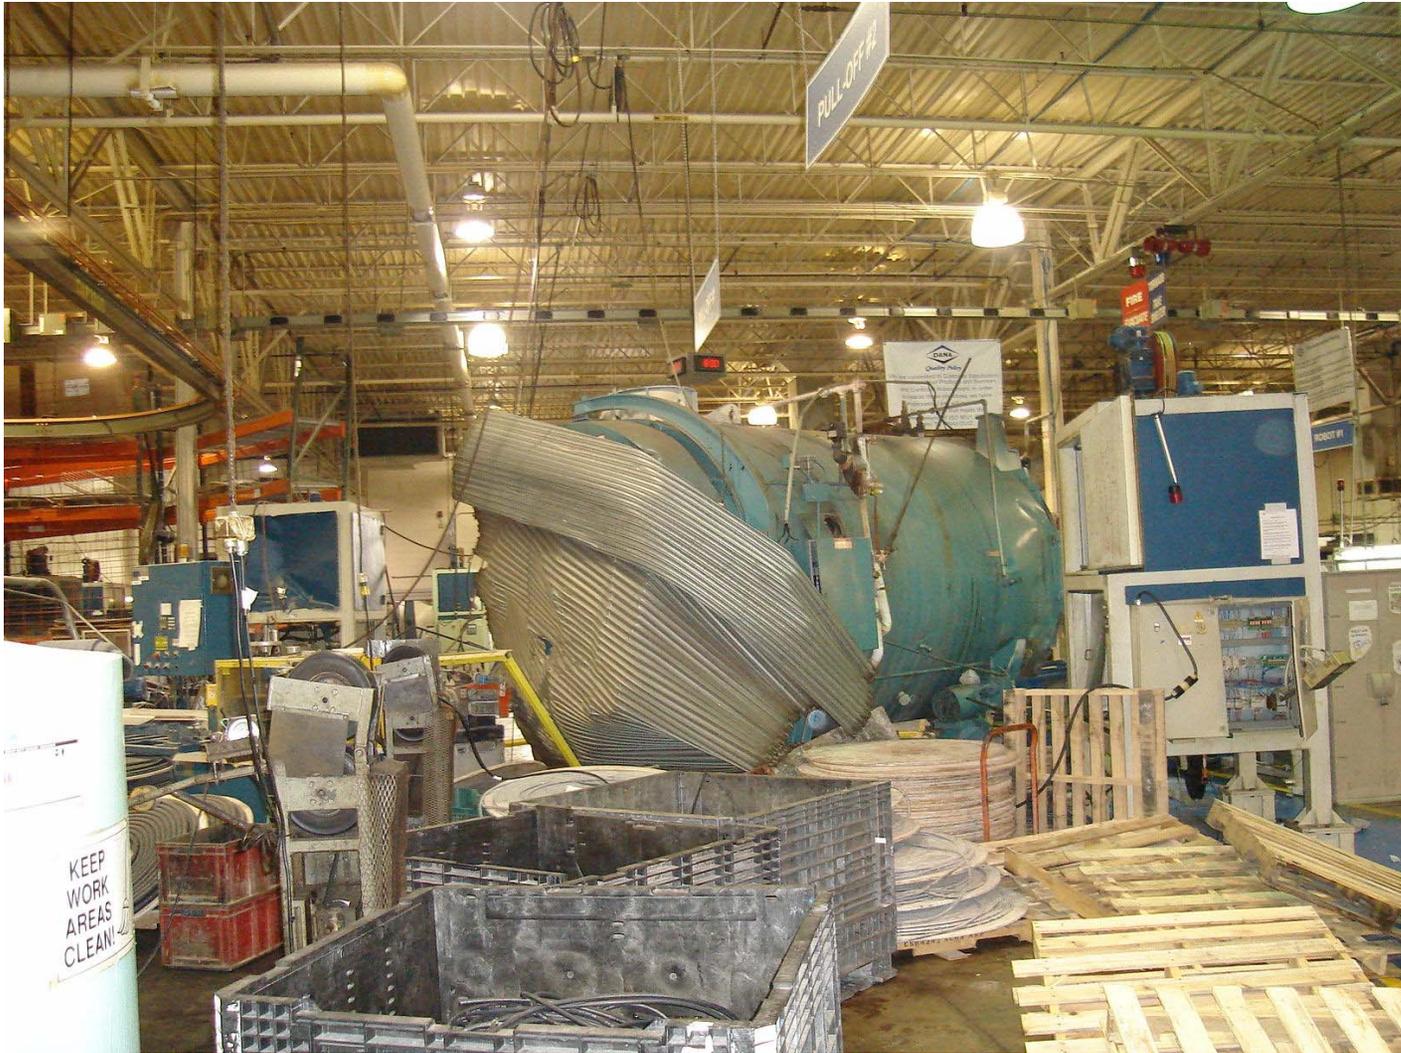
Shortly after Mr. Evans entered the boiler room, boiler #2 exploded, sending the boiler through the industrial roll up door, knocking down a portion of the wall and resting over one-hundred (100) feet from its original location into the center of the manufacturing room floor (see Photos #1, #2, #3, & #4). The explosion hurled the rear door of the boiler through the opposite cement block wall, creating a thirty (30) foot hole in the outer wall of the plant (see Photos #5 & #6). The rear door and debris damaged many vehicles in the parking lot, as well as a pedestrian walkway, before coming to rest in a ditch one-hundred (100) feet from the boiler room (see Photos #7 & #8). The internal south wall of the boiler room also collapsed during the explosion, causing additional damage to property and equipment (see Photo #9).

Photo #1 – Final Location of Boiler after Explosion (Roll Up Door on Boiler)

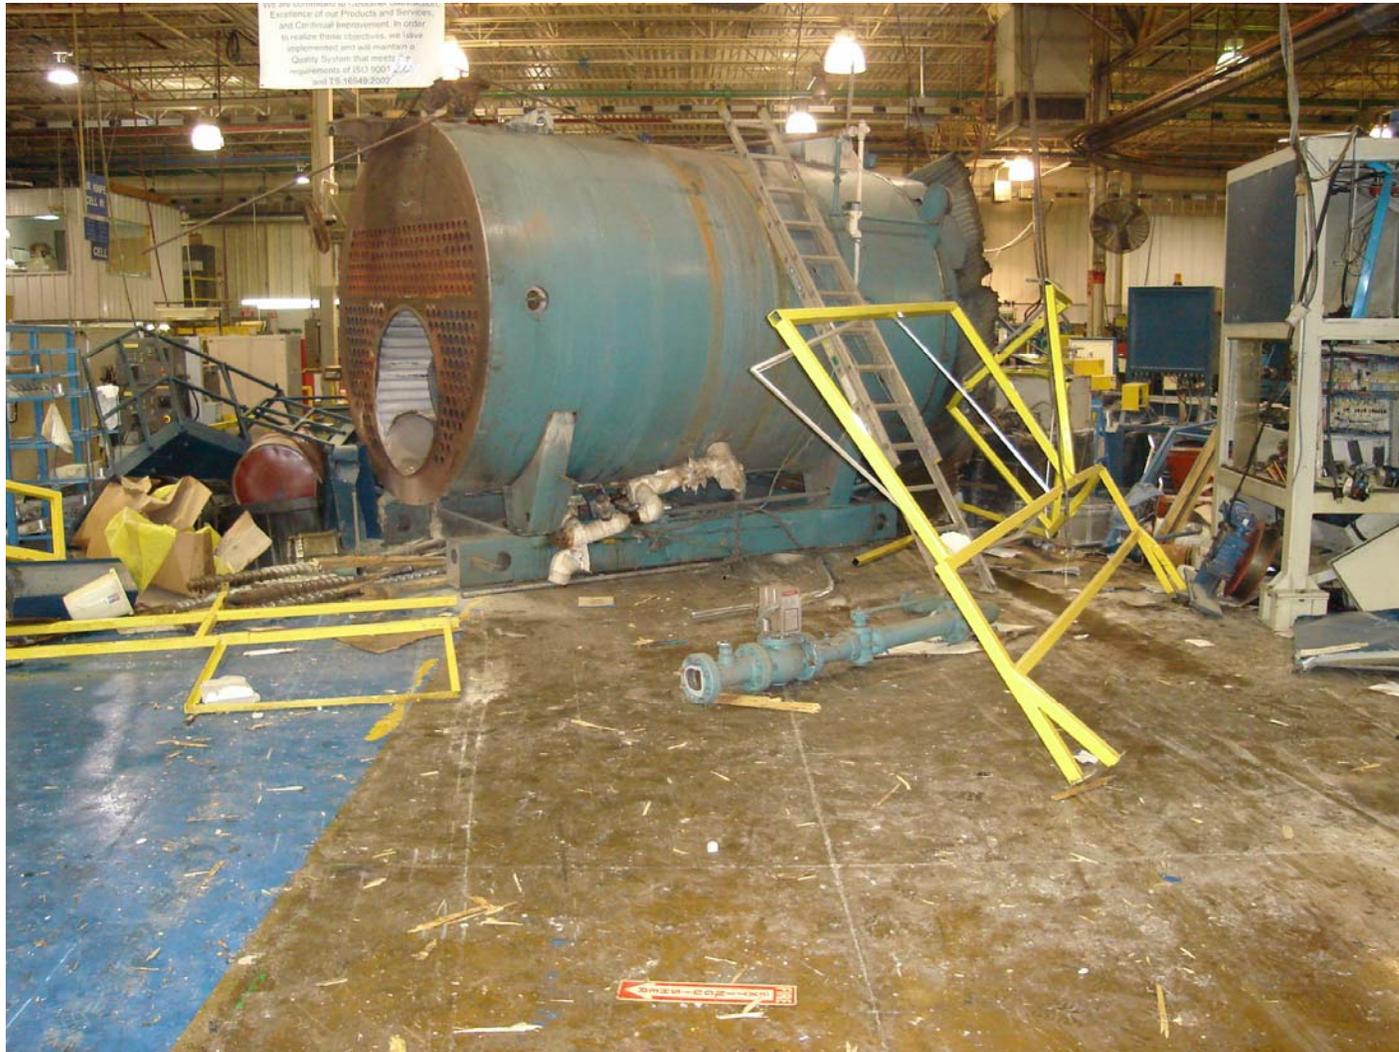
Photo #2 – Final Location of Boiler After Explosion

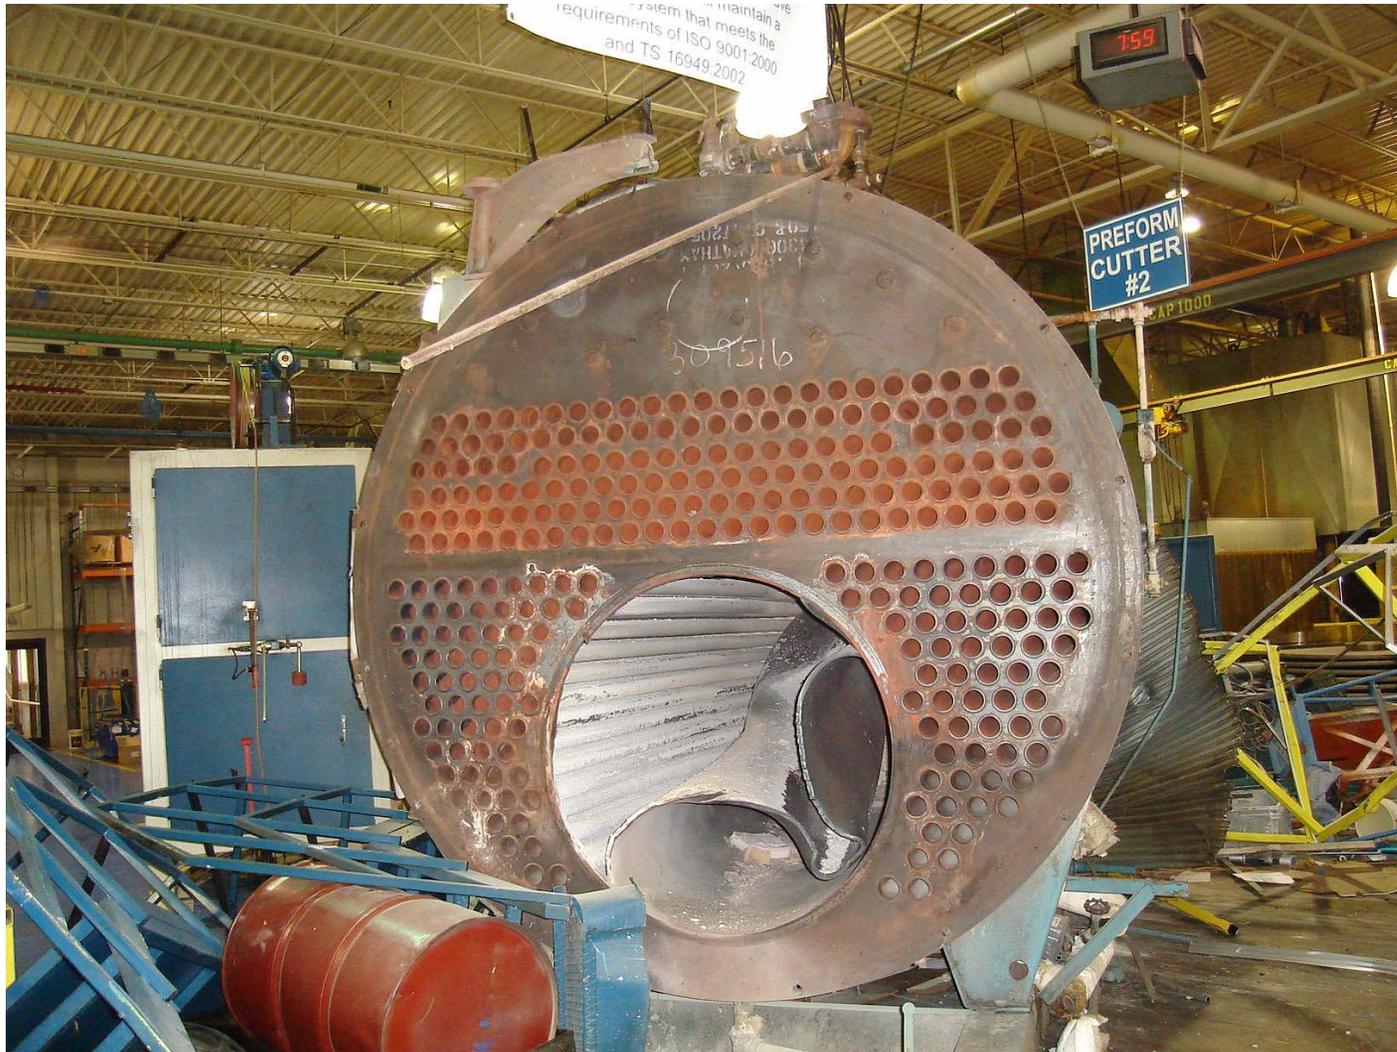
Photo #3 – Final Location of Boiler after Explosion (Exposed Furnace Tube)

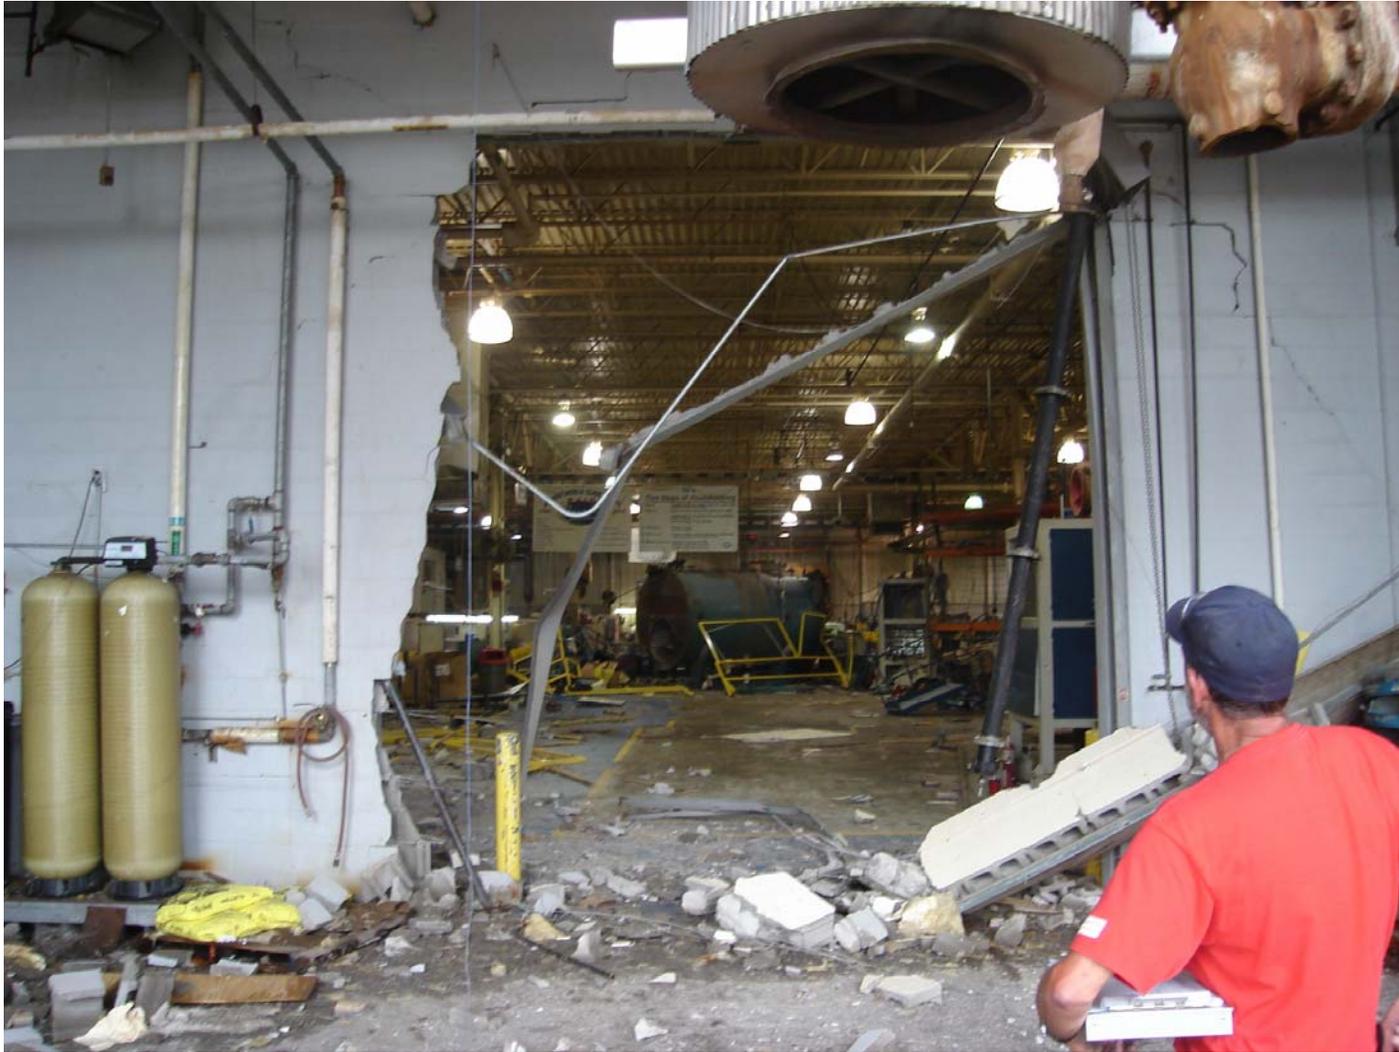
Photo #4 – Hole Created by Boiler through Roll Up Door Wall (West Wall)

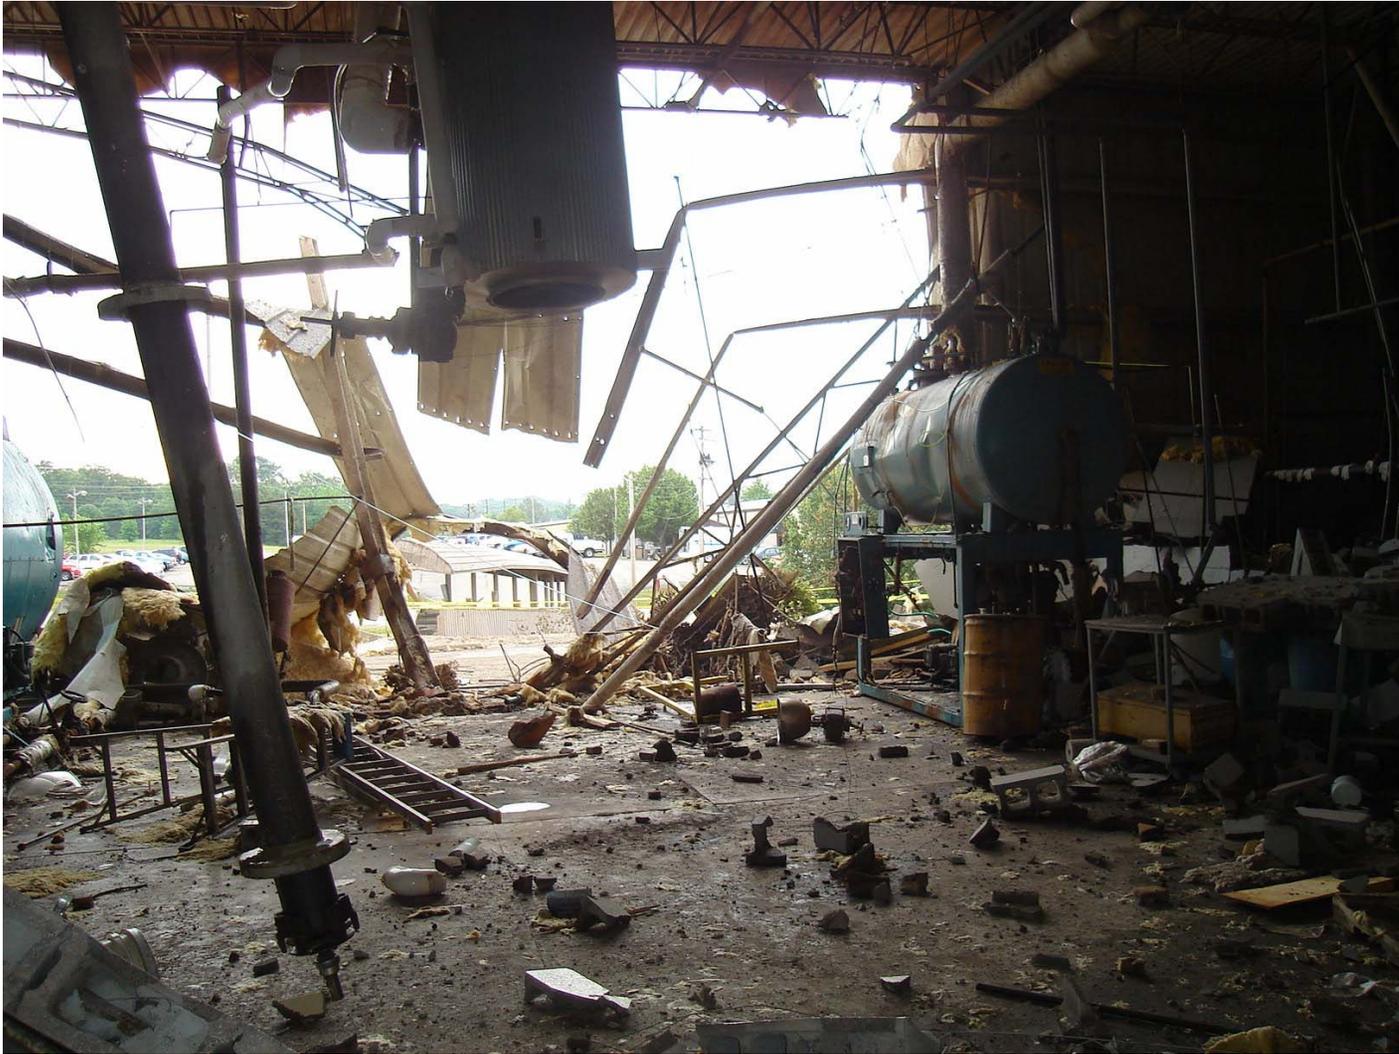
Photo #5 – Knocked Down Exterior Wall Viewed from Inside Boiler Room (East Wall)

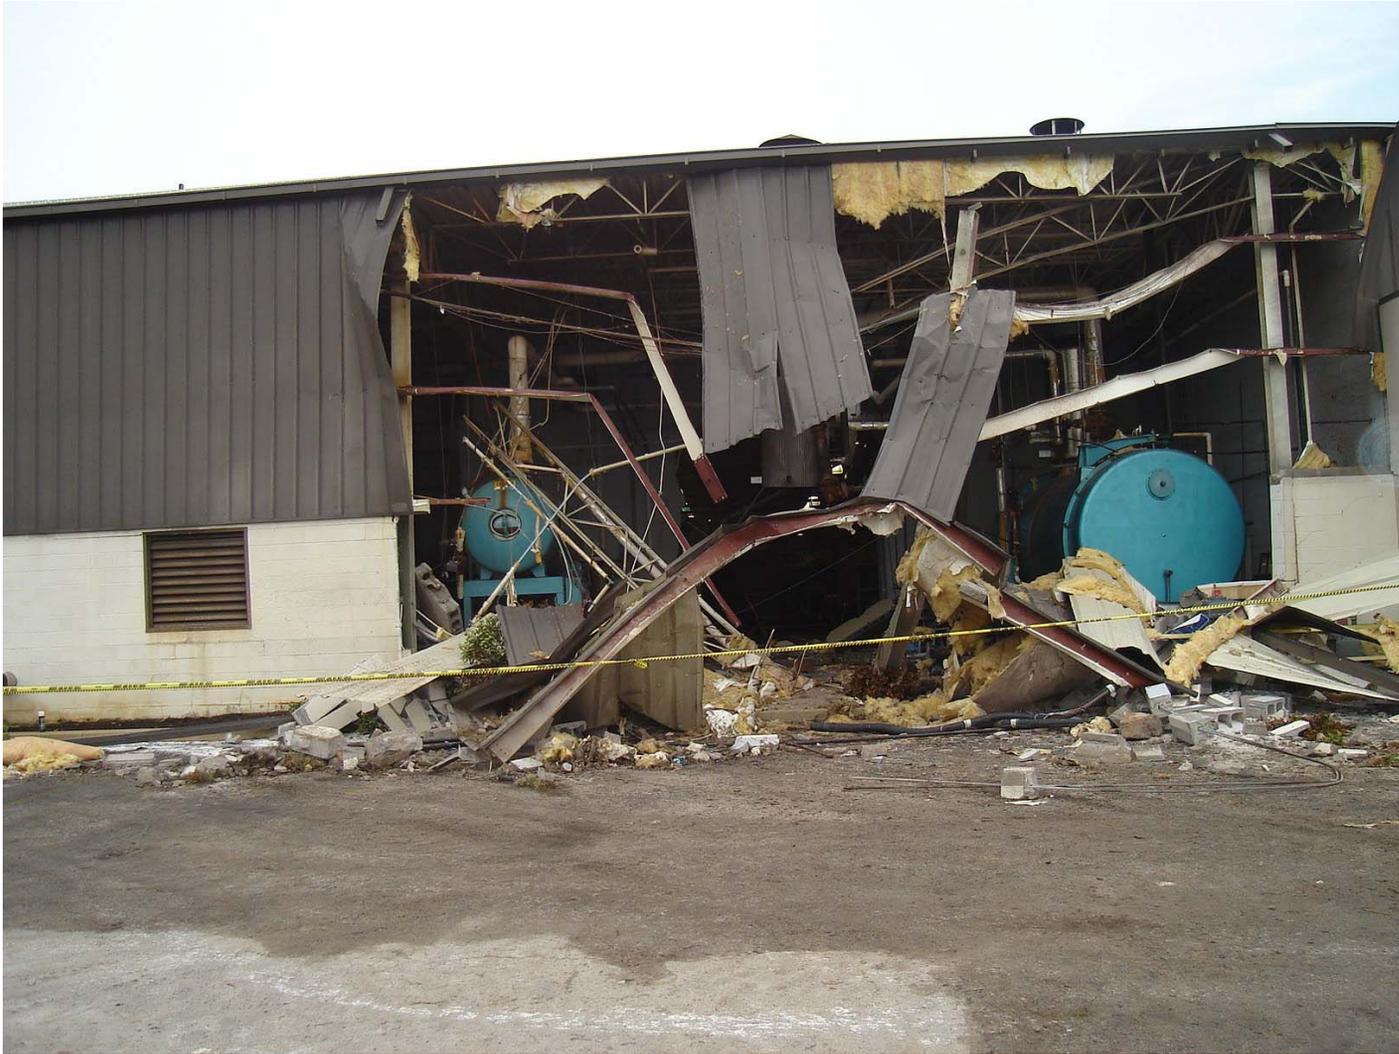
Photo #6 – View of East Wall from Outside Plant

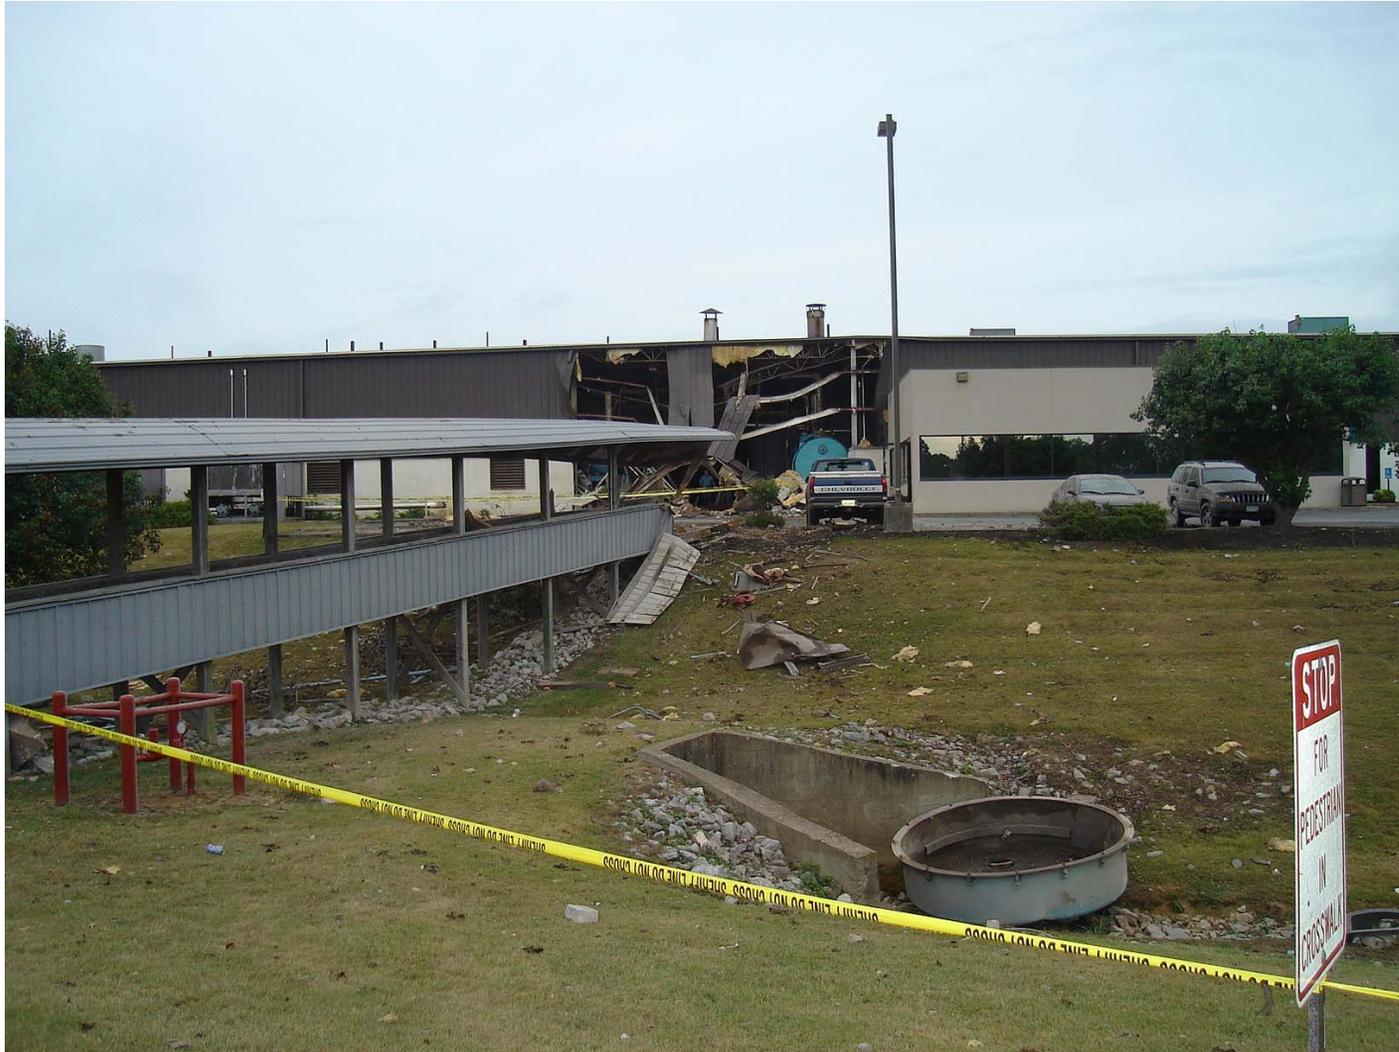
Photo #7 – View of East Wall from Outside Plant (Note Rear Boiler Door in Ditch)

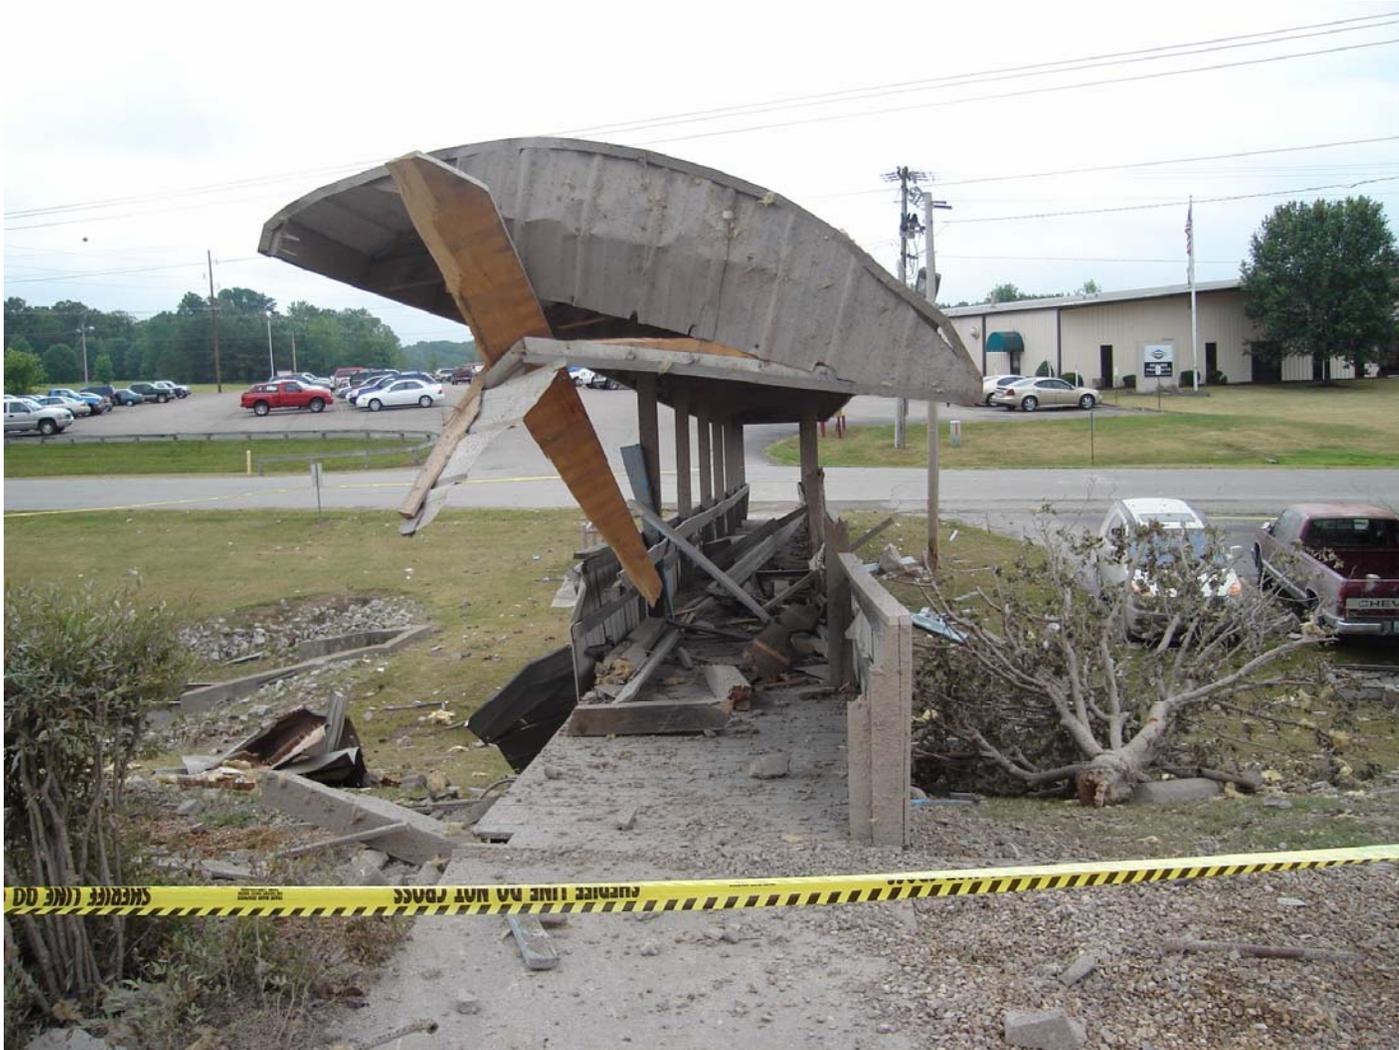
Photo #8 – View of Pedestrian Walkway Bridge

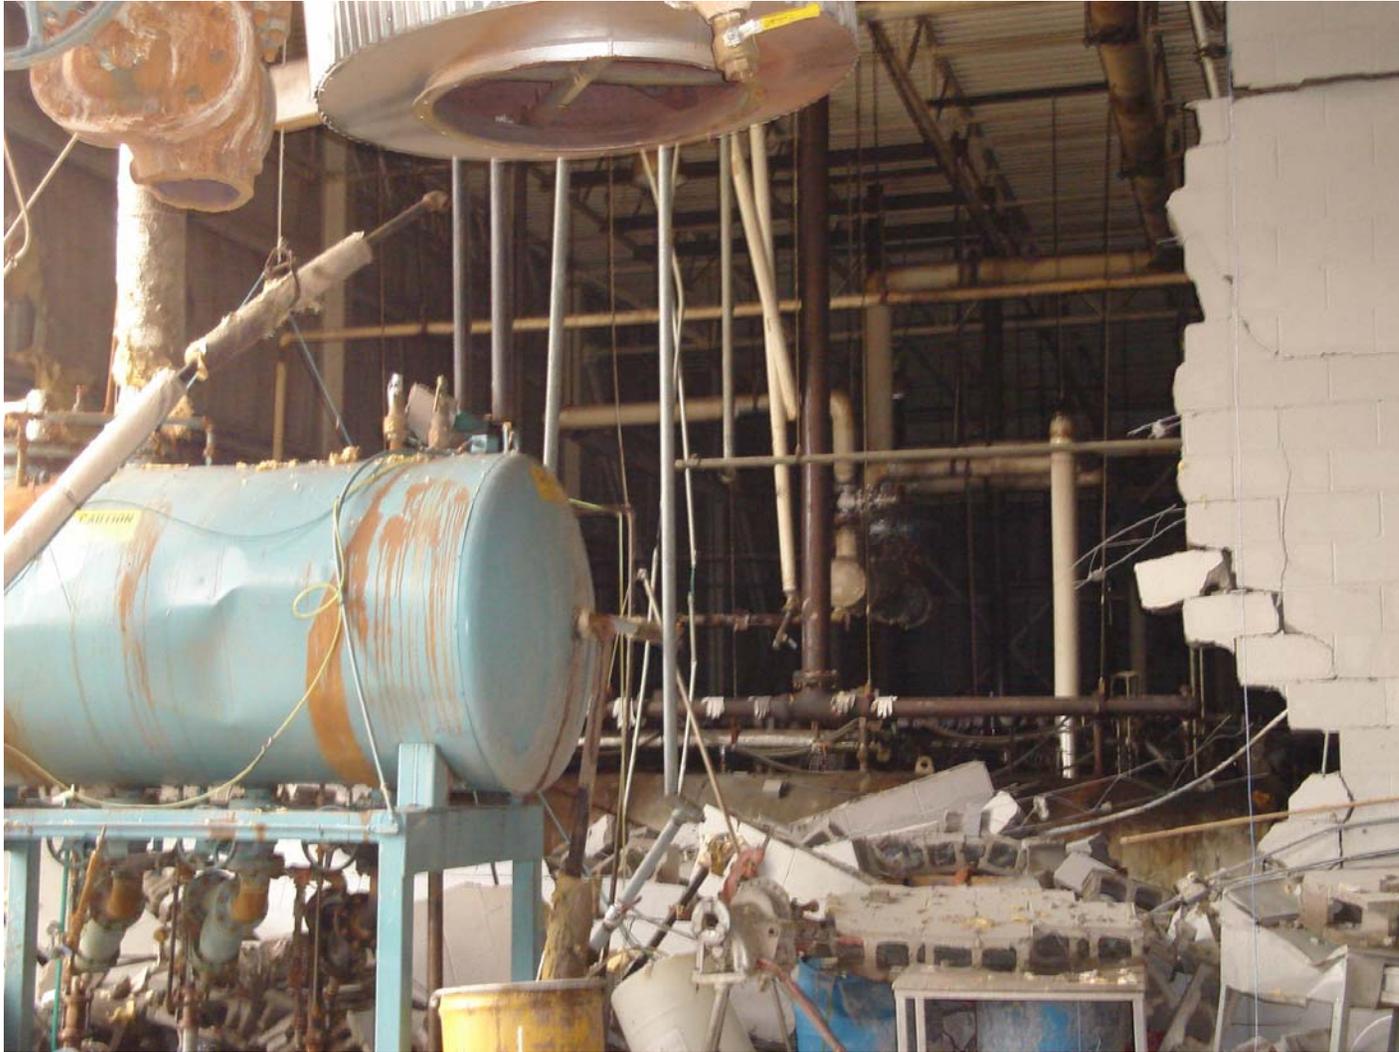
Photo #9 – Interior Wall of Boiler Room (South Wall)

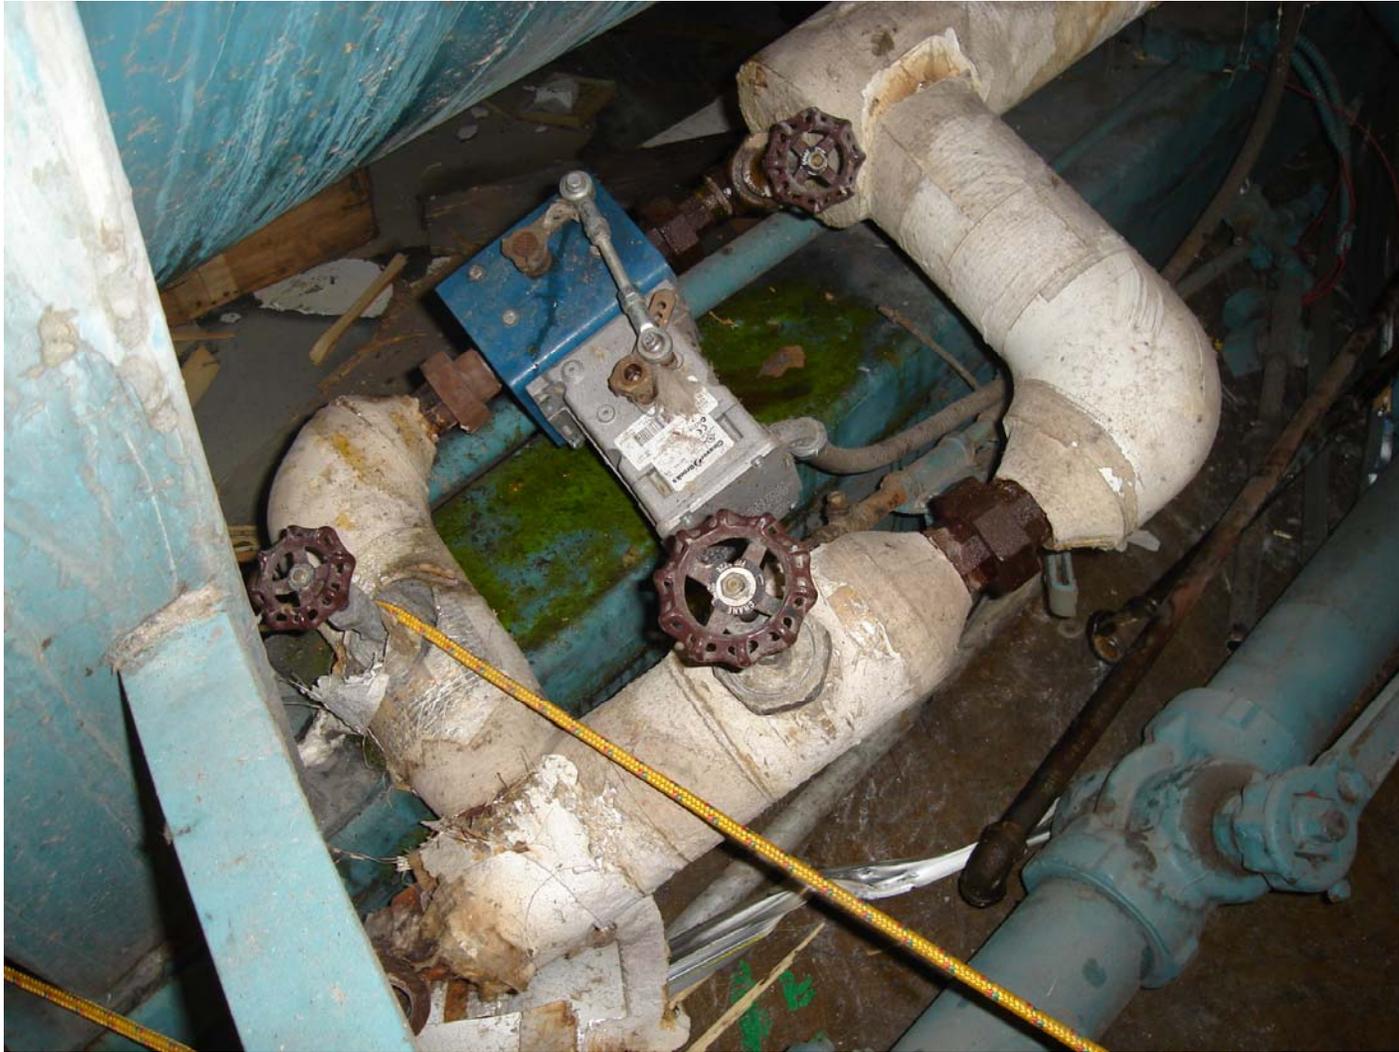
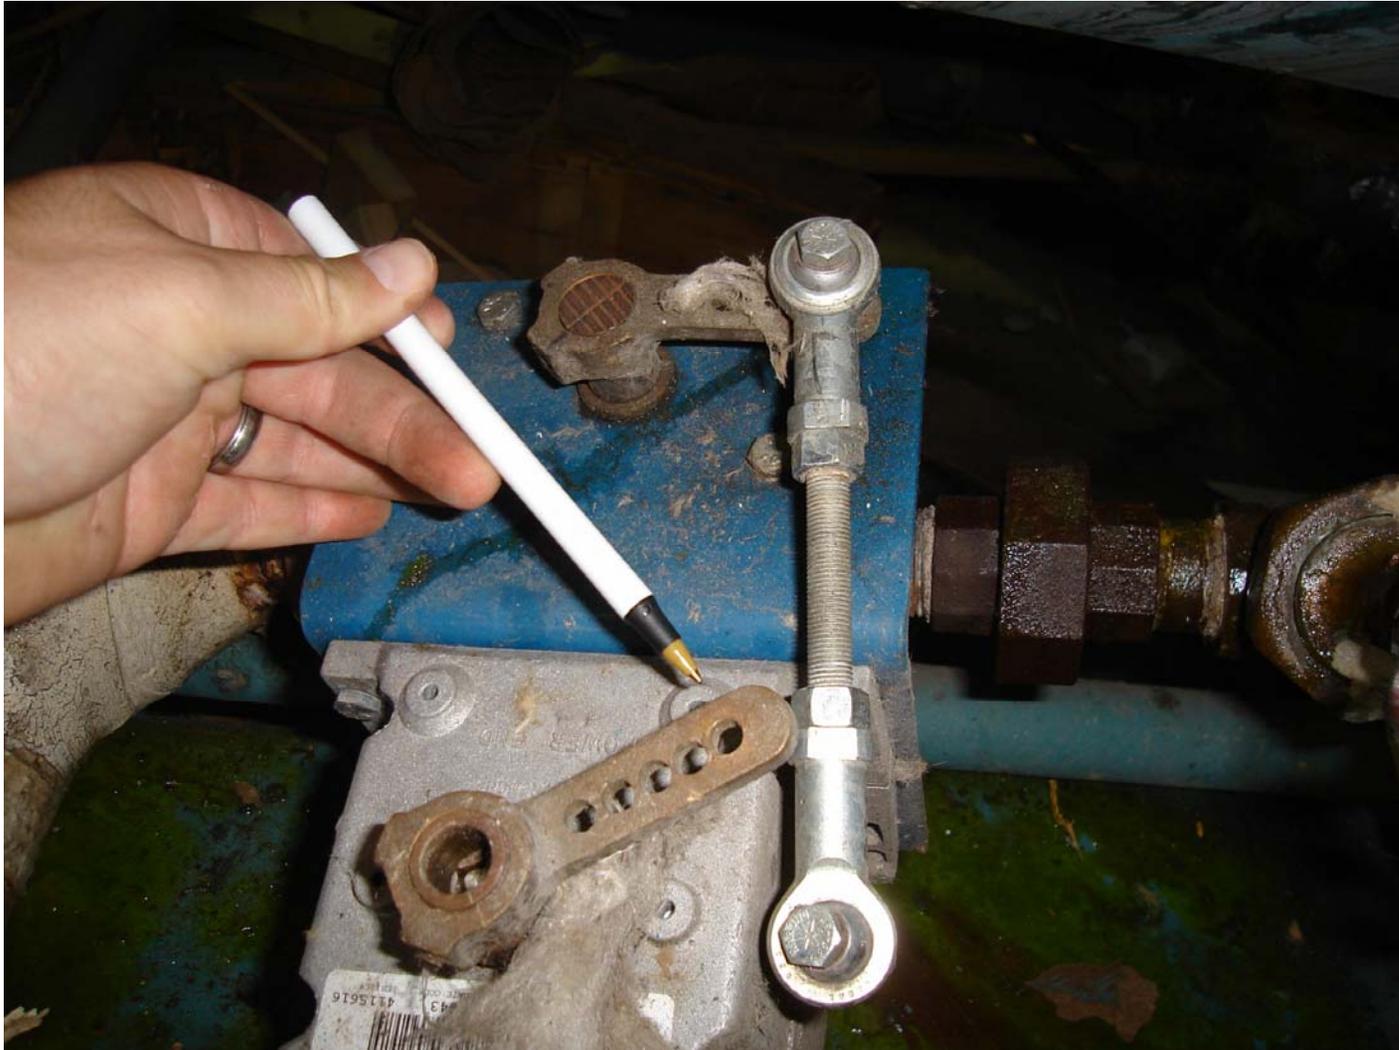
Due to the reoccurring high water condition (i.e., flooding), the decision was made by maintenance to disconnect the modulating feed controller (Honeywell) from the feed valve (Worcester ball valve) (see Photos #10 & #11). The disconnection of the controller arm was performed by Dana Corporation maintenance personnel. By disconnecting the modulating feed controller, the boiler operator would be required to throttle the feed valve to allow feed water to be introduced into the boiler. During the investigation, it was found that the bypass valve connected to the modulating feed valve had been opened halfway (see Photo #12).

3. The modulating feed controller was disconnected from its feed valve (see Photos #10 & #11). *The feed system for the boilers is a continuous system, which means the feed pumps operate constantly and the modulating feed valve opens and closes per the demand of the boilers for feed water. The operation of the modulating feed controller is controlled from the M&M controller.*

Photo #10 – Modulating Feed Controller, Valve, and Bypass (Note Disconnected Operating Arm)

Photo #11 – Modulating Feed Controller and Valve with Disconnected Operating Arm

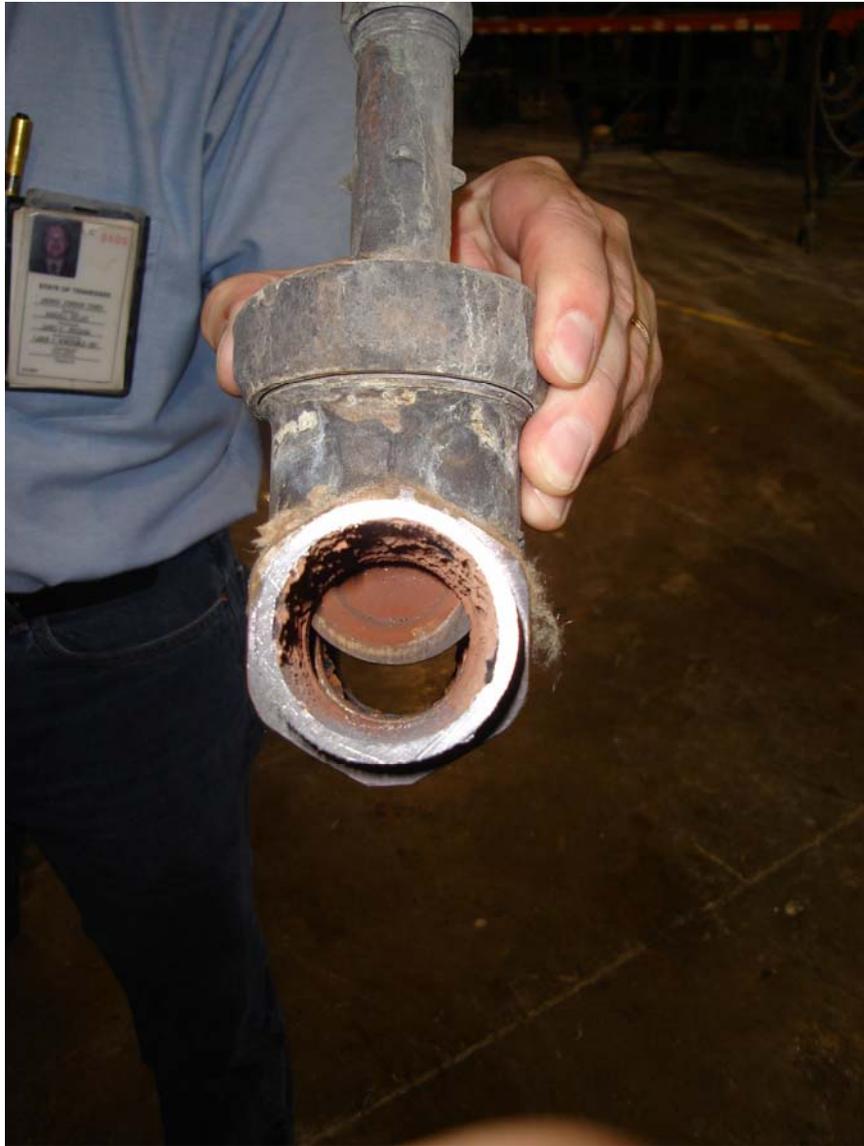
4. The modulating feed valve bypass was opened approximately halfway. This shows evidence of throttling the feed water inlet that in essence bypassed the modulating feed valve (see Photo #12).

Since the modulating feed valve bypass was opened halfway, the boiler water level would have fluctuated as the boiler fired, causing the primary LWCO to operate more as a control than a safety device. This could account for the need to remove the required manual reset on the auxiliary LWCO. With the feed valve bypass open, there would be no automatic control of the amount of feed water that enters the boiler. This could account for the high-water conditions. On the other hand, if the boiler calls for more feed water than what is delivered through the opened bypass, the boiler would subsequently go to a low-water condition; because of the manual reset, maintenance personnel would be required to manually reset the boiler in the boiler room. By removing the relay with the manual reset with one that is automatic, once the boiler water reaches a safe level, the boiler will begin to fire without any interaction from maintenance personnel. This is not allowed per the Code. (Ref. CSD-1, CW-140)

Photo #12 - Bypass to the Modulating Feed Valve. Valve was found in the half open position.

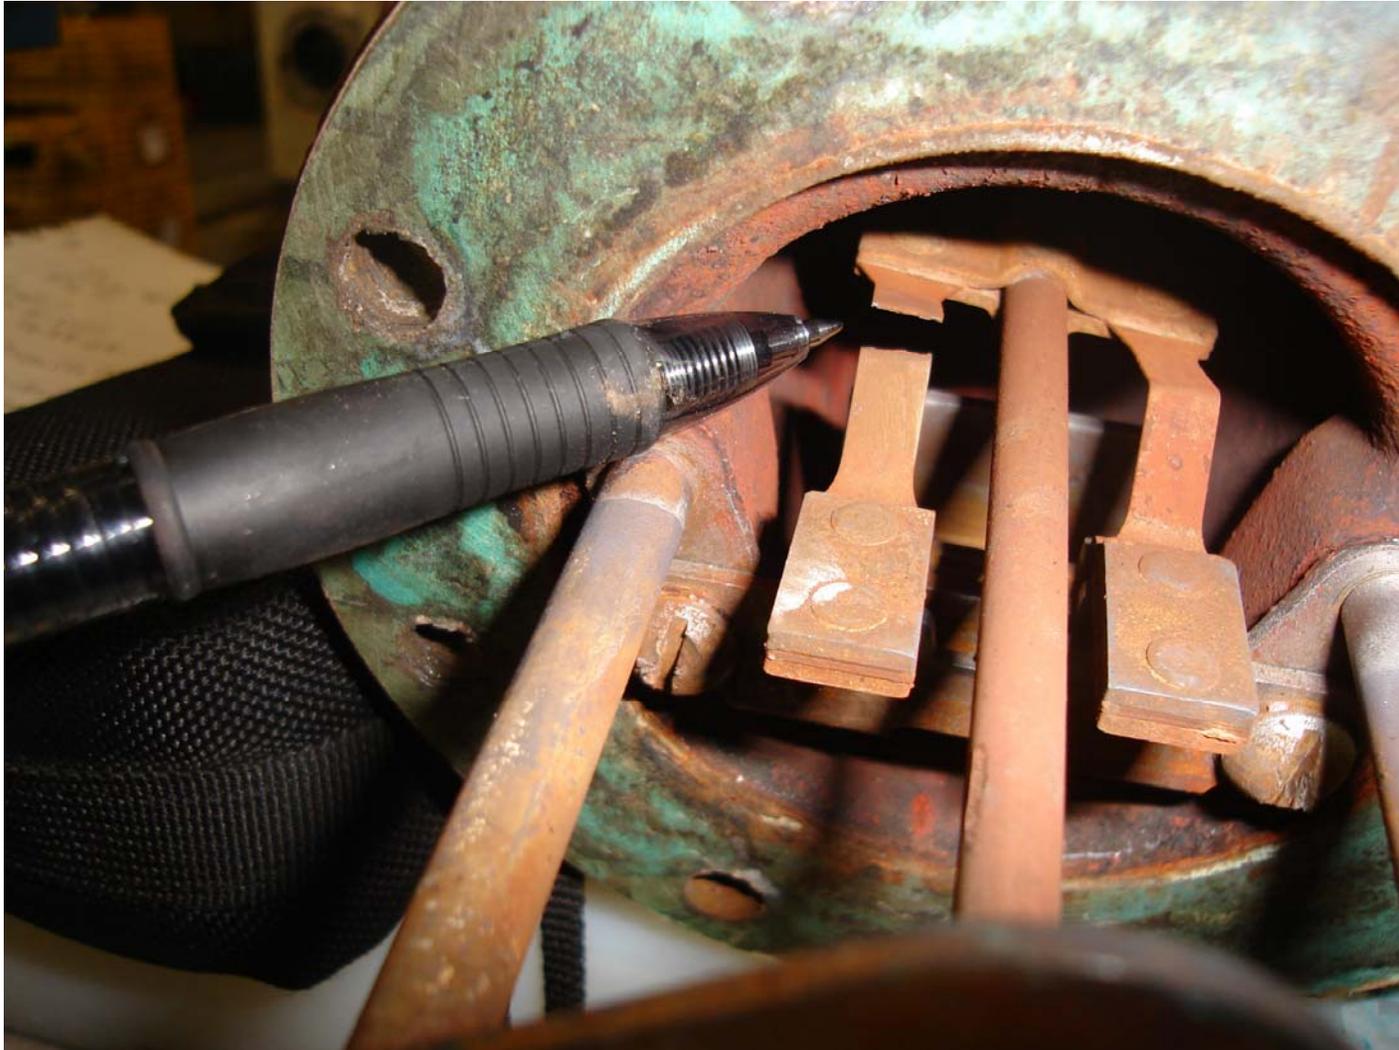
1. The float assembly on the McDonald & Miller (M&M) Series 193-7B mechanical combination low water cut-off/pump controller located on the boiler had a bent and broken spring (see Photo #13).

From the evidence, it is deduced that the primary low-water fuel cutoff (LWCO)/pump controller float was wedged in the up position. This could have accounted for the boiler continuing to fire even though the boiler was experiencing a low water condition. Past experiences of high water in the boiler, which in turn lead to the disconnection of the modulating feed control for the feed valve, could have lead to the float becoming wedged.

Photo #13 – Bent and Broken Spring on McDonald & Miller (M&M) Series 193-7B Mechanical Combination Low Water Cut-Off/Pump Controller

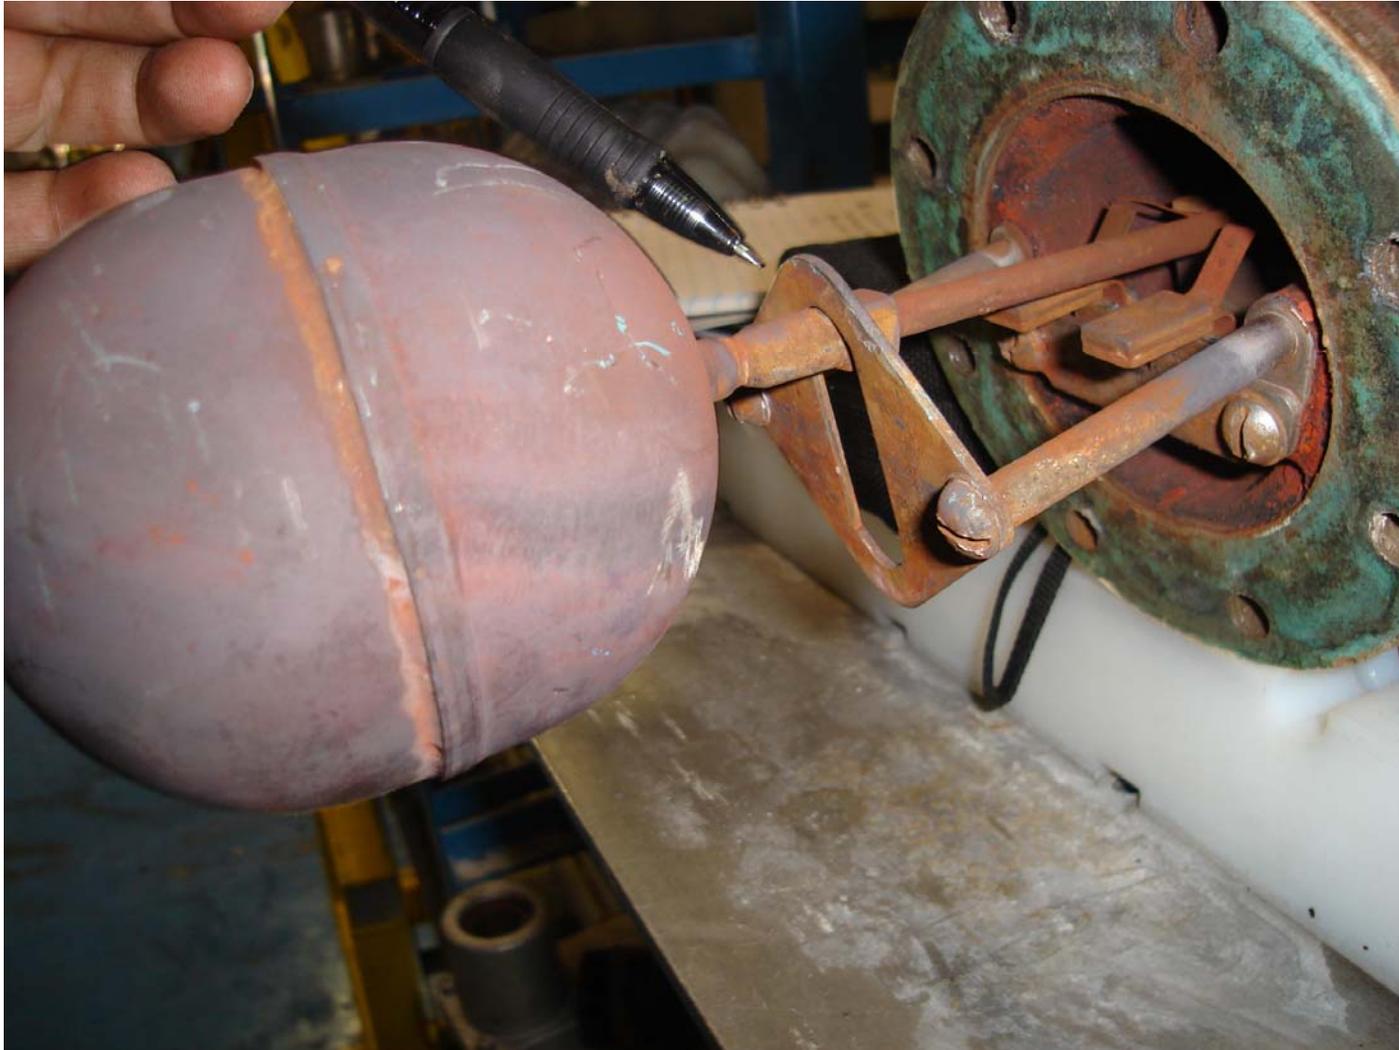
2. When the float arm assembly of the M&M Series 193-7B mechanical combination low water cut-off/pump controller was manipulated up by hand to simulate a high-water condition, the stem for the float would stick on the guide plate (see Photo #14).

Photo #14 - McDonald & Miller (M&M) Series 193-7B Mechanical Combination Low Water Cut-Off/Pump Controller stuck in the up position

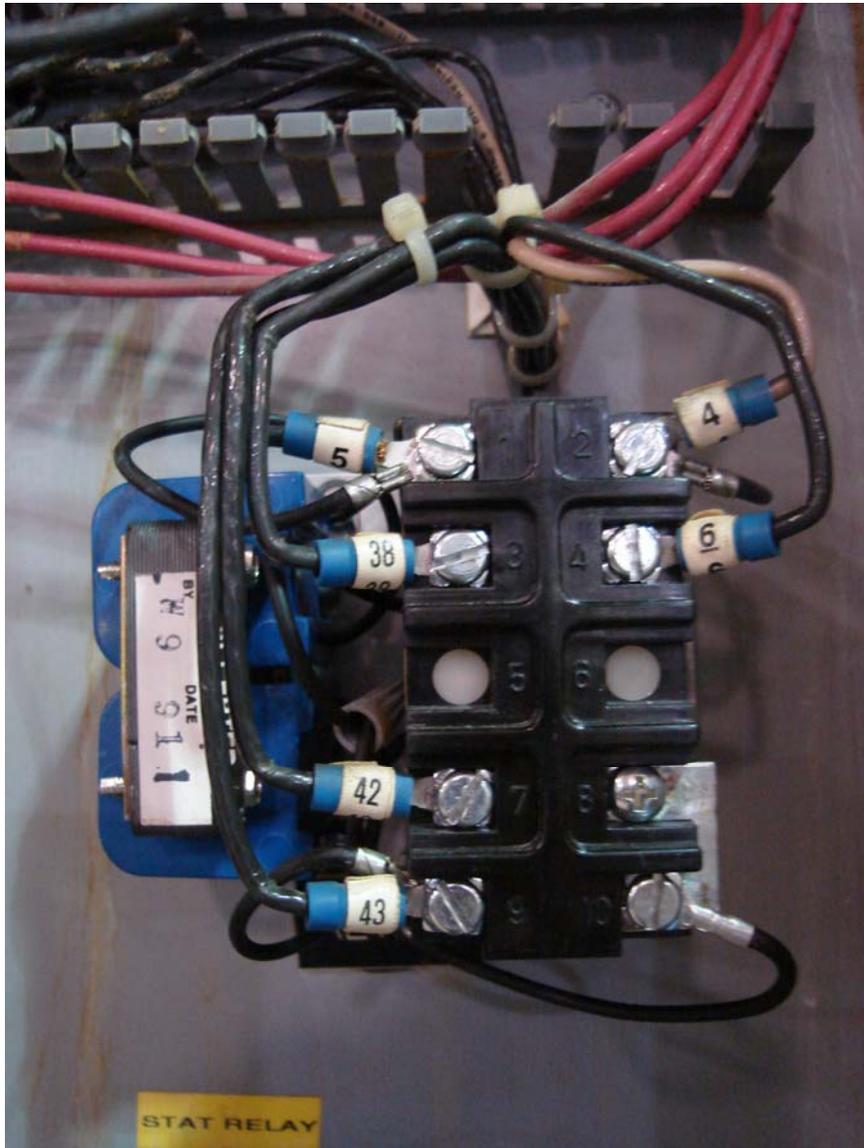
5. An improper relay (1d1d0) for the auxiliary low-water cutoff was installed by Dana Corporation maintenance personnel (see Photo #15). Due to a dissimilar connect configuration, the different wire line-up caused the circuit to remain closed, which gave a misreading of the boiler water level. Since the circuit was continuously closed, no matter if water was in the boiler or not, the safety device would read that the water level was at a safe operating level. Photos #16a and #16b illustrate the 1c1d0a and 1d1d0 relays. The 1c1d0a is the proper relay for the boiler in question; 1d1d0 was the improper relay that was installed by Dana Corporation maintenance personnel. Note the different contact configuration diagrams.

Given that the auxiliary LWCO relay was replaced with the incorrect model, the primary LWCO did not respond and cut-off the fuel supply to the boiler, the boiler continued to fire until the accident occurred. Without corroboration, it can only be speculated that operation of the boiler's

Photo #15 – Improper relay that was installed by Dana Corporation maintenance personnel for the Auxiliary LWCO
