**STATE OF TENNESSEE
DEPARTMENT OF LABOR AND WORKFORCE DEVELOPMENT
DIVISION OF BOILER AND ELEVATOR INSPECTION**

**Boiler Accident
Dana Corporation, Paris Extrusion Plant
Paris, Tennessee
June 18, 2007**

Report Date: July 9, 2007

**Report Prepared by:
Chief Boiler Inspector
Division of Boiler and Elevator Inspection
Tennessee Department of Labor and Workforce Development**

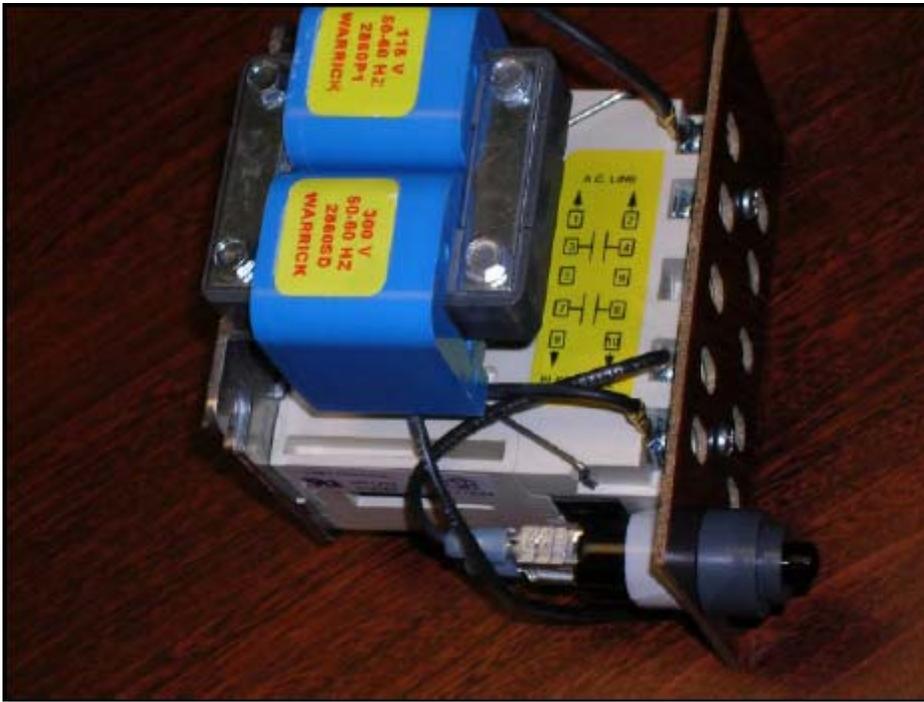
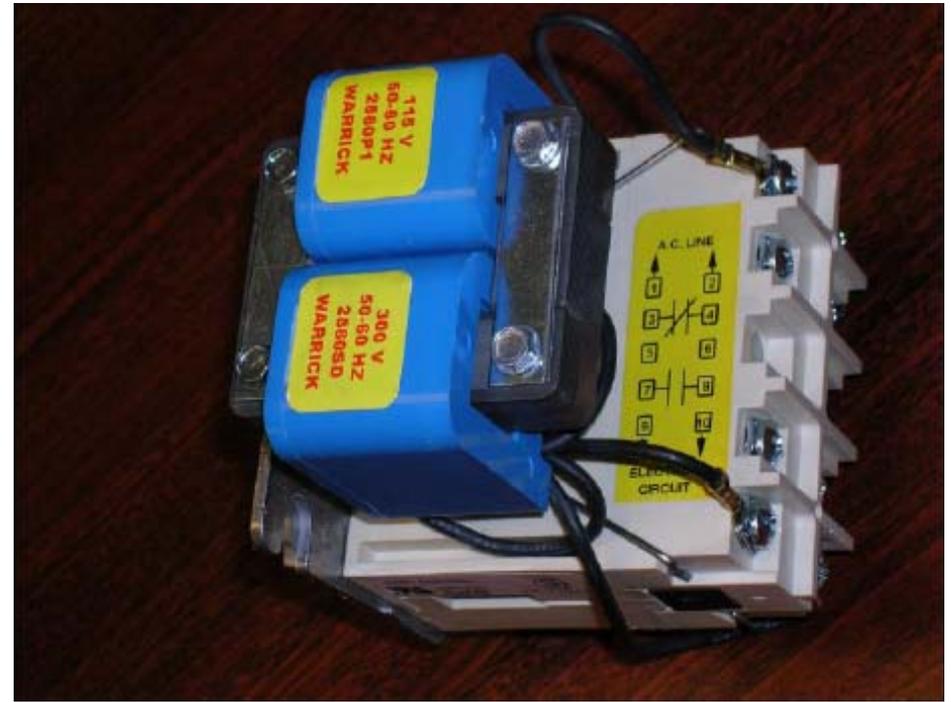
5. An improper relay (1d1d0) for the auxiliary low-water cutoff was installed by Dana Corporation maintenance personnel (see Photo #15). Due to a dissimilar connect configuration, the different wire line-up caused the circuit to remain closed, which gave a misreading of the boiler water level. Since the circuit was continuously closed, no matter if water was in the boiler or not, the safety device would read that the water level was at a safe operating level. Photos #16a and #16b illustrate the 1c1d0a and 1d1d0 relays. The 1c1d0a is the proper relay for the boiler in question; 1d1d0 was the improper relay that was installed by Dana Corporation maintenance personnel. Note the different contact configuration diagrams.

Photo #16a – 1c1d0a Relay with Manual Reset

Photo #16b – 1d1d0 Relay without Manual Reset

***Note the difference in the contact configuration diagrams**

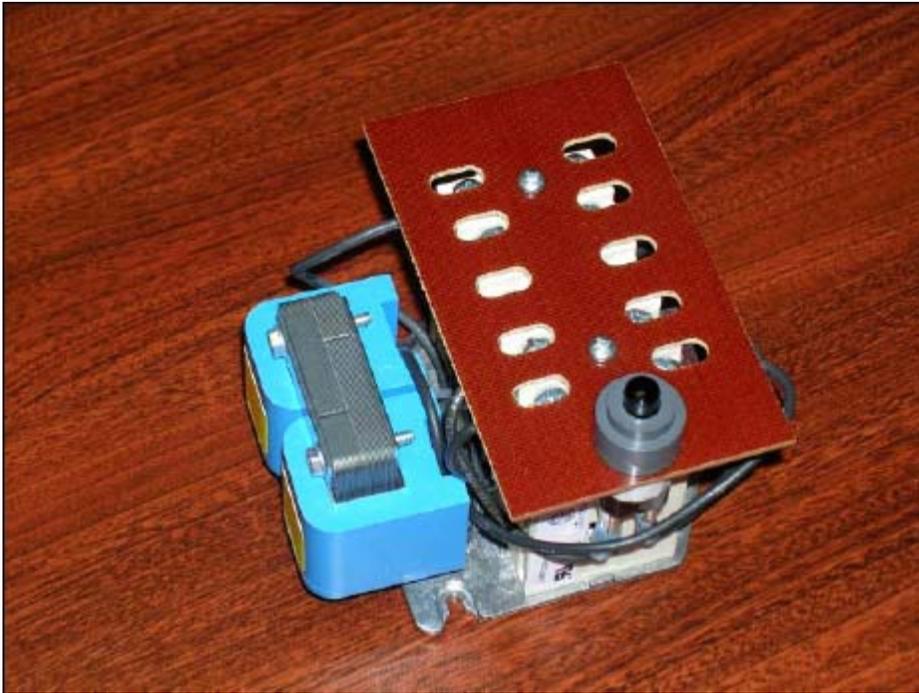
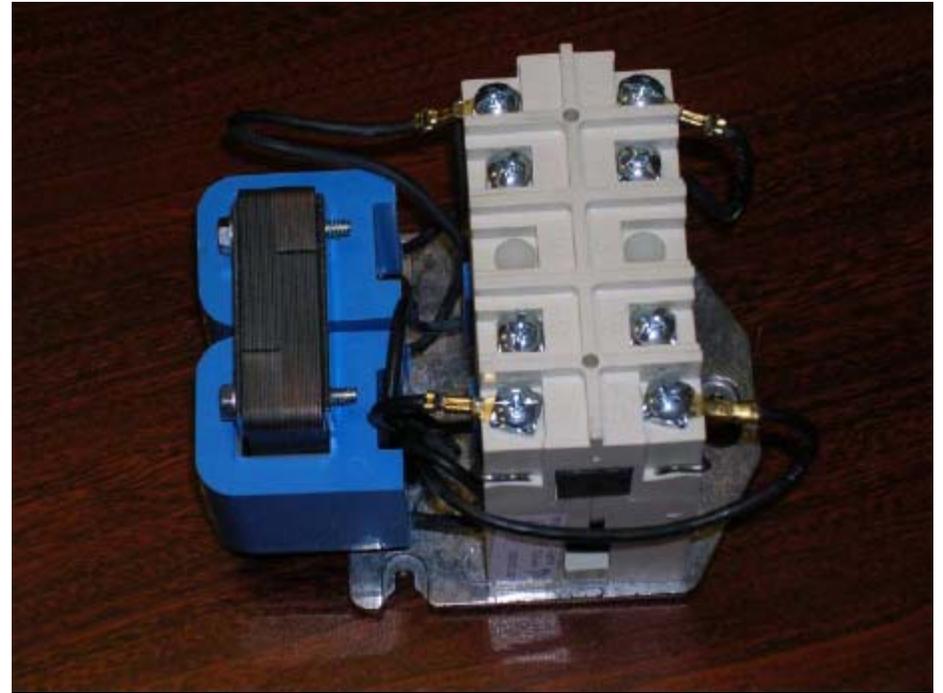
6. The manual reset for the auxiliary low water cut-off was removed when the improper relay was installed. On the Cleaver-Brooks CB Packaged Boiler, the auxiliary LWCO is intended to be installed with the Code required manual reset switch. Photo #17a illustrates the proper relay that should have been installed, Note the manual reset button and compare with Photo #17b that has no manual reset.

Photo #17a –1c1d0a (Proper Relay with Manual Reset)

Photo #17b – 1d1d0 (Improper Relay without Manual Reset)
