**MARINE INVESTIGATION REPORT**  
**M05W0111**

**LOSS OF PROPULSION, SUBSEQUENT STRIKING OF BERTHED  
PLEASURE CRAFT AND GROUNDING**

**ROLL-ON/ROLL-OFF FERRY *QUEEN OF OAK BAY*  
HORSESHOE BAY, BRITISH COLUMBIA  
30 JUNE 2005**

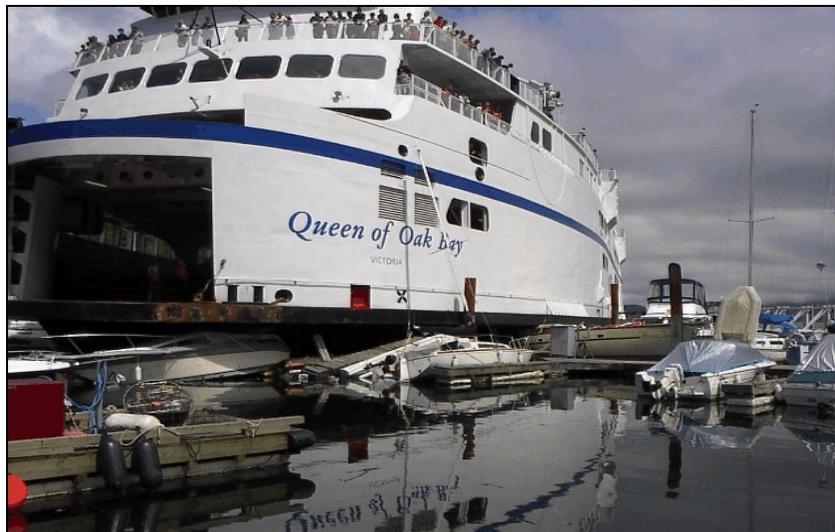
**Photo 1.** *Queen of Oak Bay* aground in Sewell's Marina

The vessel suffered minor damage to the No. 2 propeller and some scraping damage to its hull. There was extensive damage to the marina and 28 pleasure craft moored there.

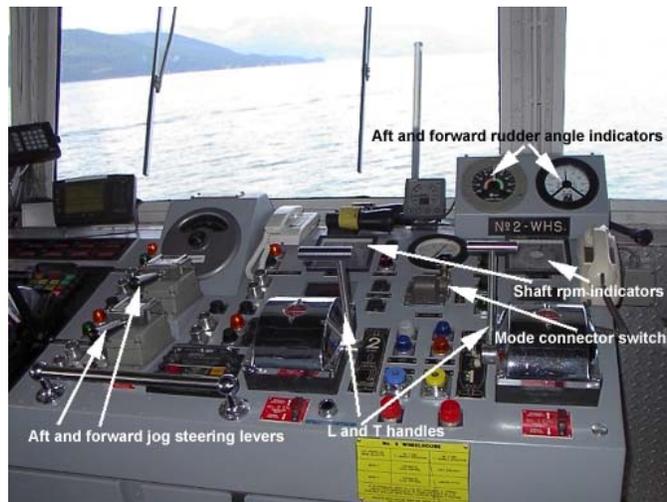
**Photo 2.** Wheelhouse control console

Wheelhouse manoeuvring consoles on C Class ferries do not have a mimic board showing the propulsion plant's condition. Relying on the propeller rpm gauges may therefore be misleading and, without gauges to likewise indicate engine rpm or the position of the clutches, it is impossible to tell if an engine is declutched but running, idling, or fully stopped.

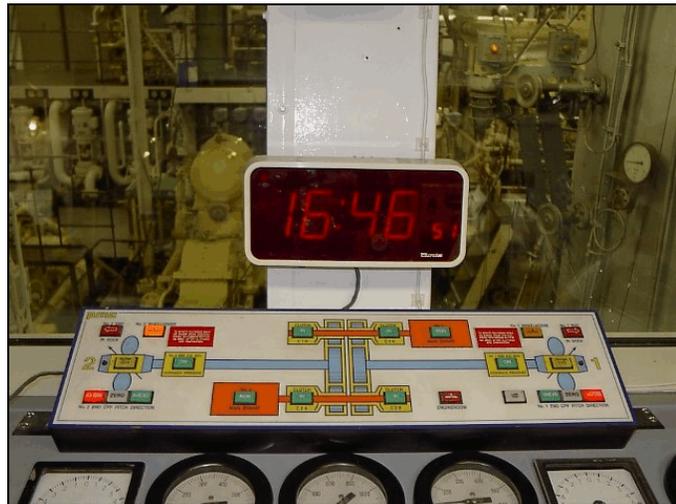
In the event of a malfunction, neither the engine control room nor the wheelhouse has a direct, audible alarm to alert operators to an accidental or inadvertent disengagement of one or more clutches.

**Photo 3.** Mimic board in engine room

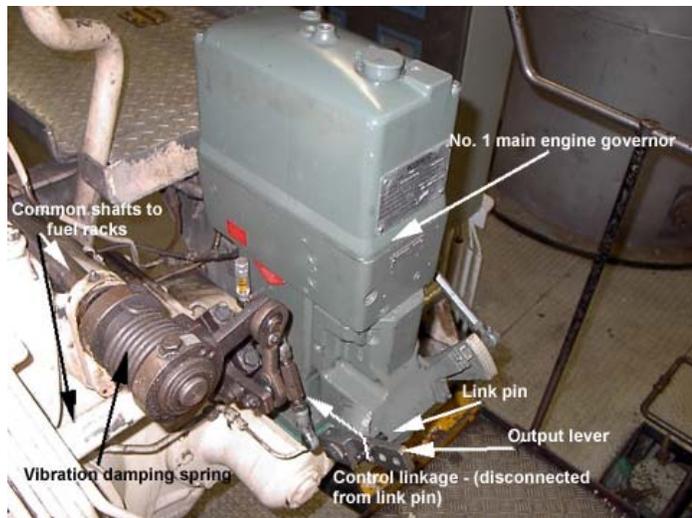
A castellated nut on the link pin for connecting the governor's output lever on the No. 1 main engine governor's output shaft to a control linkage was found on the floor plates beneath the governor. The linkage had slid out of the governor's output lever link pin, causing the governor to become disconnected from the engine's fuel control rack linkages (see Photo 4).

No broken pieces of the locking split pin were found in the vicinity of the nut, nor were any left behind in the bore of the link pin or the nut.

The orientation of the fitted link pin was contrary to that indicated in the manufacturer's drawings, which indicated that the pin was to be inserted with its head on the side of the link rod, with the nut lying on the outer side of the output lever. There was no indication that the orientation of the pin would have resulted in a detrimental effect or condition.

The link pin was designed to slide into its designated bored hole in the output lever. Wear from usage created an excessive clearance between itself and the bored hole.

**Photo 4.** No. 1 main engine governor and disconnected fuel rack linkage

The function of a governor is to limit an engine's rpm around a set point, preventing it from overspeeding. As the castellated nut loosened under vibrations, the control linkage fell out. This allowed the No. 1 main engine's governor to become disconnected from its fuel-control racks, leaving the engine without speed control. Neither the engine fuel-control shafts nor individual fuel pump racks were fitted with return springs (nor were they required to be). Therefore, overspeeding of the engine could not be prevented because the fuel racks could not be brought back to zero.

The absence of a split pin on the securing nut on a governor linkage of the No. 1 main engine thus caused the governor to become disconnected from the fuel racks. The two main engines were interconnected at this time, and this caused the overspeeding No. 1 main engine to drag the No. 2 main engine into a shutdown condition with it, leaving the vessel without propulsion.
