London Offshore Consultants Pte. Ltd.

Our Ref: 4076/C4/R001/JMW/LOCS

“HEBEI SPIRIT”
COMMENTS ON THE INCHEON MARITIME
SAFETY TRIBUNAL (SPECAIL TRIBUNAL)
DECISION - 4TH SEPTEMBER 2008

Date: 21 November 2008

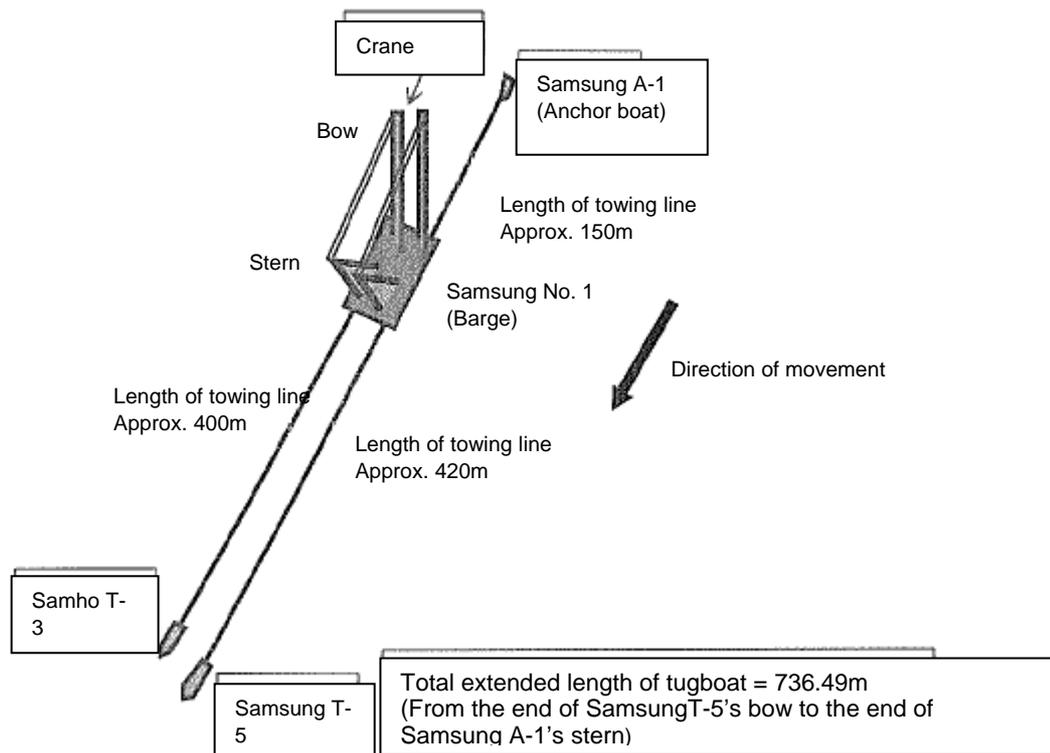
[Picture 1] The position of the vessels during normal navigation of the Marine Spread. (The bow of the barge is where the crane boom is located. Therefore, the barge was being towed by its stern at the time of the accident).

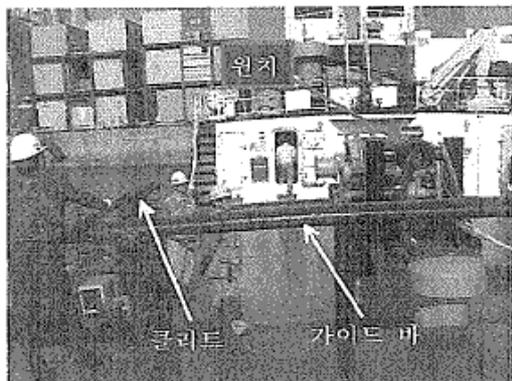
[Picture 6] The shape of the towing winch, and guide bar and cleat on the stern deck of “Samsung T-5”

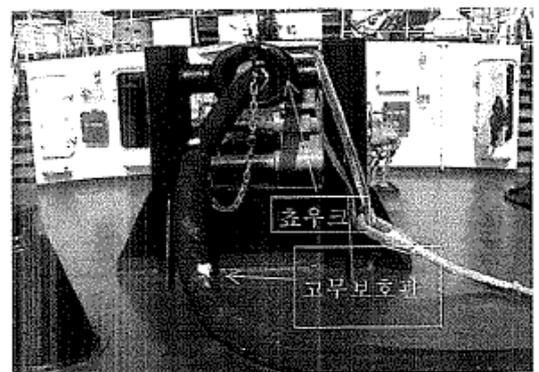
[Picture 7] Towing line choke and rubber sleeve behind the towing winch of “Samsung T-5”

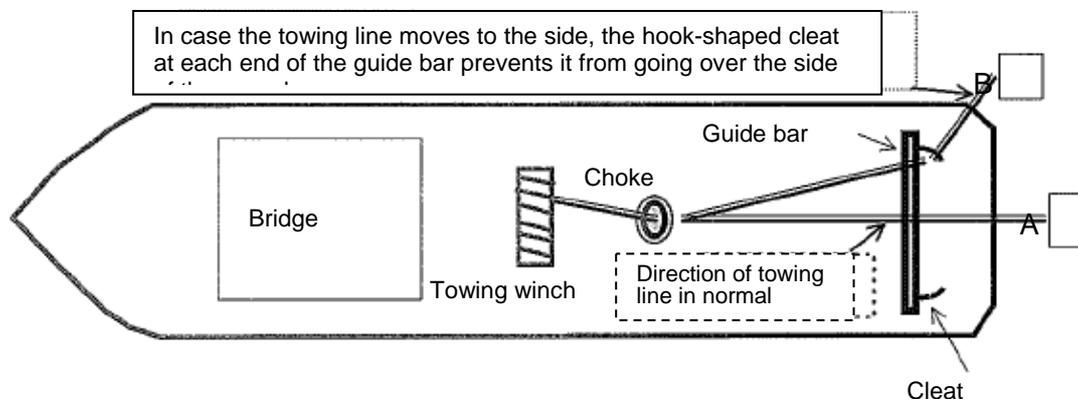
[Picture 8] The towing line that is released out of and wound onto the towing winch goes through and over the choke and the guide bar.

A rs in a normal case where the towing line stretches out along the center of the stern. **B** illustration of how the towing line gets trapped by the cleat at the end of the guide bar and is prevented from falling off when straying to the side.

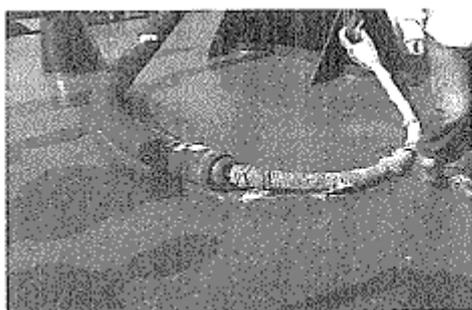
[Picture 9] Round eye at the end of the towing line wound around the towing winch

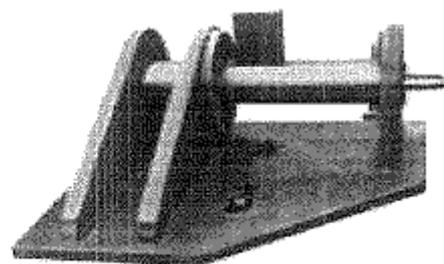
[Picture 10] Smit bracket that is attached respectively to the port and starboard side of the stern deck of “Samsung No. 1”

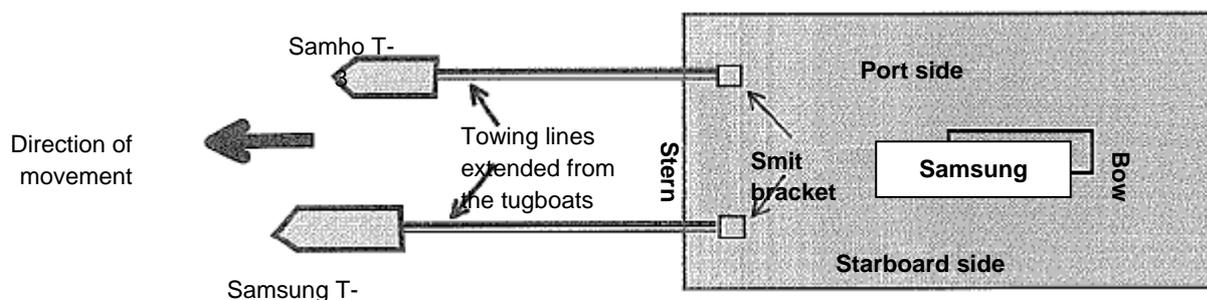
[Picture 11] Illustration of “Samsung No. 1” being towed by its stern by connecting the towing lines of “Samsung T-5” and “Samho T-3” to the smit bracket attached to the bottom of the stern deck of “Samsung No. 1”

It is obvious from the pictures/videos taken both during the collision and afterwards that the “SAMSUNG NO.1” was being towed with its crane booms fully rigged, with falls and spreaders beams hanging loosely. The wind resistance of the crane booms is a substantial component of the resistance of the crane barge against the towing pull of the tugs as the IMST have described in their Decision below. However, they have just accepted this situation and not commented on whether this was the correct towing arrangement for this barge (i.e. should the boom have been lowered for towage, the spreaders secured), and whether the consequences of this were taken into account by the operators/managers of the marine spread and the masters on the marine spread. That is, being aware of the effects of the increased wind resistance on the movement of the barge.

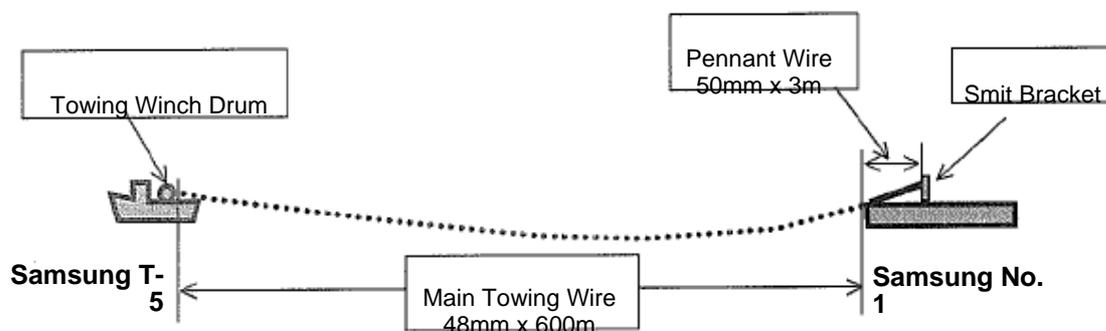
[Picture 12] Composition of the “Samsung T-5” towing line on the Towage Approval Check List. (The total length of the towing line is 603 m. However, given that the pennant wire is placed on the deck of the barge, the maximum length of the towing line that can be used is 600 m, and the actual length of the same during navigation may be adjusted by the master as he deems appropriate.)

The IMST are technically misleading the reader regarding the usage of the full length of the tow line on each tug. Even if the tow lines on each tug were 600m and 500m respectively, these full lengths could not be used. It is usual to retain a certain number of turns on the drum of each winch to ensure that the wire does not slip off. This, of course, will decrease the length of the tow line available.

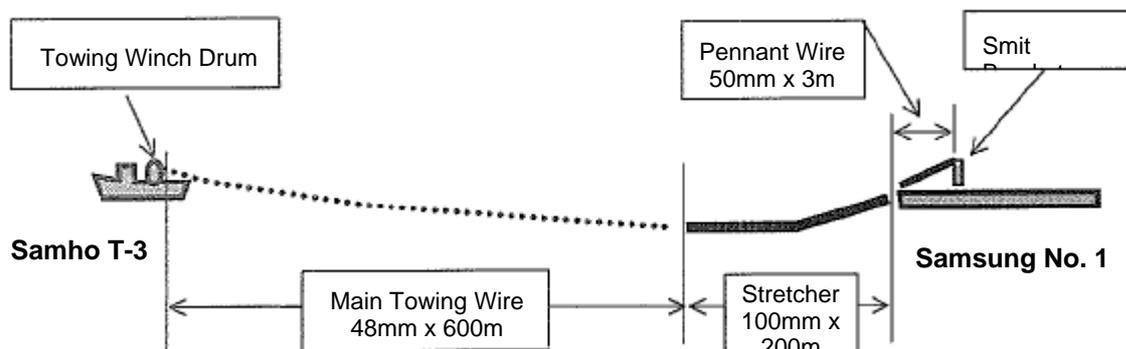
[Picture 13] Composition of the “Samho T-3” towing line on the Towing Approval Check List. (Unlike the composition of the “Samsung T-5” towing line, a P.P rope is additionally connected between the main towing wire and the pennant wire to absorb tension impact. Given that the pennant wire is placed on the deck of “Samsung No. 1,” the maximum length of the “Samho T-3” towing line that can be used is 700 m, and the actual length of the same during navigation may be adjusted by the master as he deems appropriate.)

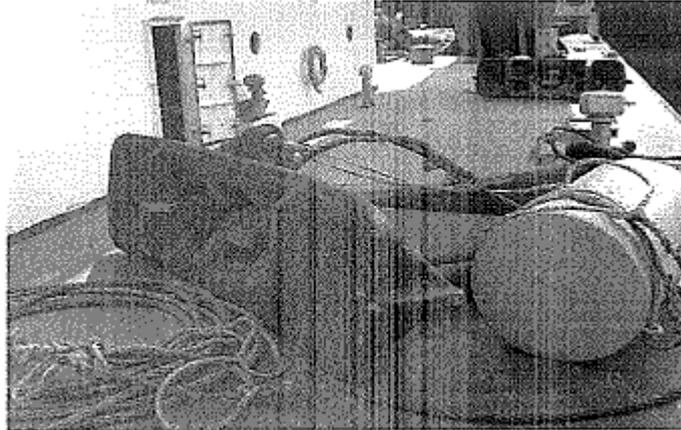
[Picture 14] “Samsung No. 1” positioning anchor and yellow iron anchor buoy to indicate the location of the anchor

It is important to note that IMST have shown that the “SAMSUNG NO. 1” crane barge is rigged with a larger mooring anchor than the VLCC, 19.7 tonnes against 15 tonnes, and yet both are of a type that provides high holding power. Although the anchor chain on the VLCC is large in dimension than that on the crane barge, the latter has fifteen shackles, whereas the VLCC has 14 shackles. Whereas the fully laden VLCC has a deadweight of 258,068 tonnes, the crane barge is only 13,061 tonnes and yet both have similar anchor arrangements. In addition, as the IMST have described above, the mooring anchor on the crane barge is free-fall, that is, it is designed and should be relatively easy to release this anchor in an emergency. Therefore, the IMST reference to the difficulties that the “SAMSUNG A1” would have in deploying the positioning anchors for the crane barge in waves of 4m in height is irrelevant. The free-fall mooring anchor should be able to be deployed at any time without any need for tug assistance.

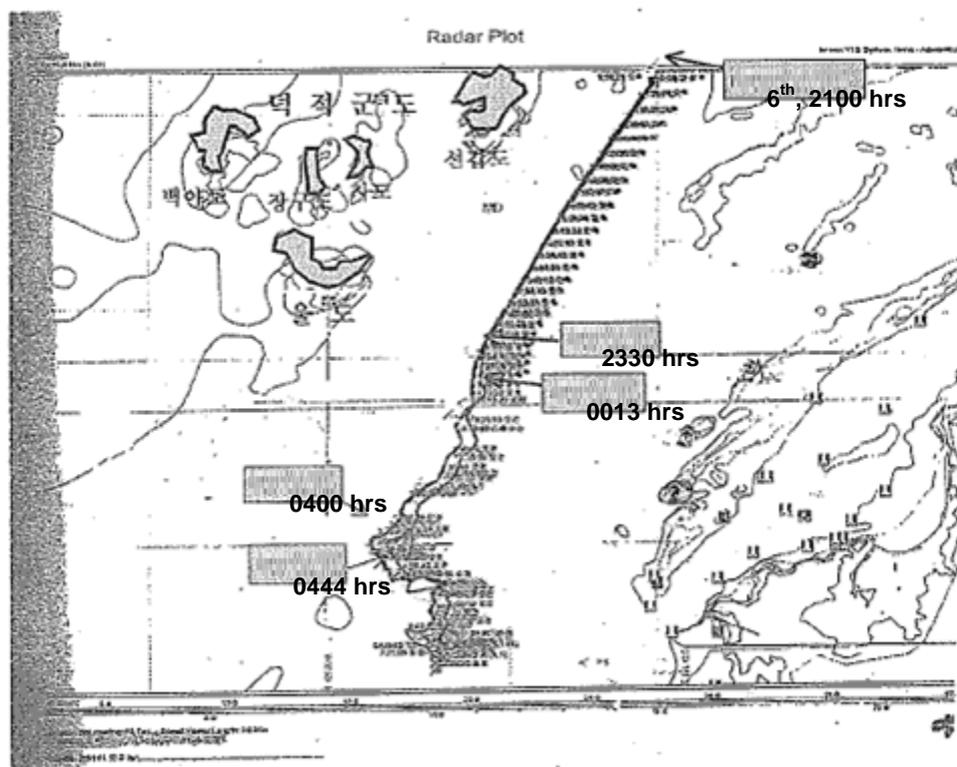
[Picture 18] At around 2330 hours, 30 minutes before when the master Seung Min Cho transferred its duty to the chief officer Sung Ho Kwak, the Marine Spread passed by Ul-do. From that time the tugboats were suddenly pushed to the south and the track of the Marine Spread became very unstable.

From Picture 18 in the IMST report, the track of the marine spread from 0013 hours to about 0400 hours was in the general south west direction the tow was planning to make. Certainly, the track of the spread prior to 0013 hours is a uniform south west track, but then the vessel was on hand steering and probably gaining some protection from the weather from the off lying islands to the west. However, once the vessel cleared the shelter and went onto automatic steering, it would be expected that the track of the vessel would then be less uniform than that shown previously. As long as the spread could be controlled by helm and engine movements to ensure that it followed the general track then there is unlikely to be a major concern. Certainly, there are no reports of the Chief Officer raising any concerns with the duty officer on “SAMHO T-3”, those on “SAMSUNG No.1”, the duty officer on “SAMSUNG A1”, or even Daesan VTS, nor even displaying signals to show that the spread had problems. Consequently, there was no seriousness for him to realize as the IMST have assumed in hindsight.

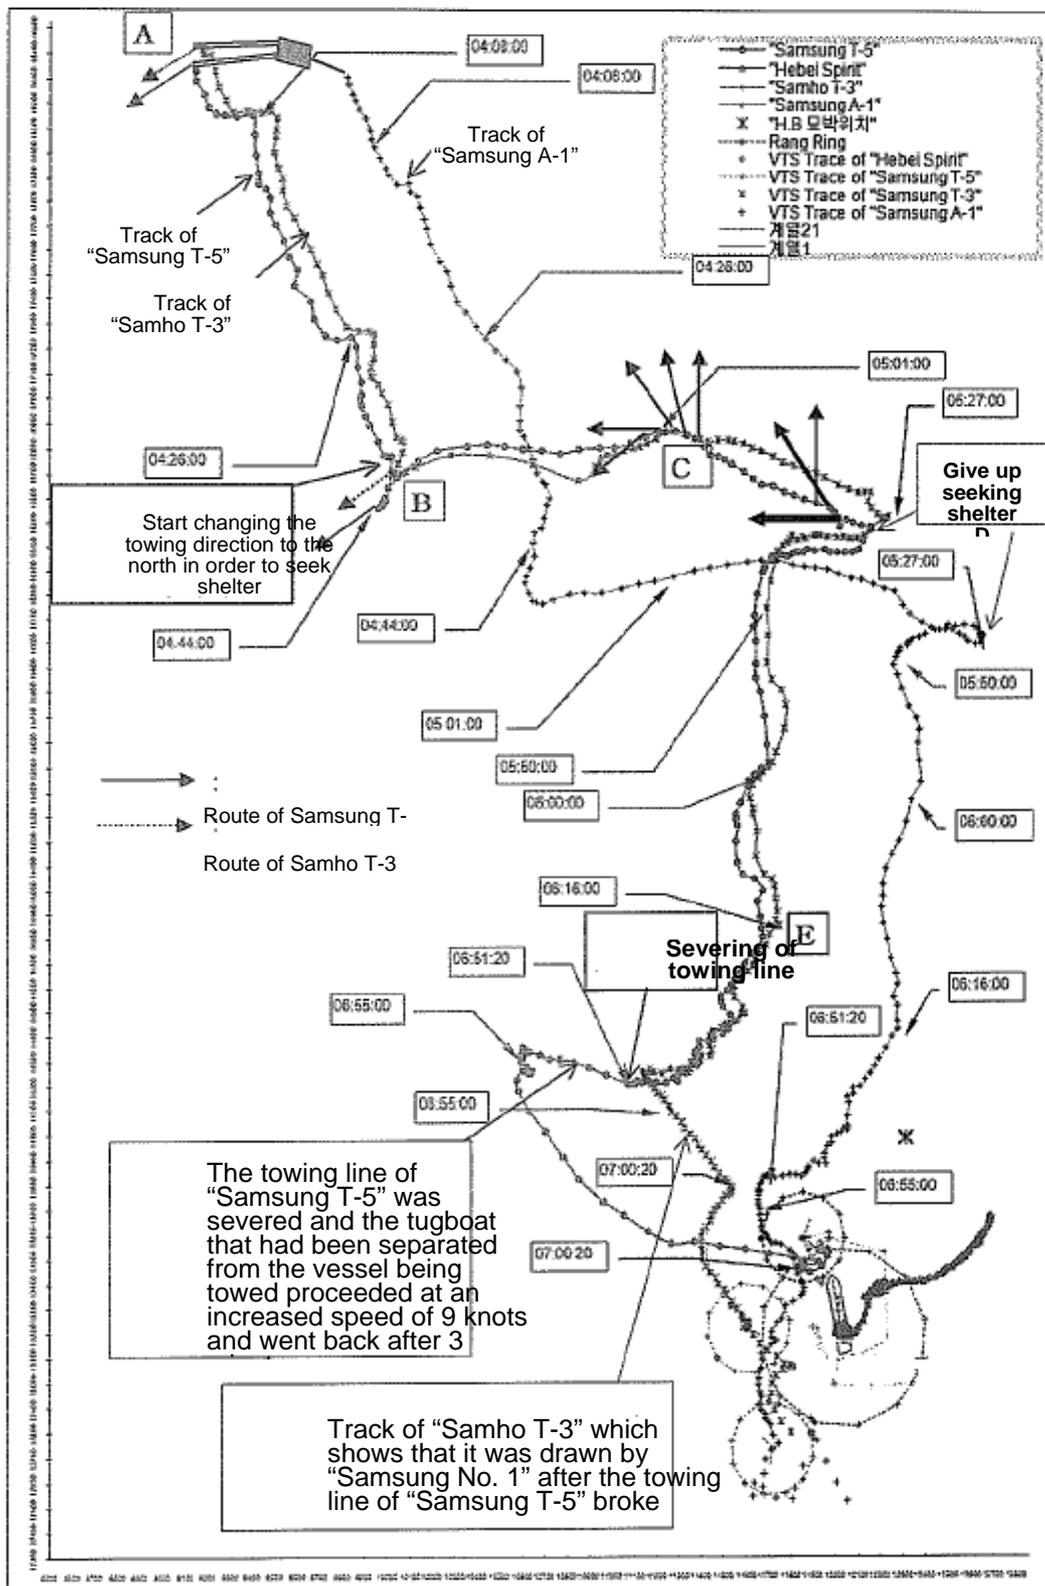
[Picture 19] Voyage tracks of relevant vessels appearing on the radar screen of the Daesan VTS by adding the tracks of the tugboats and statements of the relevant persons.

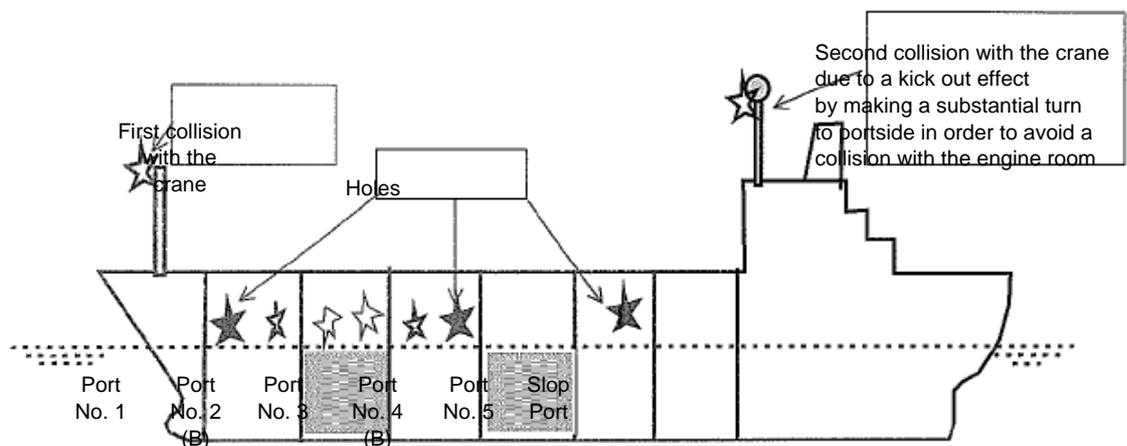
[Picture 20] Damage to “Hebei Spirit” due to the collision. There were a total of nine moments of impact and the puncturing of three holds. The gray parts are empty ballast tanks.

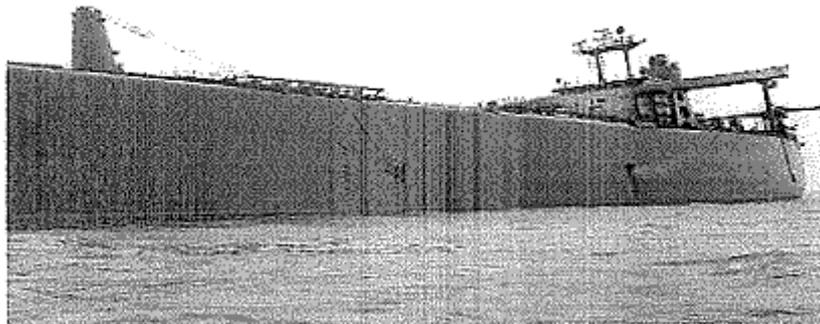
[Picture 21] The holes in the nos. 3 and 5 port cargo tanks of “Hebei Spirit” (the air [inside the cargo tanks] is leaking after the oil spillage)

This is not air, but inert gas billowing from the holes in the side shell plate.

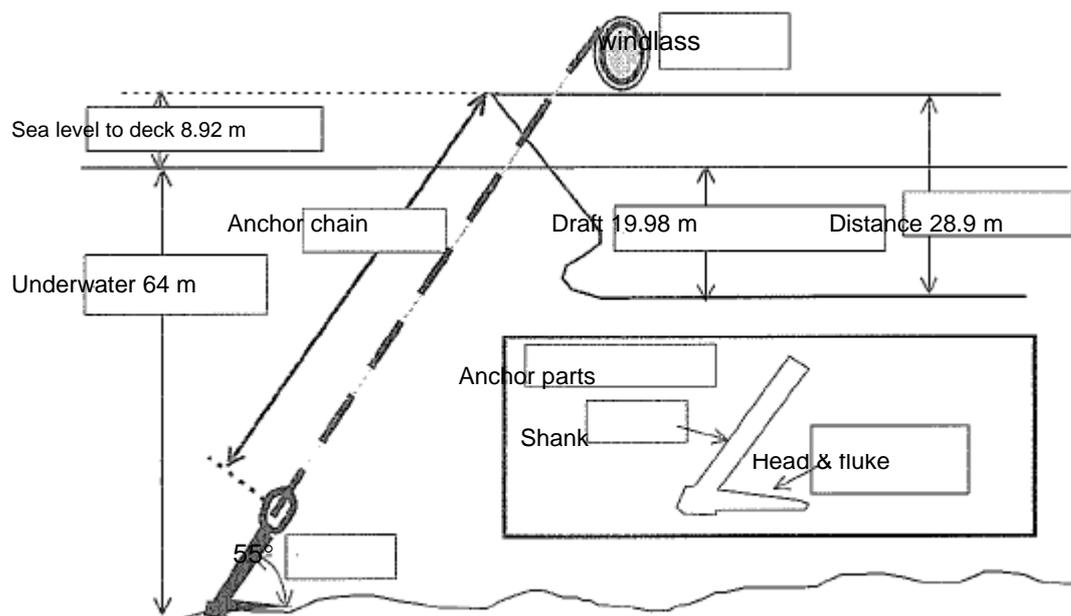
[Diagram 3-2] In the sea depth such as that at the anchoring location of “Hebei Spirit” and where the external forces are weak due to the structure of the hull of the ship, the length of the anchor chain is approximately 85 m (3 shackles) at the point where the anchor head has just left the seabed and holding power becomes zero (short stay situation). At that time, the strong wind probably caused the anchor chain to lengthen, and therefore, the length of the anchor chain floating above the sea bed is probably longer than this.
