# Machinery failure on *HC Rubina* and subsequent contact with the wharf

Brisbane, Queensland | 29 October 2013

**ATSB Transport Safety Report**  
Marine Occurrence Investigation  
305-MO-2013-012  
Final – 14 November 2014

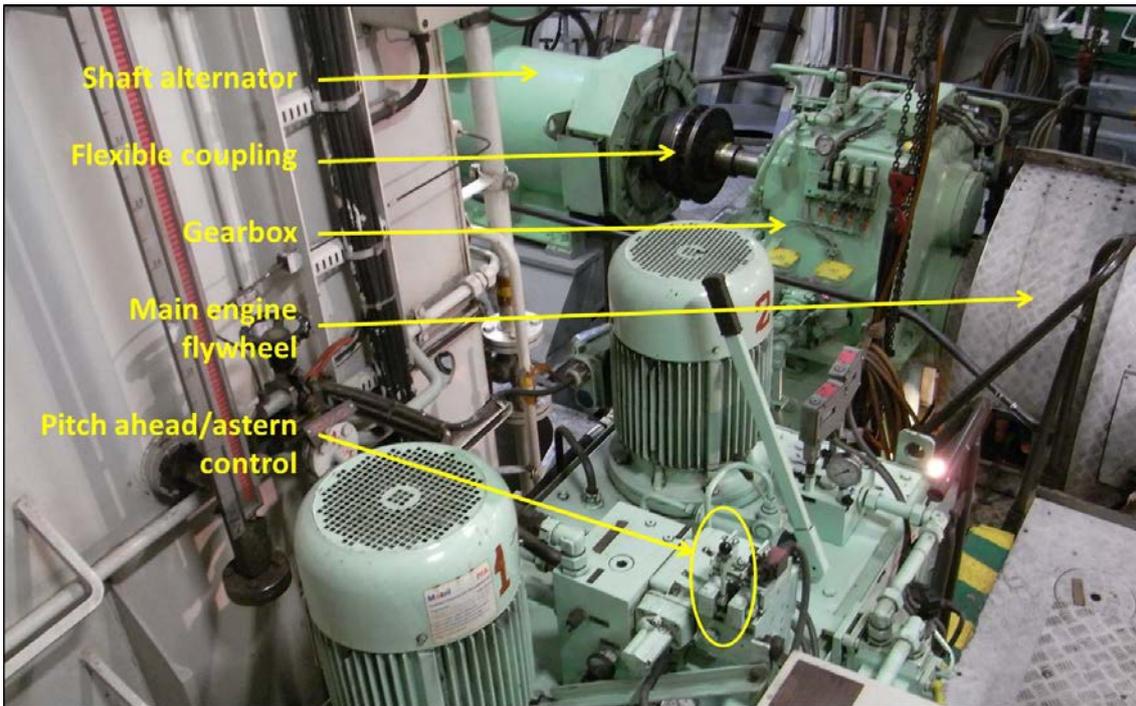
Figure 4: Photograph with the local control station and flexible coupling (guard removed)

At about 1958, the shaft alternator flexible coupling catastrophically failed. The aft end of the engine room quickly filled with smoke and power to the bow thruster was lost. The second engineer ran from the CPP local control station, which was about 3 m from the flexible coupling, to the forward end of the main engine to escape the smoke. The propeller pitch setting was left between 3 and 5 per cent ahead.

At the time of the incident, the pitch was being operated from the local control station (Figure 4) following a complete failure of the pitch control system. The pitch order was being relayed from the bridge via telephone to the second engineer, who was manually operating the ahead and astern pitch control hydraulic valves until the required pitch was achieved.

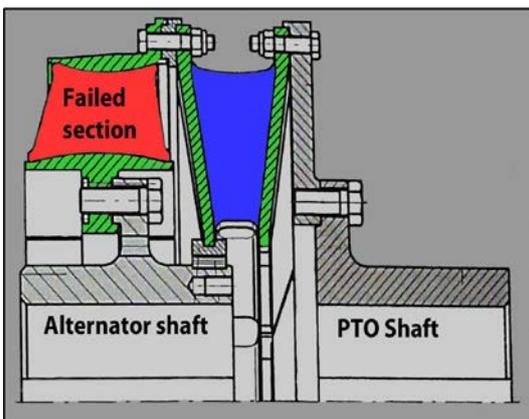
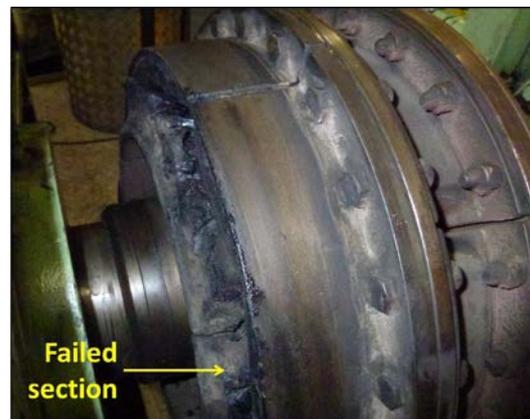
Figure 5: Shaft alternator flexible coupling

The coupling (Figure 5) transmitted the output power to the shaft alternator through an annulus rubber ring (red). The annulus ring was bonded to steel plates (green) and radial rubber segments (blue) which were also bonded to steel plates (green).

According to the manufacturer, the condition of the flexible coupling deteriorated as a result of loading and age. Therefore, they recommended it be replaced every 12 years.

At the time of this incident, *HC Rubina* was 14 years old and there were no available records to indicate that the coupling had ever been replaced. Further, no electronic job histories could be found for this task, or any task, prior to the middle of 2008. No other records were available relating to the maintenance of the coupling. Therefore, the ATSB concluded that the coupling was probably the original installed item and had exceeded its prescribed service life, being 14 years old.

While the nature of the damage sustained prevented the ATSB from specifically identifying the coupling failure mechanism, it was likely that the failure arose because it had deteriorated through age, to a point where it was no longer capable of carrying its rated load.

*HC Rubina's* electronic planned maintenance system (PMS) did not contain any instructions relating to the shaft alternator flexible coupling. Therefore, the PMS could not produce a notification to ensure the shaft alternator flexible coupling was replaced at 12-year intervals in accordance with the manufacturer's instructions.

The Australian Transport Safety Bureau recommends that IMM Shipping takes action to address the lack of instructions in the planned maintenance systems of its managed ships, to ensure that ship equipment is maintained in accordance with manufacturers' requirements.
