Report on the investigation of  
a main engine room fire on board

***Pride of Canterbury***

while berthing in Calais

on 29 September 2014

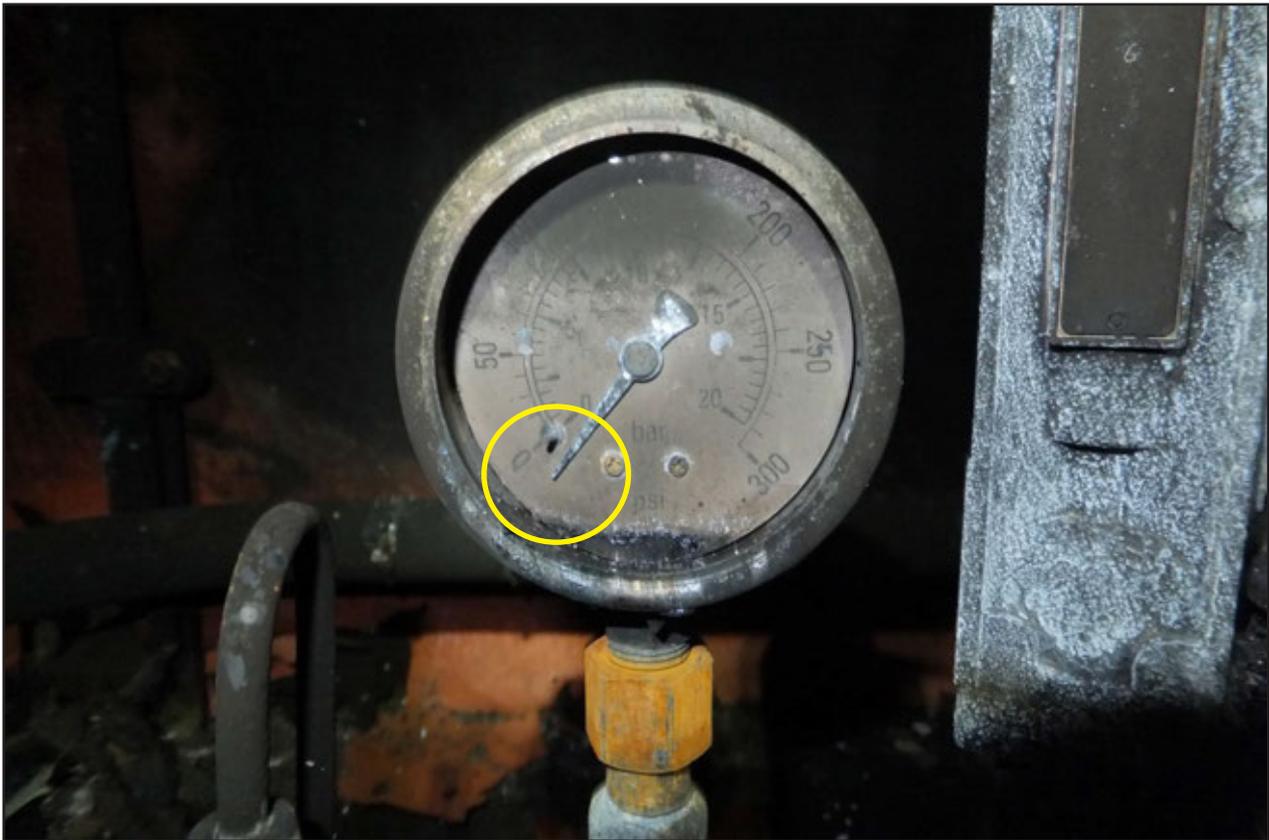
**Figure 3:** Starboard controllable pitch propeller system oil distribution box return line oil pressure gauge (PG3) (post-fire)

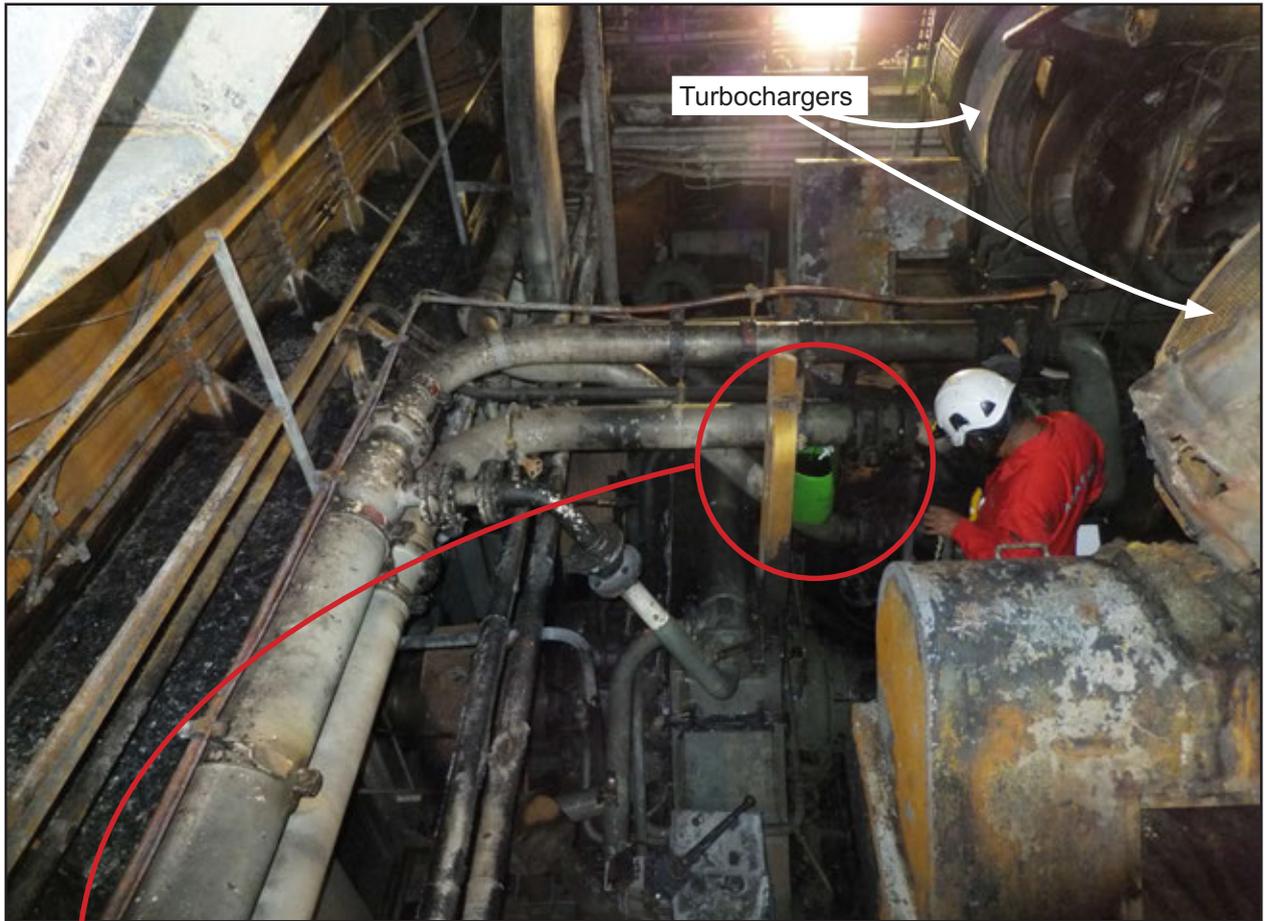
The motorman who was on watch in the main engine room then saw hydraulic oil spray from a flanged pipework joint situated between the two starboard main engine turbochargers (**Figures 5 and 6**). The hydraulic oil ignited immediately. The motorman and remaining personnel evacuated from the main engine room and raised the alarm in the ECR. At 0804, the fire alarm was automatically activated by the sensor heads situated above the starboard main engines.

**Figure 5:** Area aft of starboard main engines

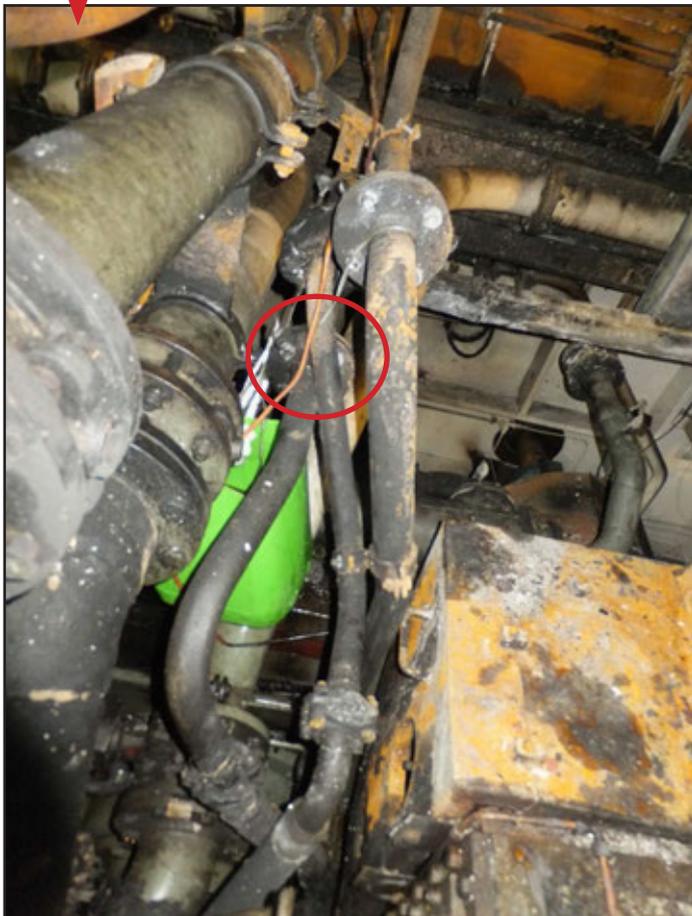
**Figure 6:** Failed flanged joint

The fire was initiated following the spray of hydraulic oil, from a ruptured pipework joint in the starboard CPP system, onto the hot exhaust uptakes of the starboard main engines. The flanged joint ruptured because the CPP system became over-pressurised as a result of the back pressure valve (PSV3) becoming jammed in the closed position.

The ruptured flanged joint (**Figure 6**) was in a section of the return line from the OD box to the CPP oil service tank. The back pressure valve (PSV3) was in the same line and was critical to the operation of the CPP system as it maintained the overall system pressure. When this component failed to operate correctly, there were no means within the system to effectively relieve excess pressure. In addition, pressure safety valve (PSV1), which enabled pressure to be dissipated into the return line, was set to operate at 145 bar. This was significantly higher than the pressure at which some parts of the system were able to withstand as built.

It has not been possible to determine at what pressure the flanged joint that caused the spray of hydraulic oil failed, but had the joint been a hydraulic coupling rated to cope with the maximum system design pressure it might have held in this instance. Although hydraulic systems will often operate at different pressures within the same system, careful consideration of the pressures that could be experienced in the event of component failure should be made to minimise the possibility of a high pressure leak into a section of the system designed to operate at a lower pressure.

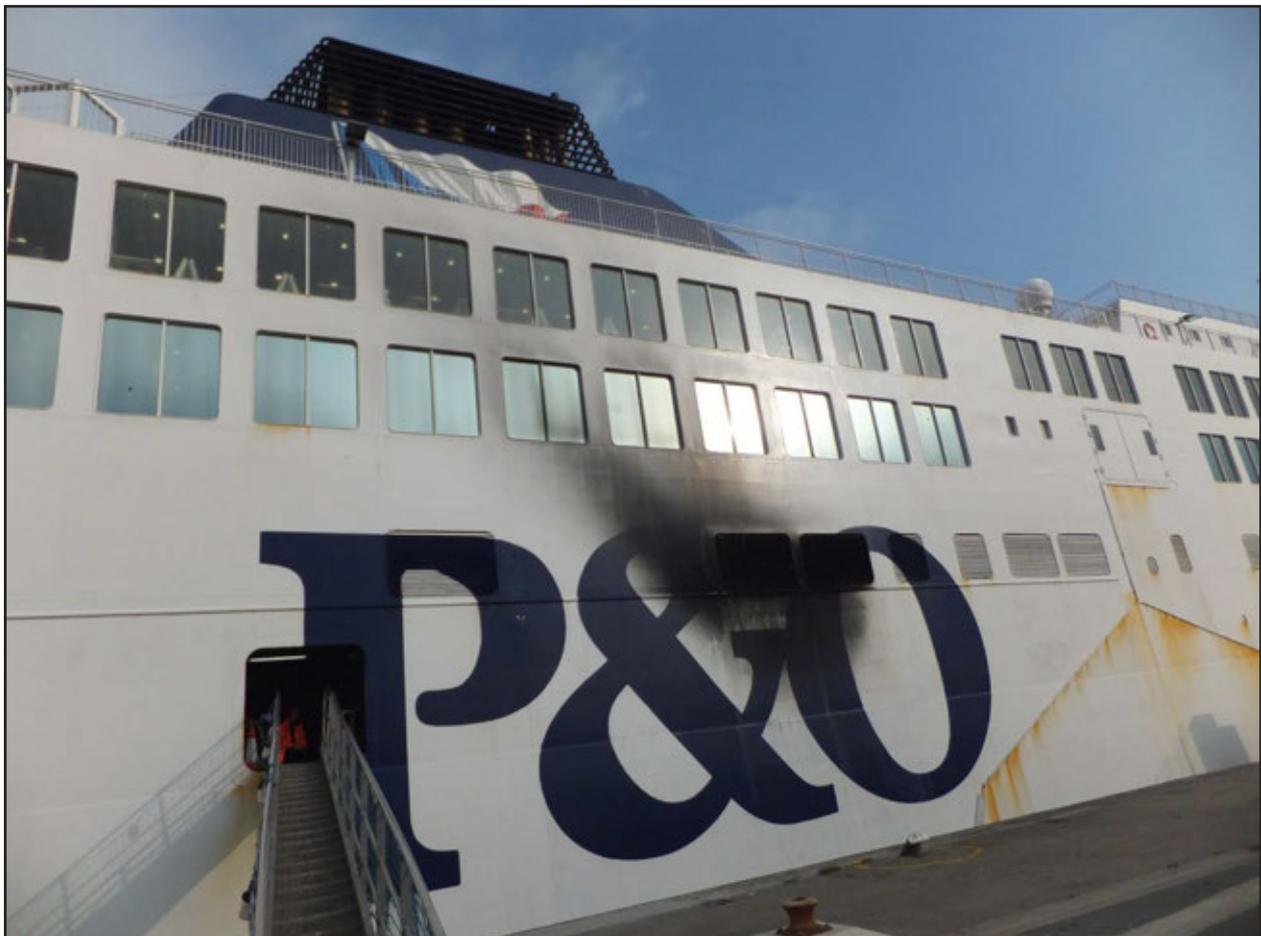
External damage to *Pride of Canterbury* was limited to some smoke staining leading from two main engine room ventilator grills on the starboard side of the ship (**Figure 9**). Internally, damage was limited to the main engine room, where the fire had been centred above the starboard gearbox (**Figure 10**). The greatest damage was sustained in the area of the aft bulkhead, deckhead, and to equipment situated on deck 2 on the starboard aft side (**Figure 11**). The severity of fire damage decreased as the distance from the starboard gearbox increased, with only smoke damage sustained to the port area of the engine room. Following the accident, *Pride of Canterbury* was towed to a local shipyard for repair.

**Figure 9:** Smoke staining on starboard side

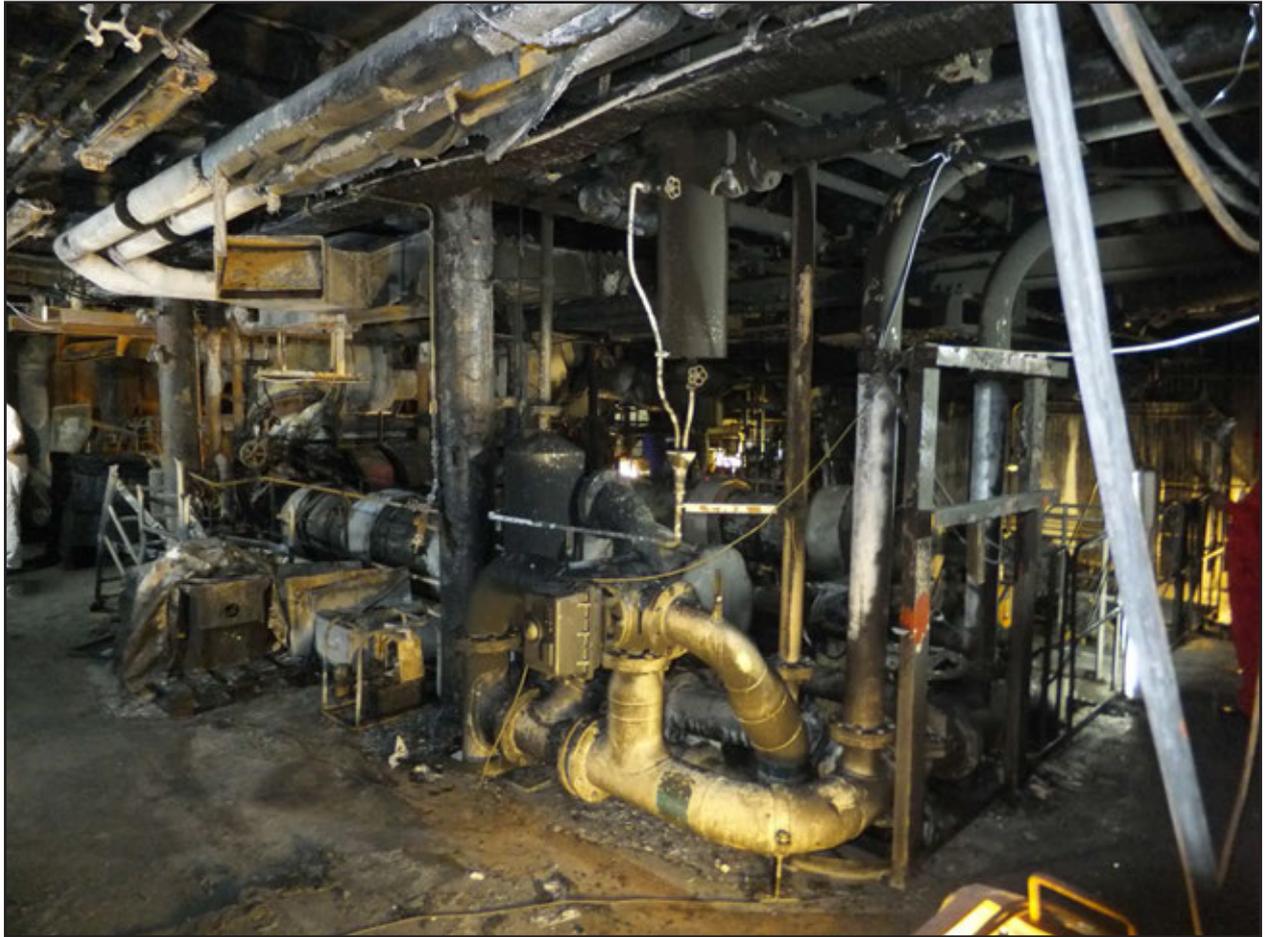
**Figure 10:** Fire damage around starboard main engines, deck 2

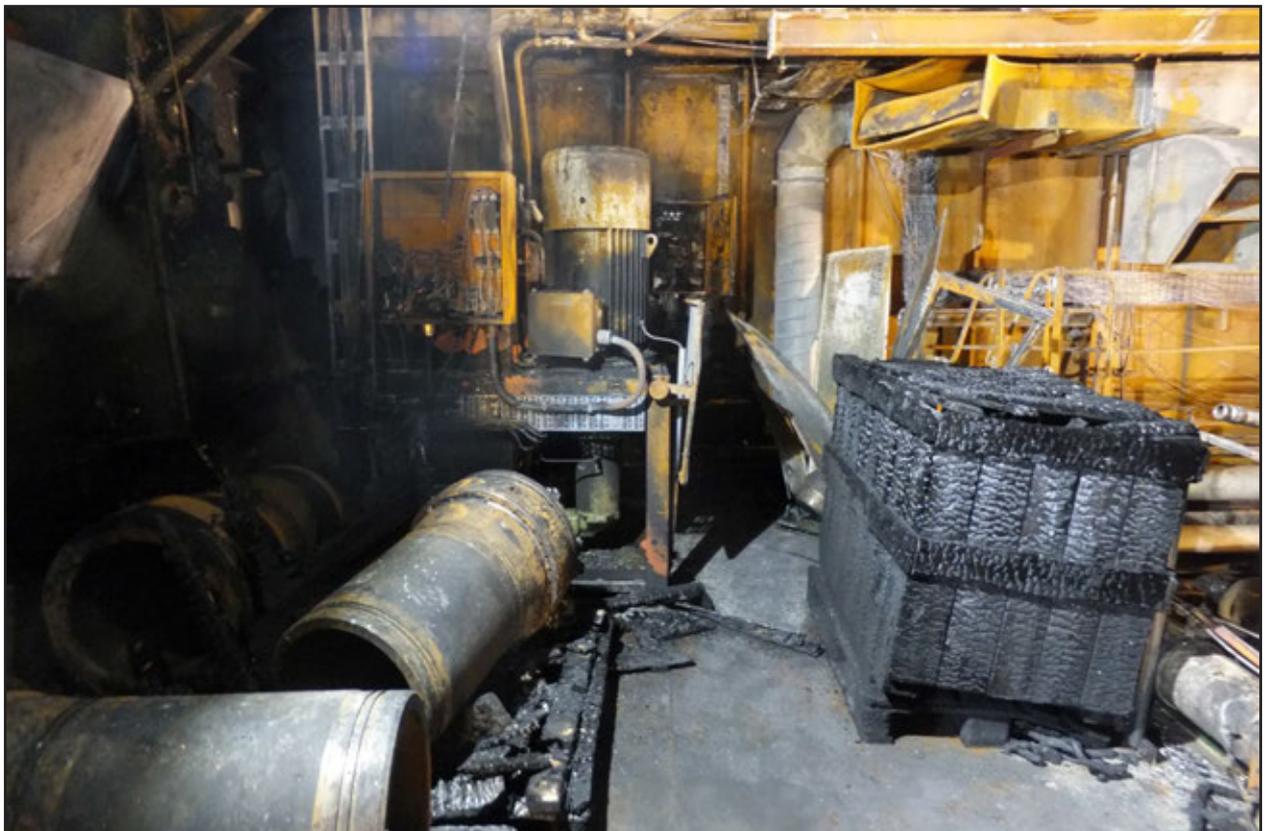
**Figure 11:** Fire damage looking aft on starboard side, deck 2

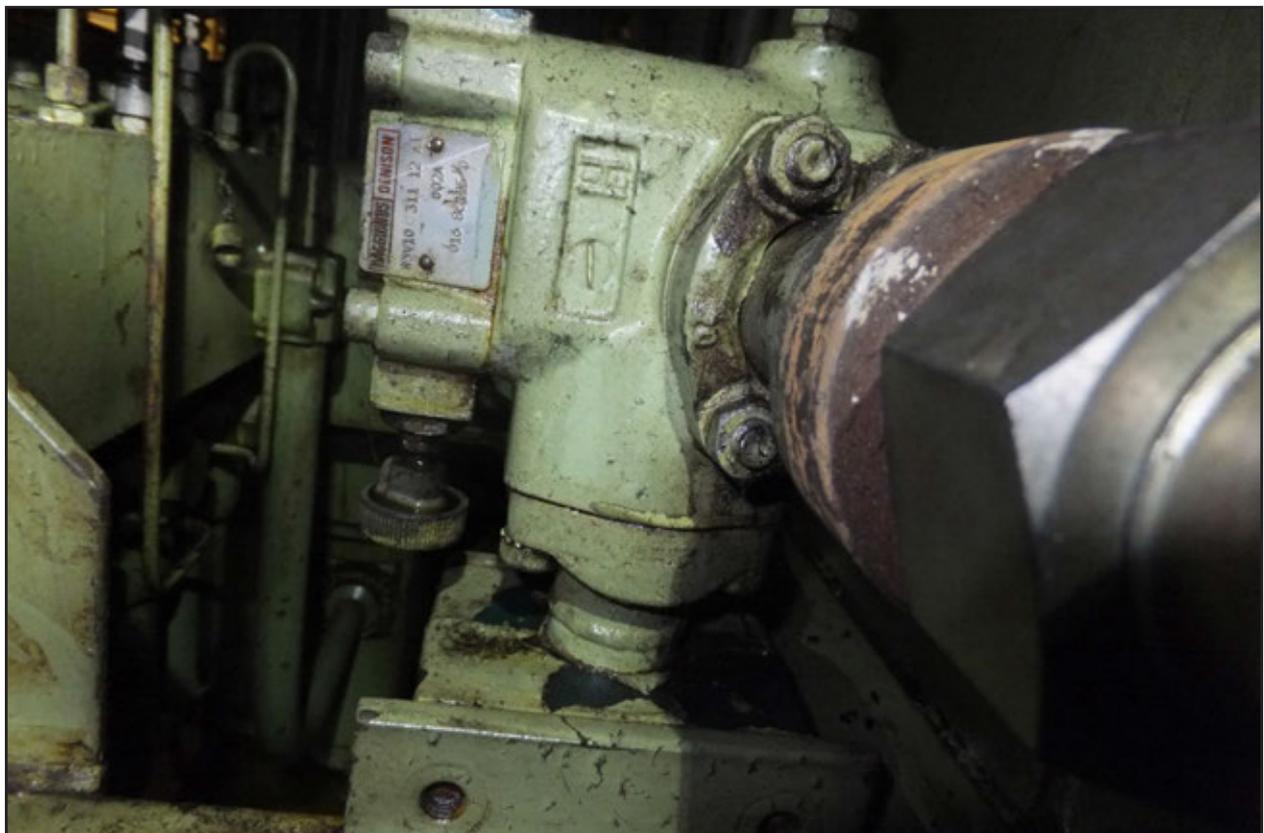
The system oil pressure was regulated by maintaining the return line from the OD box at 8 bar utilising a pressure safety valve (PSV3) termed a back pressure valve (**Figure 16**). A further pressure safety valve (PSV1) was fitted in the supply line to the OD box to enable pressure to be dissipated into the return line if it exceeded 145 bar. **Figure 17** shows the fire-damaged starboard hydraulic module with the relevant components highlighted. An oil cooler was situated after the back pressure valve and a non-return valve (NRV6) was positioned immediately before the return into the reservoir.

Figure 16: Back pressure valve (PSV 3)

The back pressure valve (PSV3), when tested, although intended to release at 6-8 bar, released at much greater pressures, ranging from 20 to 77 bar. When dismantled it was found that the piston was worn, allowing it to tilt and stick sporadically. The valve supplier considered the amount of wear was normal given its 23 years of service. The pressure safety valve (PSV1) was also dismantled and found to be worn, but to a much lesser extent.

- Replaced PSV1 and PSV3 on all CPP hydraulic modules.
- Implemented a maintenance programme in which at least PSV1, PSV3 and NRV6 are disabled and their function checked once every 5 years.
- Added a full flow check-valve, with an opening pressure of 10-12 bar, in the return oil circuit by-passing PSV3, the Oil Cooler and NRV6. Also, an additional alarm signal was to be fitted in the control system to give an alarm at 9-10 bar.

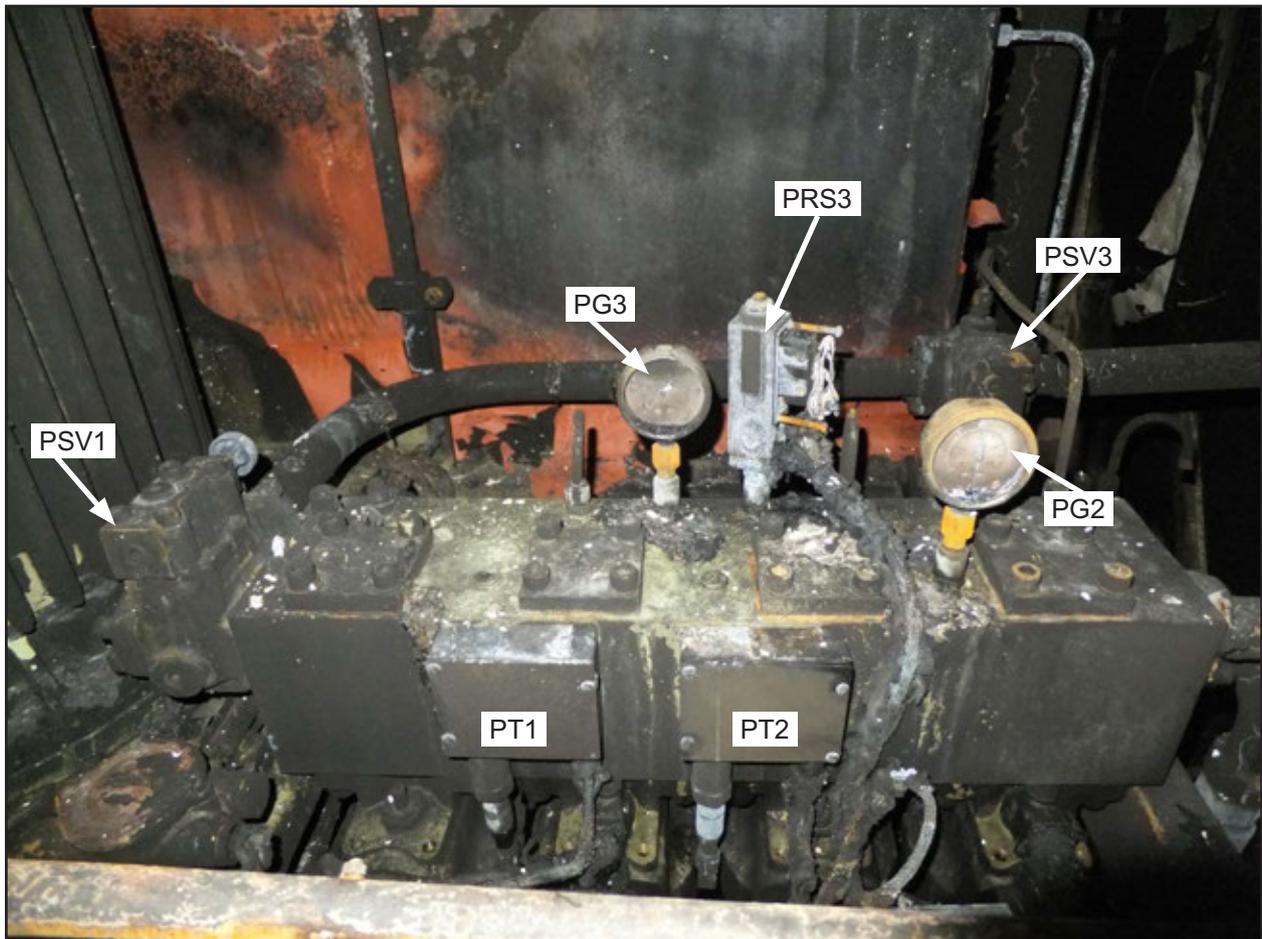
**Figure 17:** Fire damaged starboard controllable pitch propeller hydraulic module

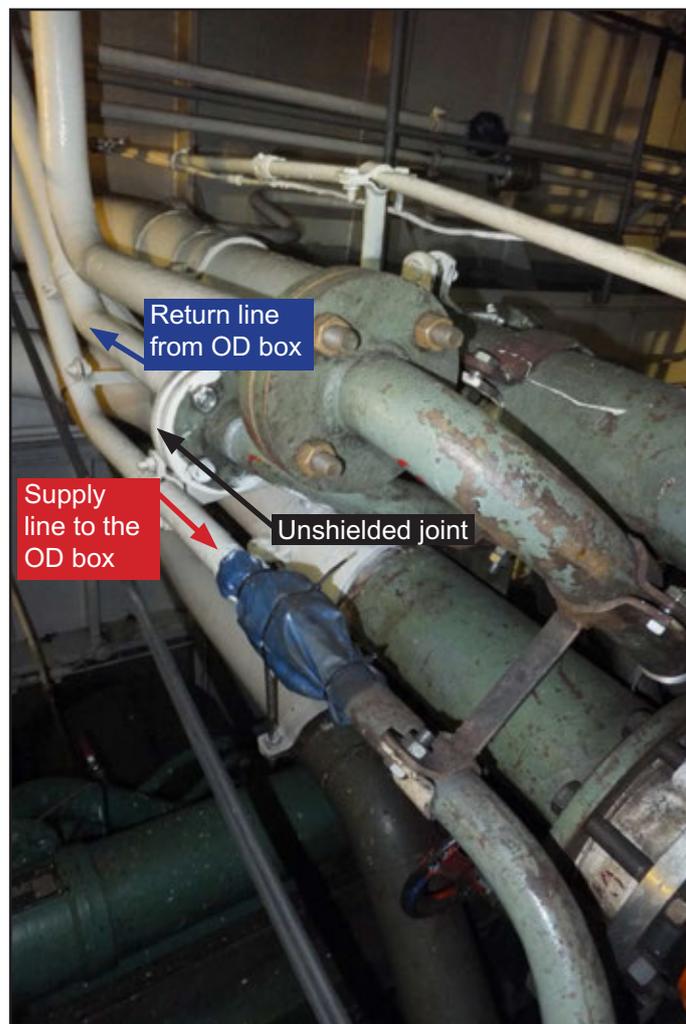
The pipework joints on the supply line to the OD box, which experienced 100 bar in normal operation, were made using hydraulic couplings and were shielded to prevent a spray of oil in the event of leakage (**Figure 18**). The return line from the OD box, which normally experienced up to 8 bar, employed flanged joints and, although some of these joints were shielded, not all of them were protected in this way. In particular, the return line joints positioned between the main engine turbochargers were not shielded (**Figure 19**).

**Figure 19:** Unshielded joint on port controllable pitch propeller system

However, the shielding of joints, which is a requirement for ships constructed on or after 1 July 2002, and recommended for other ships in respect of pressurised flammable oil systems, was a relatively easy modification that could have been carried out retrospectively. On board *Pride of Canterbury*, all hydraulic couplings on the supply line to the OD box were shielded, but only some of the flanged joints on the return line from the OD box were protected. Critically, in the zone between the two starboard main engines where the leak occurred, there was no evidence after the fire of shielding on the flanged joints. Given the port side arrangement had no shielding for the same joints (**Figure 19**), it is concluded unlikely that shielding was ever in place on the starboard side.

Although surveyed and inspected on a regular basis, the omission of shielding from some of the CPP pipework joints had not been acted upon. If an effective joint shield had been fitted, this simple last line of defence would have prevented a spray of oil being released onto the hot exhaust uptakes to cause the fire in this case.

- Checked that all CPP system flanges meet standards recommended by manufacturers.
- Checked all CPP system flanges are fitted with protective coverings.
- Examined hi-fog systems to ensure that the system provides full coverage of all high-risk machinery.
