DANISH MARITIME ACCIDENT INVESTIGATION BOARD

# MÆRSK BATTLER

Marine accident report on MAERSK BATTLER's loss of tow and the foundering of MÆRSK SEARCHER and MÆRSK SHIPPER on 21 and 22 December 2016

The report is issued on 30 August 2017

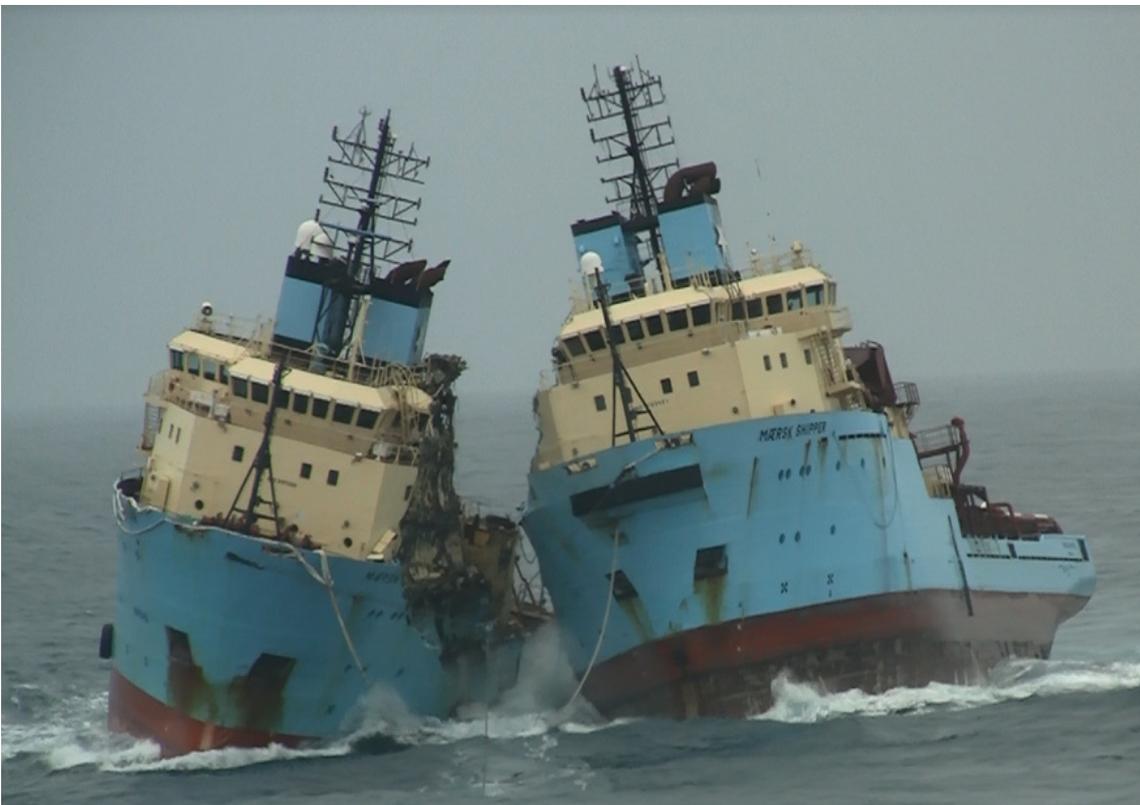
On 21 December, the weather deteriorated and the towage was affected by a westerly 4.5 m swell. At dawn, the crew could see that, during the night, both ships had suffered contact damage, primarily to the superstructures, and that the ships were no longer lying steady in the water next to each other. Both vessels rolled and showed a tendency to list towards each other, especially MÆRSK SEARCHER (figure 6).

*Figure 6: Towage at noon on 21 December 2016 leaving the English Channel at the Celtic Sea.  
Source: Private photo*

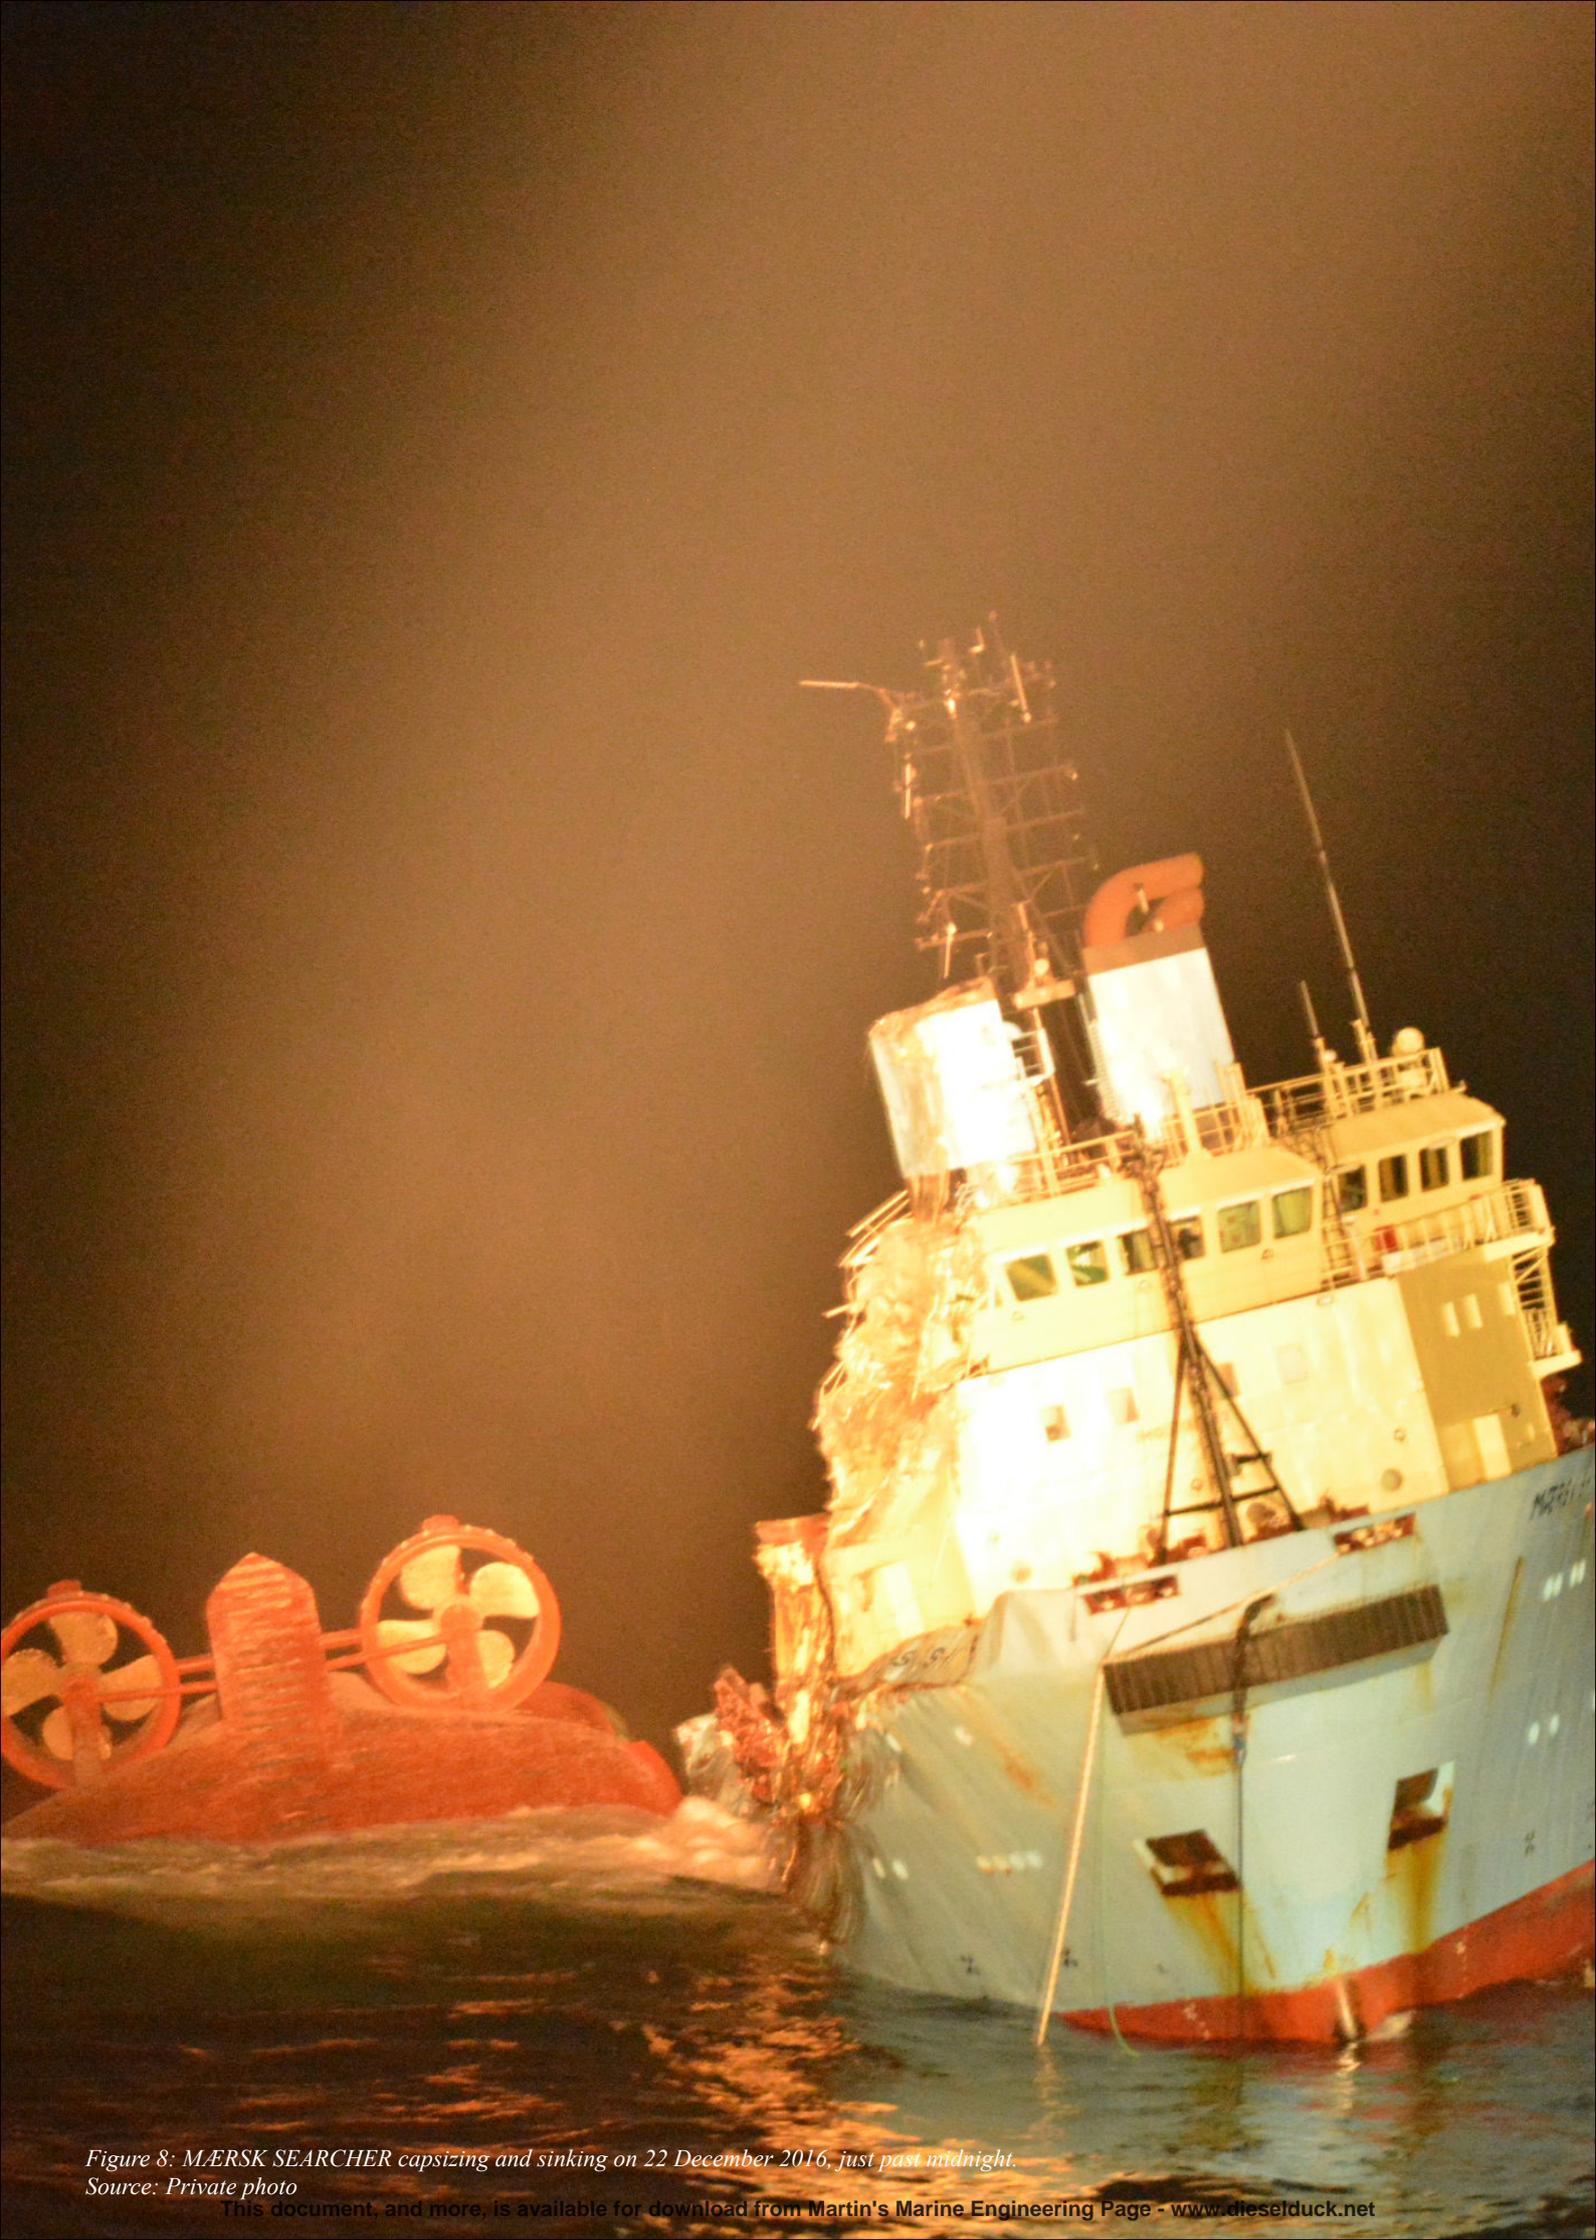
Figure 8: MÆRSK SEARCHER capsizing and sinking on 22 December 2016, just past midnight.

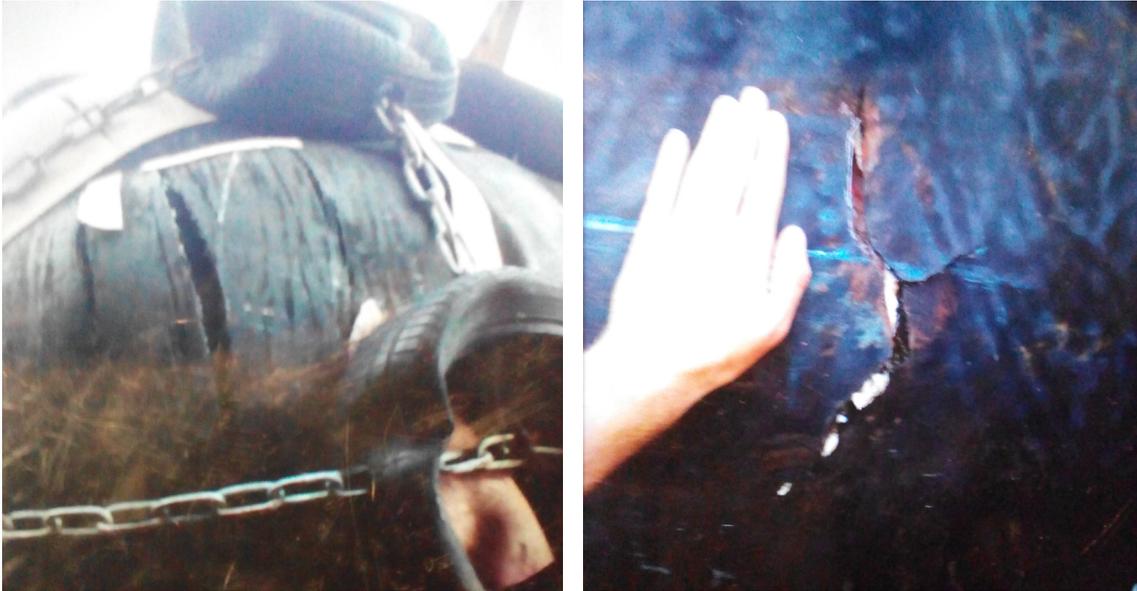
Through the broker, the company rented the three used fenders, which were delivered to the port of Fredericia. At delivery, they showed signs of wear and appeared to be somewhat damaged, which was documented through photos (figure 14, next page).

Figure 14: Photos showing details of wear and damage to the fenders upon delivery.  
Source: Private photo

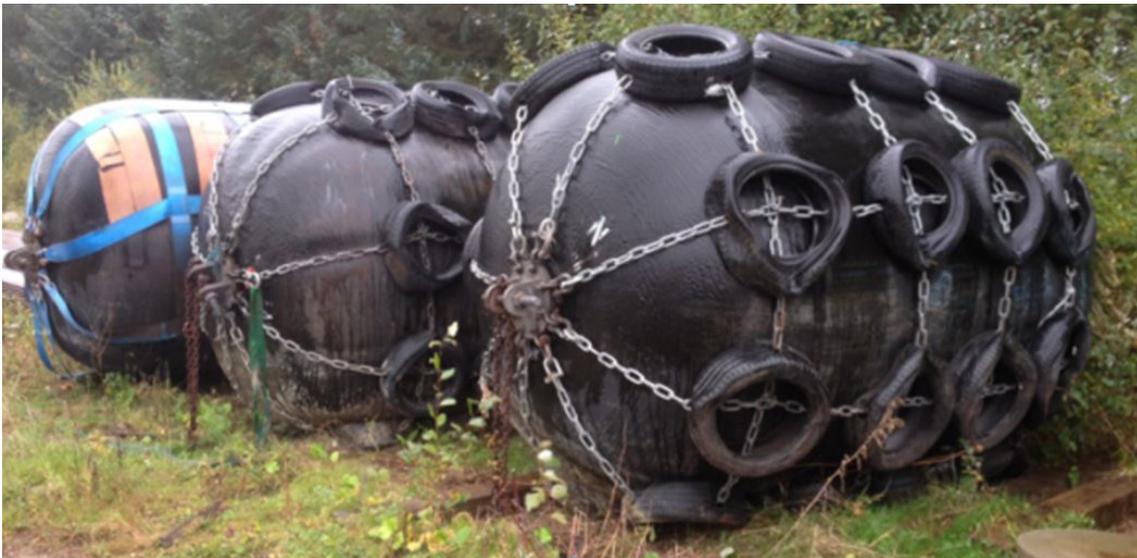
Figure 15: The fenders used for towing MÆRSK SHIPPER and SEARCHER, before delivery.  
Source: Private photo

From photos it has been established that all three fenders were of a foam elastomer type (figure 15), and not pneumatic fenders. Two had chain/tyre protection and one had sling type protection. They were used, approx. 10-12 years old, and appeared to have some external damage and general wear and tear. Their dimensions were Ø2.3 m and a length of 4.0 m.

DMAIB has, in consultation with a manufacturer of fenders, estimated that the wear and tear in itself could have resulted in at least a 30% reduction in capacity. Depending on the internal structure and its state, their strength may have been reduced by up to 100%, i.e. they may have had no remaining capacity to withstand pressure at all. If the foam-filled fen-

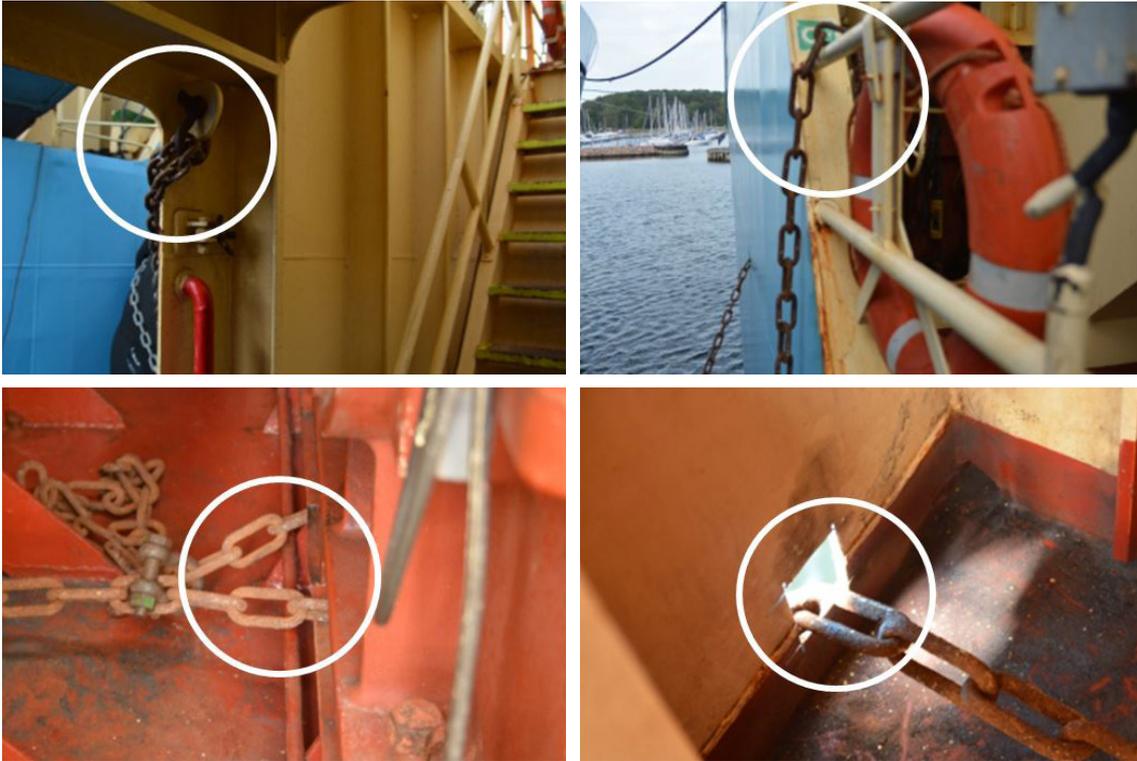
On the ship, the fender mounting chains were anchored to the existing structure as convenient (figure 18). As shown in the photos, some of the chains were mounted with sharp bends and/or passed over sharp steel edges, which might have contributed to their breakdown.

Figure 18: Connecting chains for fenders - MÆRSK SEARCHER  
Source: Private photo

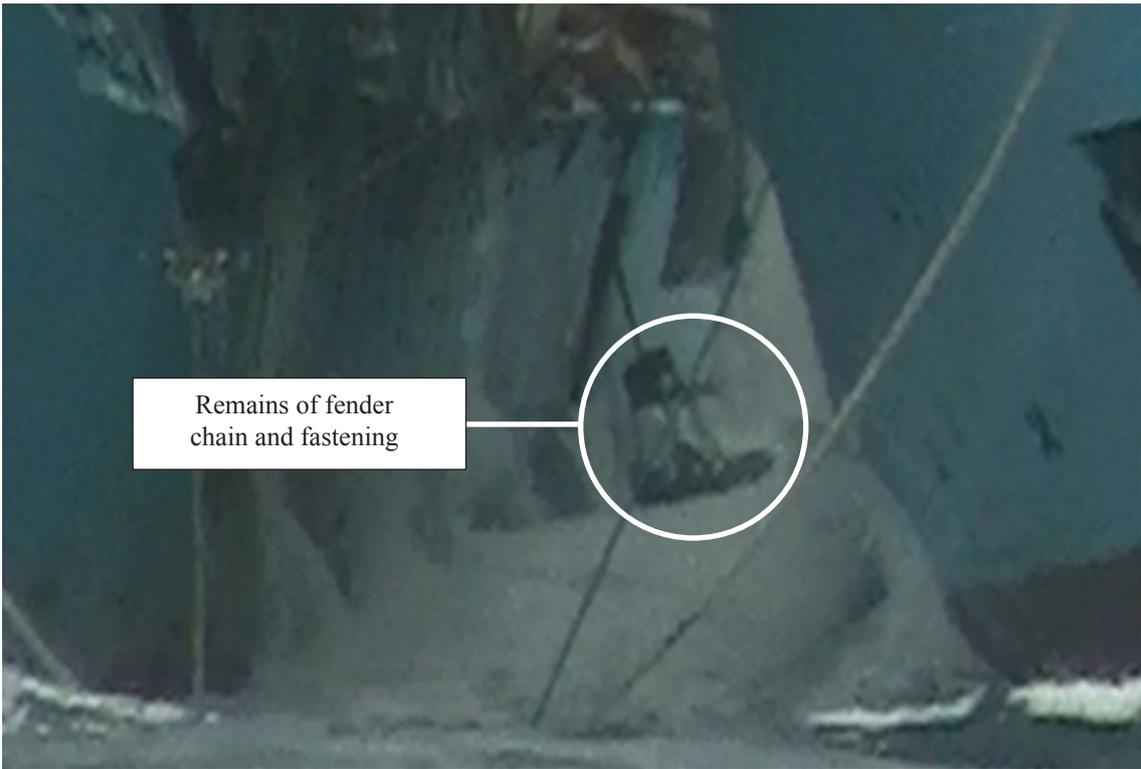
Video recordings from the accident show that the chain and fastening from one of the the fenders are intact, but the fender had disintegrated. In the picture on next page (figure19), the remains of the fender positioned in the centre can be seen. Furthermore, the recordings show that the aft fender was intact during the same period of time indicating that the forces acting on the fenders were not evenly distributed on all three fenders. When the weather conditions worsened, the force of contact was concentrated on the forward part of the ships because of the way the towing forces acted on the ships, thereby exposing the forward fenders to excessive horizontal and vertical forces.

*Figure 19: Remains of deteriorated fender between MÆRSK SEARCHER and MÆRSK SHIPPER.  
Source: Private photo*

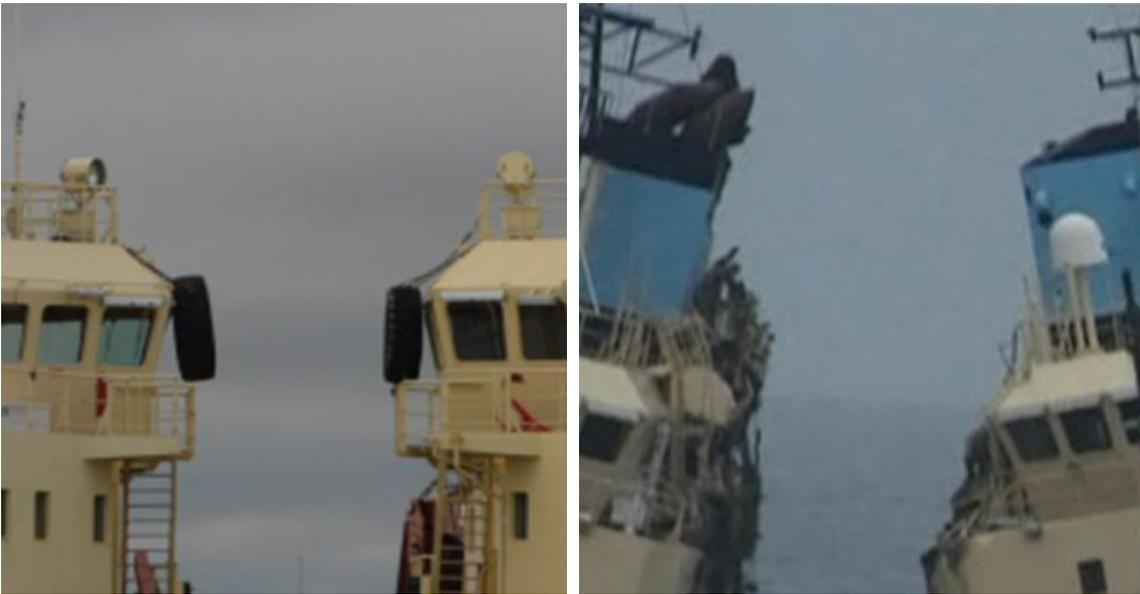
In addition to the fender setup discussed above, the planning process had identified a separate risk of the bridge wings colliding, causing structural damage to the superstructure. To counter this, it was decided to mount tyre fenders on the outer end of each bridge wing. When the towed ships started impacting, the bridge wings were crushed, and thus the tyre fenders did not have the desired effect (figure 20).

*Figure 20: Left: Tyre fenders on bridge wings Right: Bridge wings after impact.  
Source: Maersk Supply Service*

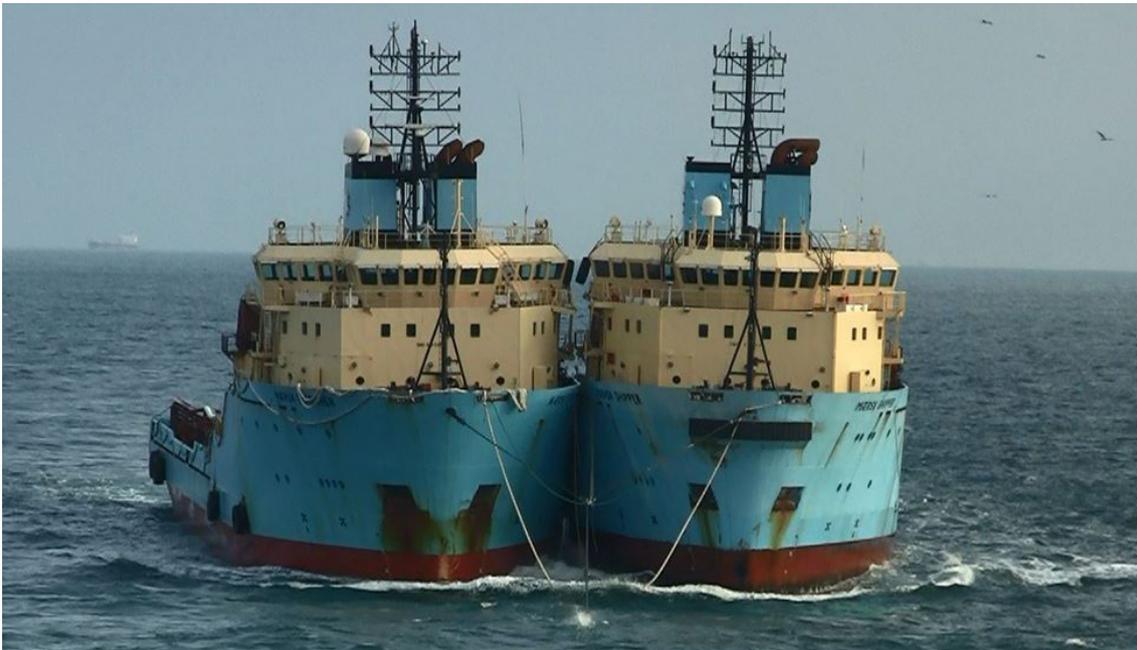
Until the ships left the English Channel and met harsher weather in the Bay of Biscay, the towed ships were apparently intact, although they may already have sustained structural damage when the fenders were lost (figure 24, next page). Photo and video recordings from 20-21 December 2016 show that both ships sustained significant structural damage to the hull, superstructure and deck appendages (figure 25, next page).

*Figure 24: MÆRSK SHIPPER and SEARCHER without fenders, but apparently intact.  
Source: Maersk Supply Service*

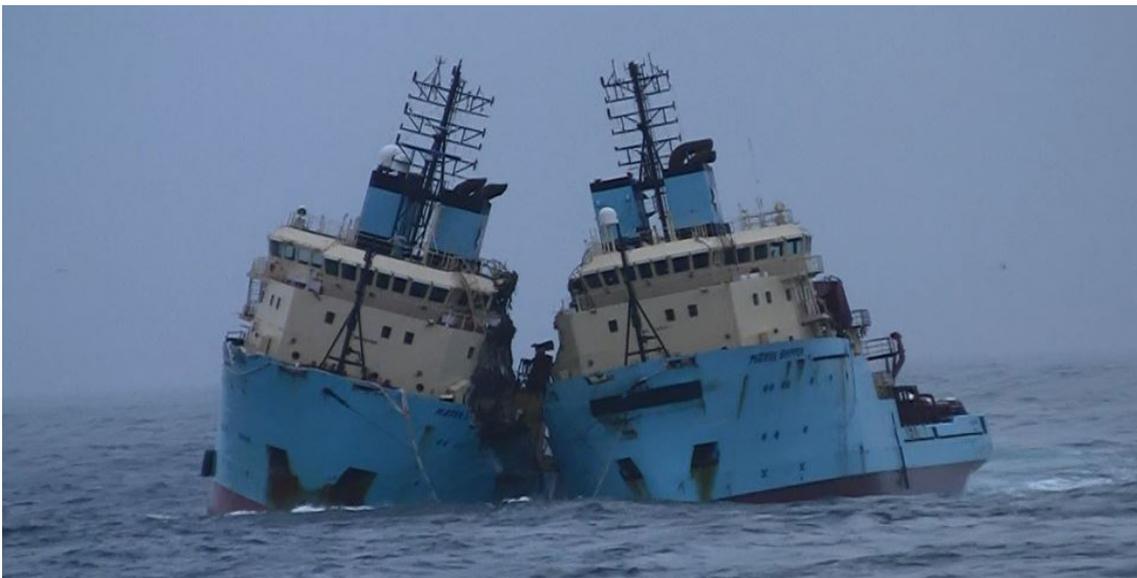
and the ships started impacting. Initially, only the bridge wings seemed to be affected, but later the impact comprised the full structures of the ships hitting each other with ever increasing force. Once the fenders were no longer effective, and the ships were still tied closely together, they continuously collided, causing progressing structural damage.

*Figure 25: MÆRSK SHIPPER and SEARCHER with structural damage.  
Source: Maersk Supply Service*

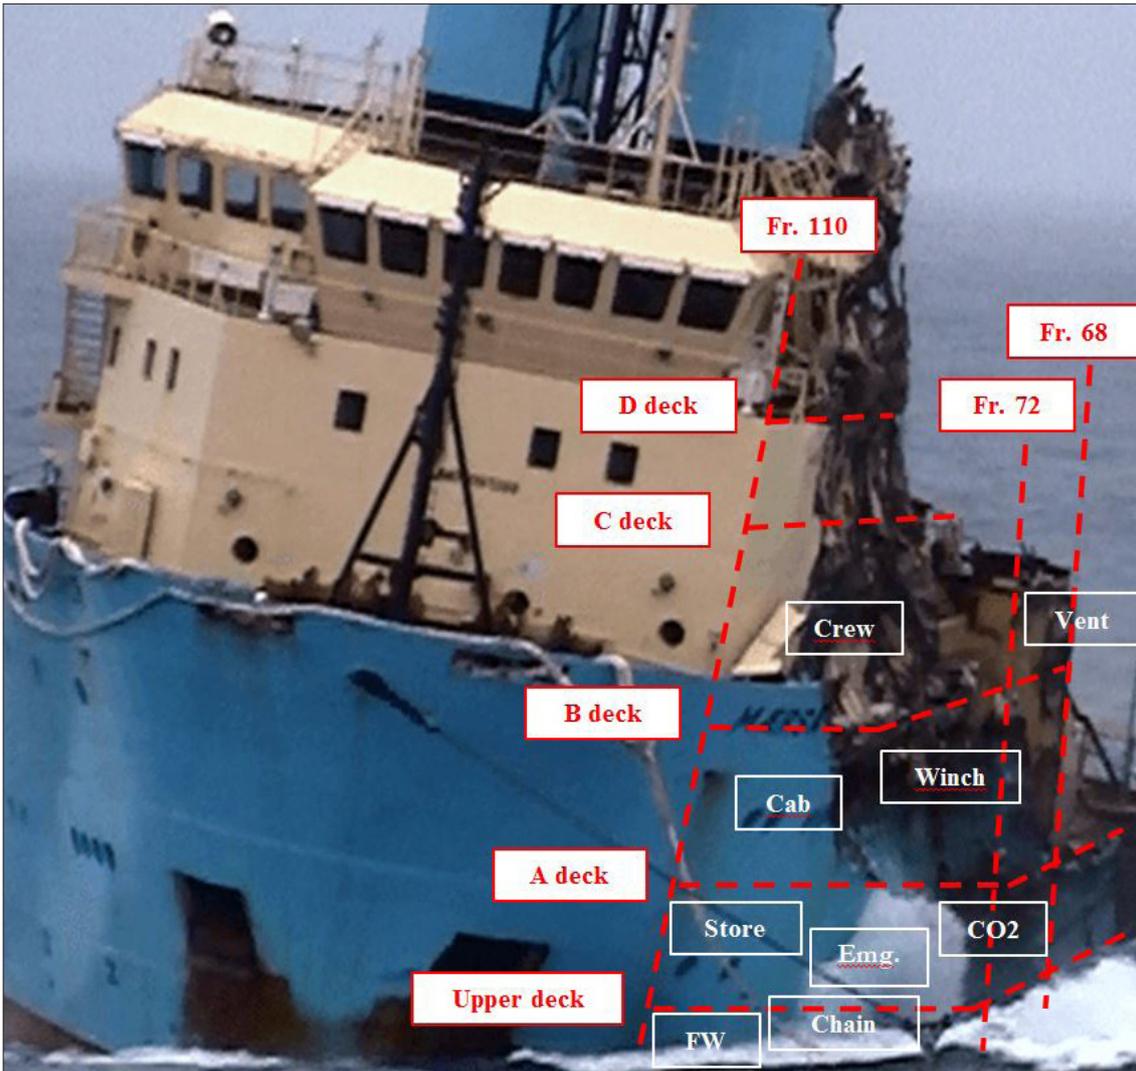
As the illustrations of MÆRSK SEARCHER show (figure 26, next page), the shell plating, superstructure, deck appendages and underlying structure had sustained significant damage in an area extending longitudinally from the front of the superstructure to aft of the engine room ventilation duct, just aft of the superstructure and winch garage.

Figure 26: Extent of the visible damage on MÆRSK SEARCHER.  
Source: Maersk Supply Service/DMAIB

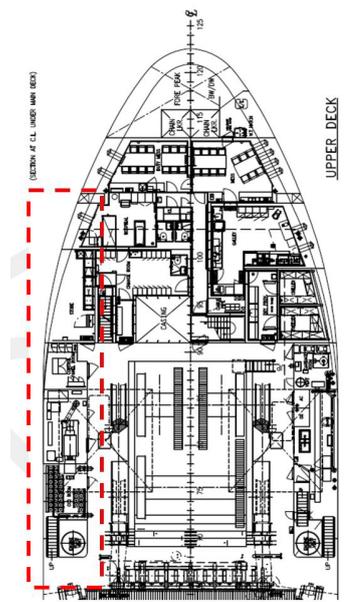
In the transverse direction, the visible damage extended from the outermost ship side to well into the accommodation area of the superstructure. The damage in some areas extended an estimated 2-3 m into the structure (figure 27, next page).

Figure 27: Extent of visible damage – top view  
Source: Maersk Supply Service/DMAIB

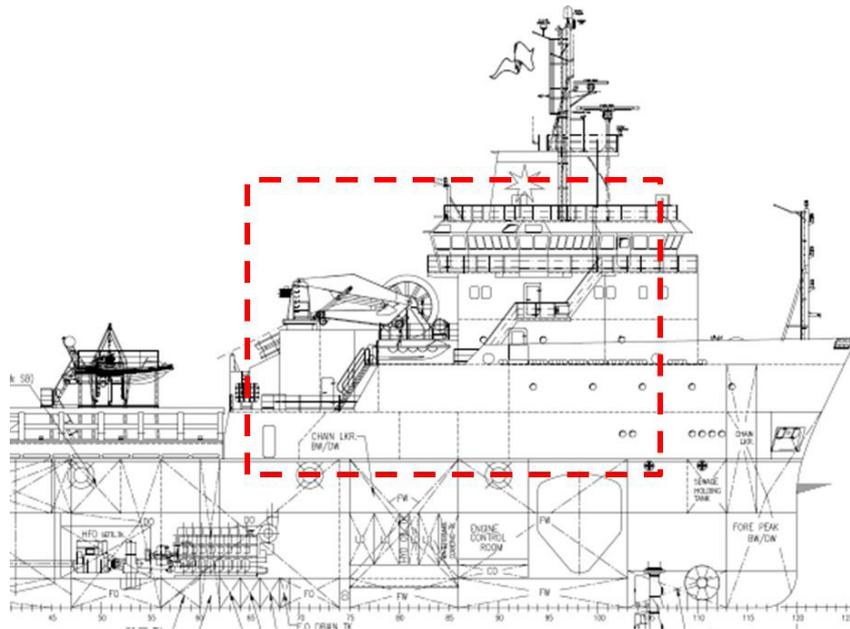
Vertically, the photos show structural damage extending from the top of the port side funnel, extending down to around the upper deck (figures 28, next page). Longitudinally, the visible structural damage extended from the forward part of the superstructure to aft of the deck crane and engine vent.

Figure 27: Extent of visible damage – starboard side view.  
Source: Maersk Supply Service/DMAIB

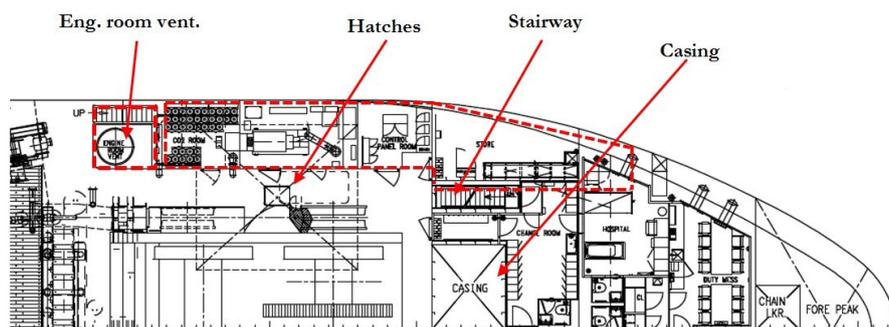
The significant damage to the ship's structure allowed a large ingress of sea water into the internal compartments of the ship. Because the ships had one large watertight compartment below the freeboard deck, any water ingress into the major part of the hull would enter into the same watertight compartment. Figure 29 on next page shows potential flooding points and areas.

Figure 29: Potential water ingress flooding points and areas.  
Source: Private photos/DMAIB
