Sinking of the US Cargo Vessel *El Faro*

Illustrated Digest

This digest of the National Transportation Safety Board's (NTSB's) Marine Accident Report **NTSB/MAR-17/01** contains a description of the accident and safety issues, and summarizes some of the safety recommendations intended to prevent such an accident from happening again. The full report and docket can be found at www.nts.gov.

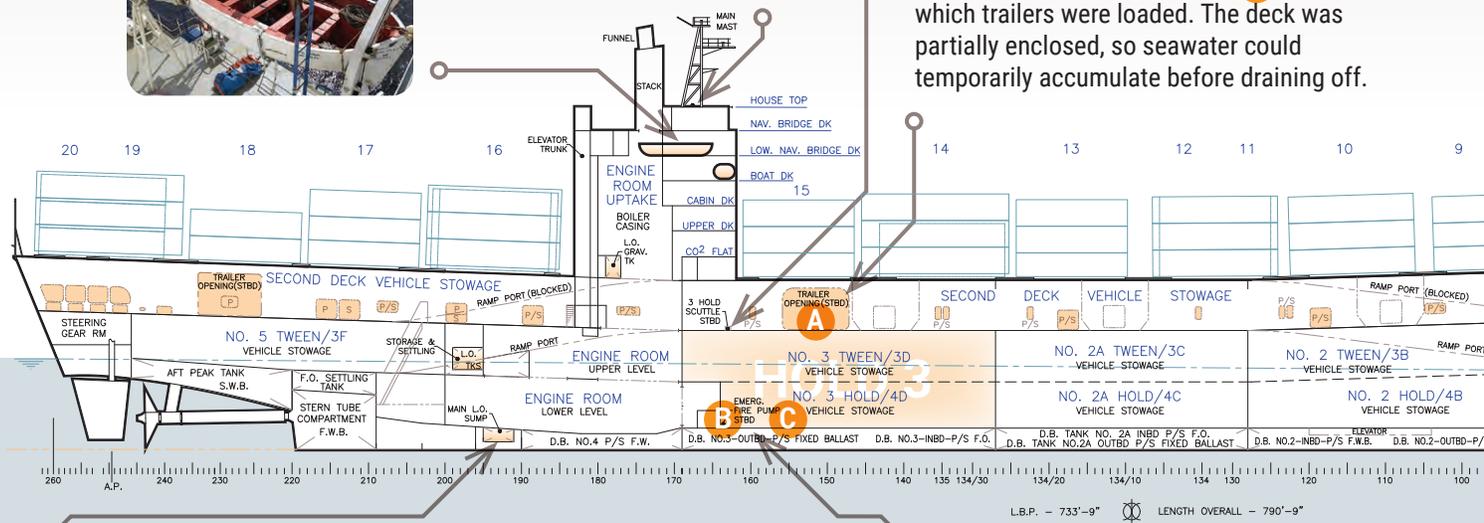
El Faro in departure condition

Open lifeboats and 25-person liferafts were stowed on the boat deck. Open lifeboats such as *El Faro*'s have not been allowed on new vessels since the 1990s, but *El Faro* was built much earlier (see Recommendations, p. 13).

Scuttles are small hatches that allow crewmembers to transit between decks. However, the scuttles on the weather deck (second deck) had to be securely fastened to ensure the ship’s watertight integrity. *El Faro* did not have remote open/close indicators for its scuttles (see Recommendations, p. 13).

Seawater could flow onto *El Faro*'s second deck through openings, including large openings in the starboard side **A** through which trailers were loaded. The deck was partially enclosed, so seawater could temporarily accumulate before draining off.

According to logbook entries, the level of lube oil in the sump had been kept at 25 or 26 inches for most of the 2 years before the accident. In rough seas, this could lead to loss of propulsion (see Loss of lube oil suction, p. 7).

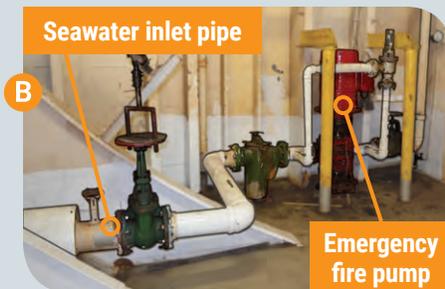
Cargo hold 3 housed the emergency fire pump, which was connected to a seawater inlet pipe **B** (photo at left is of *El Yunque*'s emergency fire pump and unprotected inlet piping). Similar components, although arranged differently, made up the corresponding system on board *El Faro*. Hold 3 was also used for vehicle storage. **C**

Once the deck became wet in hold 3, automobiles were more likely to break free of their lashings. An automobile likely struck the intake piping leading to the emergency fire pump. Seawater piping to the emergency fire pump in cargo hold 3 was inadequately protected from such impact.

One or more of the vehicles in hold 3 had likely struck the emergency fire pump, or “fire main” piping, at the starboard side of hold 3. The inlet piping to the fire main system was designed to supply seawater to the suction side of the emergency fire pump. With a severe breach, seawater would have flowed into hold 3 at a rate that would inevitably overwhelm the capabilities of *El Faro*’s bilge pumps. It is likely that the piping was breached earlier than 0714, based on the continued flooding of hold 3 after the scuttle was secured and the hold was being dewatered by bilge pumps. (Vehicles had likely been adrift at

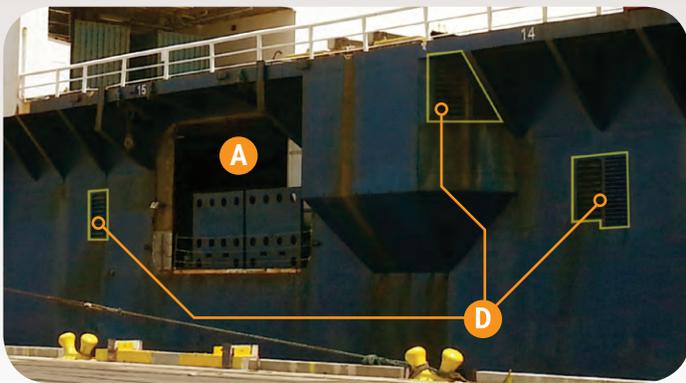
Louvered openings in the hull **D** allowed air to flow in and out of the cargo holds via ventilation ducts. These were required to be opened under way, but could have been shut in heavy weather. Pictured at left is the starboard side of *El Faro*, just above hold 3. Louvered vents are outlined in yellow and a large trailer opening **A** is also visible.

As the ship’s permanent angle to the sea (sustained list) increased past 15 degrees, the high seas would have allowed water to enter the hull through ventilation openings.

The increasingly large induced list to port from wind and increasing flood water levels in hold 3, combined with the vessel’s rolling in the storm seas, likely caused seawater to enter cargo hold ventilation openings in the hull. It was possible to close these openings, but they were left open during the event; they were not considered downflooding points in any available guidance documents. Seawater poured into hold 3 and then into hold 2A and 2. At **0714**, the chief mate told the captain that the chief engineer had said that, “something hit the fire main, got it ruptured, hard” (see How the water got in, p. 6).

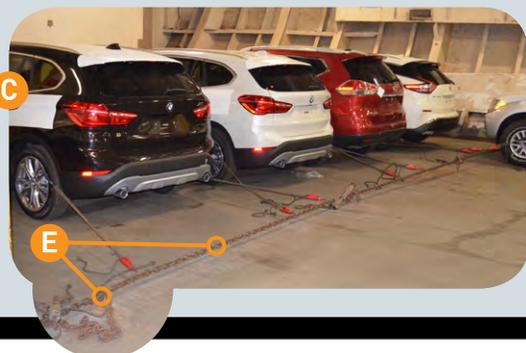
Instead of each automobile being secured to the deck at each corner, they were secured to a long chain across the width of the ship **E** (photo at left is from a similar lashing arrangement on board *El Yunque*). As the ship encountered heavy weather, vessel motion increased and lashings would have failed more easily as the deck became wet and the ship rolled (see How the water got in, p. 6).

At **0544**, the captain was heard on the VDR saying “We got cars loose,” likely referring to automobiles that had broken free from their lashings. The automobile-lashing arrangement did not meet the requirements of the vessel’s approved cargo-securing manual, making automobiles more likely to shift in heavy weather.

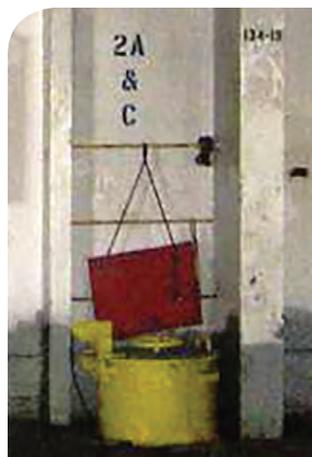
The crew found that a scuttle (small watertight hatch) on the second deck, starboard side, was open and seawater on deck was flowing over it and down into cargo hold 3. The ship’s list to starboard was causing seawater to pool near the scuttle located on the starboard side. The captain told an engineer to begin transferring ballast water from the starboard ramp tank to the port ramp tank.

Second deck scuttle to hold 2A, similar to hold 3 scuttle
Photo: Herbert Engineering

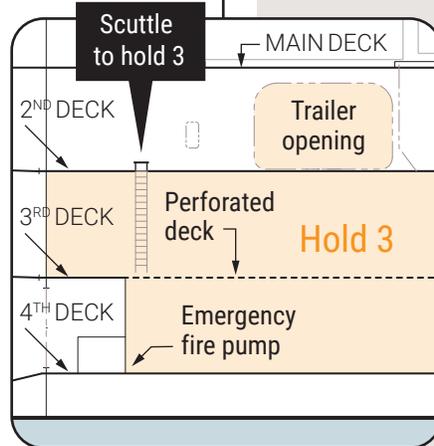
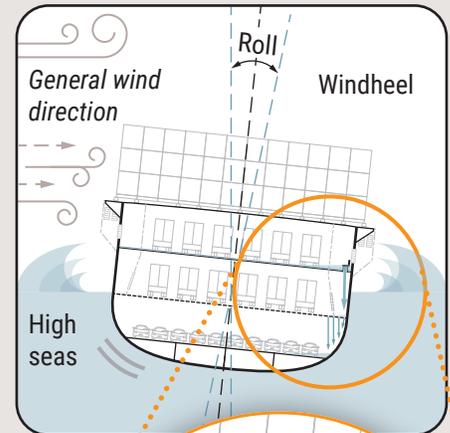
How the water got in

El Faro's partially enclosed second deck had a number of scuttles that had to be closed and fastened (“dogged”). Flooding began through an open scuttle.

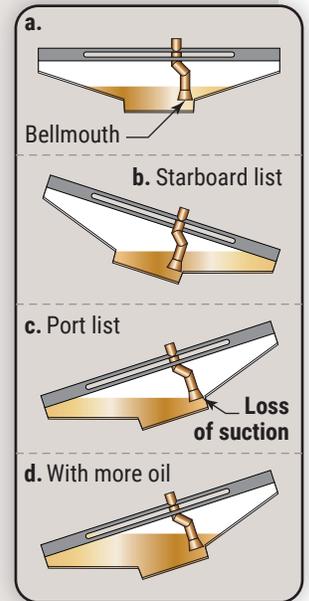
Loss of lube oil suction

Because the bellmouth (intake) for the main propulsion engine lube oil pump was located toward the starboard side, it mattered whether the ship was listing to port or starboard. (The trim of the ship also affected the oil suction; forward trim was worse). It also mattered how much lube oil was in the sump.

Log books indicated no more than 26 inches of oil in the sump in the months before the accident (a). With this oil level, the bellmouth would not take in air (lose suction) with an 18-degree list to starboard (b), but would lose suction with an equivalent list to port (c). With 32 inches of oil in the sump, the bellmouth would continue to take in oil with the same 18-degree list to port (d) allowing normal functioning.

The loss of lube oil pressure would have triggered a protective device, the low lube oil pressure switch, which would have shut off the flow of steam to the main engine. (However, steam continued to flow to turbogenerators for lights and other systems.) To reset the switch, lube oil pressure would have to be restored. Without propulsion, El Faro could not maneuver and was at the mercy of the storm.

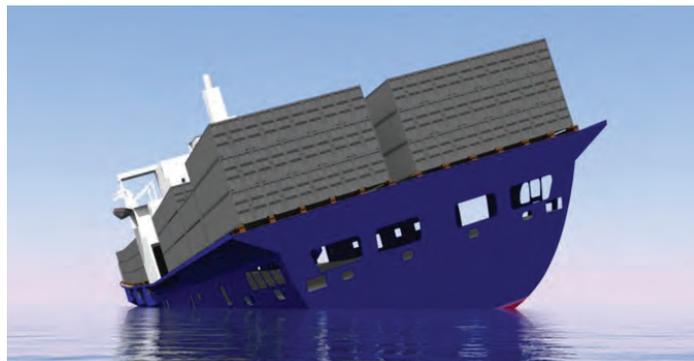
***El Faro* computer rendering in static surface water showing list to port of 18° with departure trim 5.8 feet by the stern due to flooding of hold 3 estimated at 20% and windheel.**
