MARINE INVESTIGATION REPORT

M02W0061

MALFUNCTION OF AUTOMATIC STEERING CONTROL FOR RIGHT ANGLE DRIVES

BOWEN QUEEN

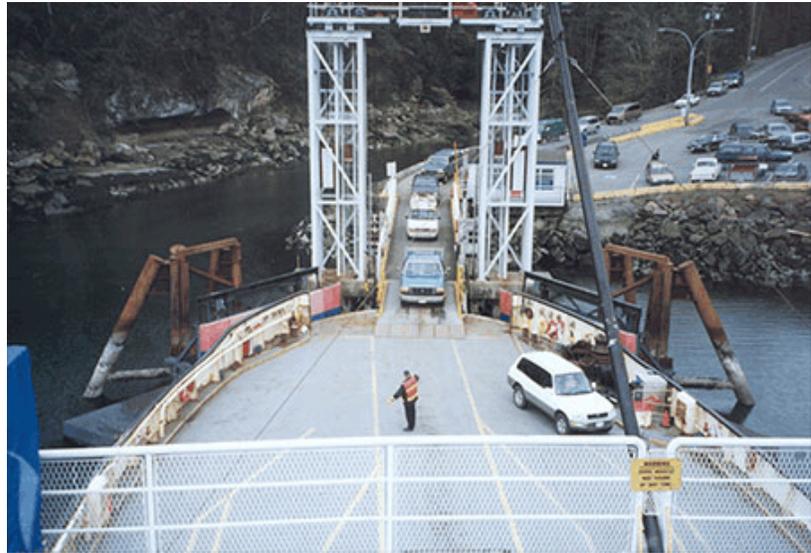
Figure 3. View of vehicle deck and a loading operation as the ferry is pushing against the wing walls of the dock.

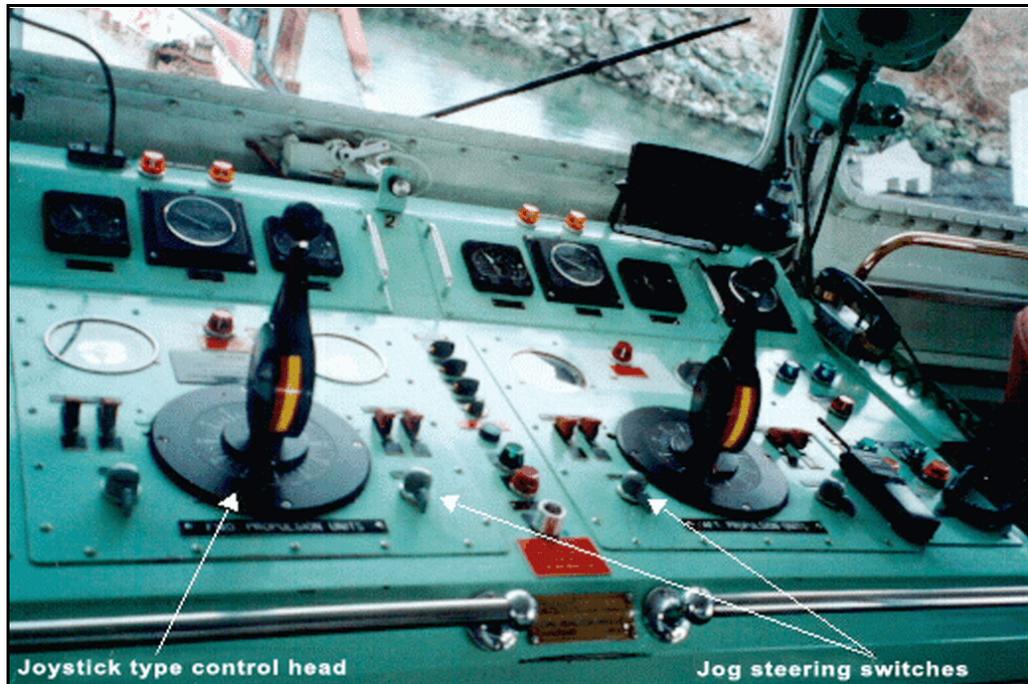
Figure 4. View of control console showing control heads, jog steering and rudder angle indicators.

The alarm system warns of failures or malfunctions in the power supply and hydraulic circuits. However there is no audio-visual alarm to give warning of a spontaneous deviation between the command signal from the joystick (set point) and the actual position of the leg (measured value). A 'look out' on the bridge would become aware of such a rotation only by its effect on the ship's heading or by looking at the RAD angle indicator.
