## MARINE INVESTIGATION REPORT

M01L0129

### STEERING GEAR FAILURE AND SUBSEQUENT GROUNDING

THE BULK CARRIER *CEDAR*  
NEAR DESCHAILLONS-SUR-SAINT-LAURENT  
16 NOVEMBER 2001

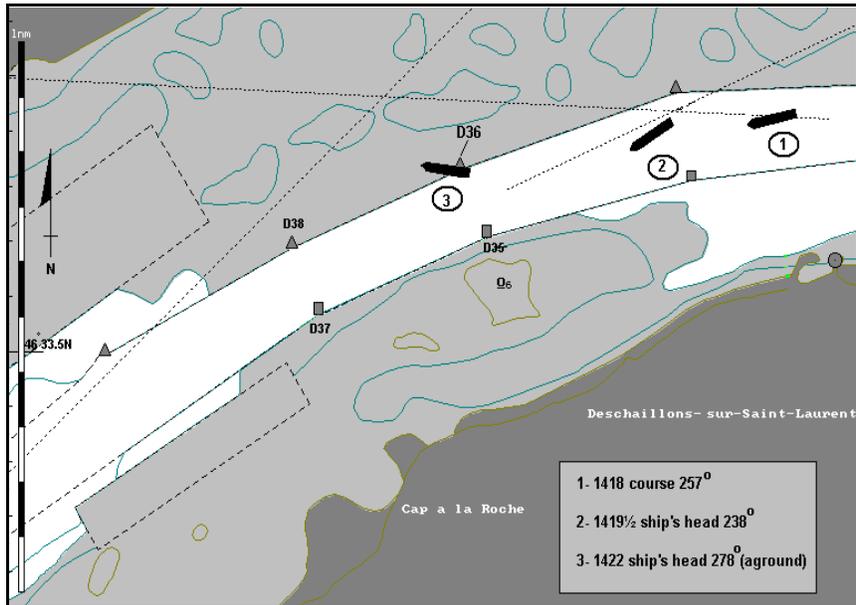
Figure 2. Ship's movement (positions approximate)

The pilot ordered hard to port, but there was still no response from the rudder. In very quick succession, both NFU joysticks were tried but neither gave any effect. The vessel was swinging to starboard and the current, setting at about 070°(T), had caught the port bow. At about this time, the master entered the bridge and was informed of the loss of steering. Full astern was ordered on the main engine and the crash stop sequence was initiated. Before astern power could be developed, the vessel exited the north side of the channel on a heading of approximately 285°. The *Cedar* was still making close to 9 knots and, as the bow came into contact with the channel bottom, the vessel's head shifted to port about 7° before coming quickly to a stop at 1422. The vessel was now aground at position 46°33'48" N; 072°07'33" W on a heading of 278°(position 3, Figure 2), the helm hard to port, but the rudder still to starboard about 4°.

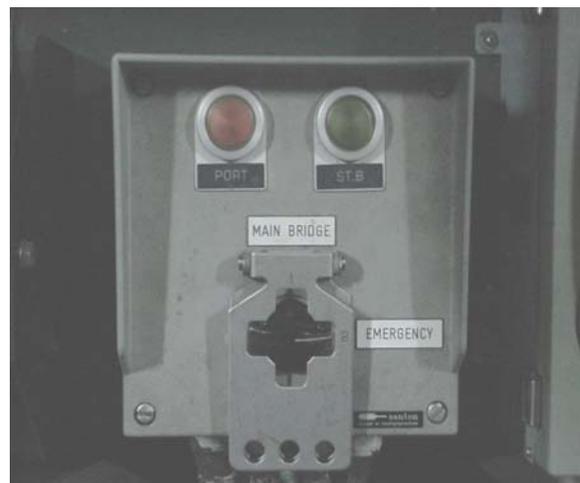
Figure 3. Emergency Remote Control Transfer Switch

During the course of the investigation, a loose wire was found within the emergency remote control transfer switch in the steering gear flat (Figure 3). This wire was the low voltage control signal to the starboard servo power unit DCV solenoid for port rudder activation. Other wires within this switch were also found loose. The wires exhibited signs of being crimped with a tool other than a proper crimping tool.

was carefully examined and many wires were found to be loose. One particularly loose wire carried control signals for port rudder movement to the starboard servo power unit DCV solenoid. Between 1420 and 1422, port helm was applied in an attempt to stop the vessel's swing to starboard. An analysis of the recorded rudder movement shows that the rudder replied to the port helm commands in brief bursts (Figure 9). This would indicate intermittent performance of the rudder which is consistent with an on/off activation of the DCV solenoid for port helm, most probably caused by a loose wire alternately making contact and then losing contact.

1. Servo power unit hydraulic piping was changed for steel pipes, properly bent and sized. The piping was also fitted so as to forego any welding or braising.
2. Main power switches for both port and starboard servo power units were changed for more robust switches.
3. Single telemotor use was instigated by installing a selector switch on the bridge and decoupling activation of each servo power unit from its respective main steering gear pump.
4. Port and starboard servo cylinder bypass valves were re-installed in an appropriate fashion.
5. Hydraulic servo power unit plans were drawn up and filed on board.
6. All loose connections within the steering flat emergency remote control transfer switch were properly crimped and secured.

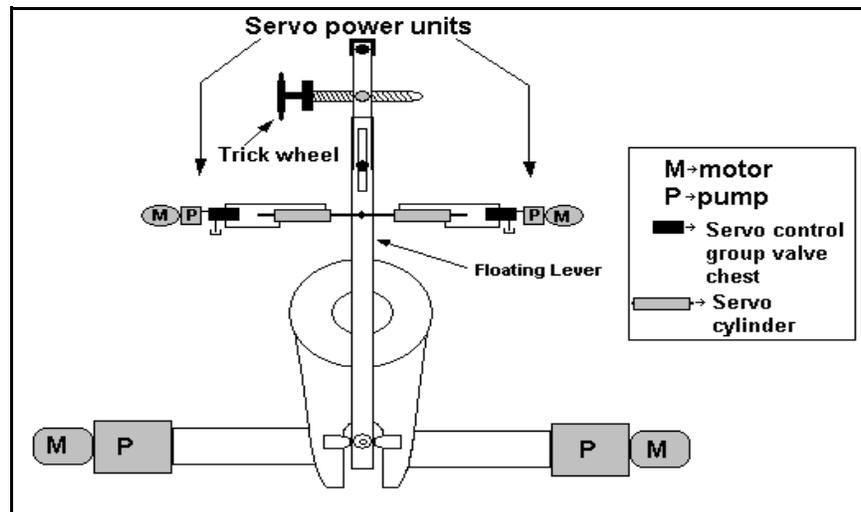
Figure 4

arrangement that is actuated by one (or both) hydraulic telemotor receivers. Each telemotor receiver consists of a servo power unit and cylinder. The servo cylinders are mounted axially opposed to each other and connected to the floating lever at a common point (Figure 4).

After the grounding it was found that, although both port and starboard bypass valves were in place on the control group valve chest of each servo power unit, they had been incorrectly installed (spring for spool valve on same side as servo pump pressure).<sup>5</sup>

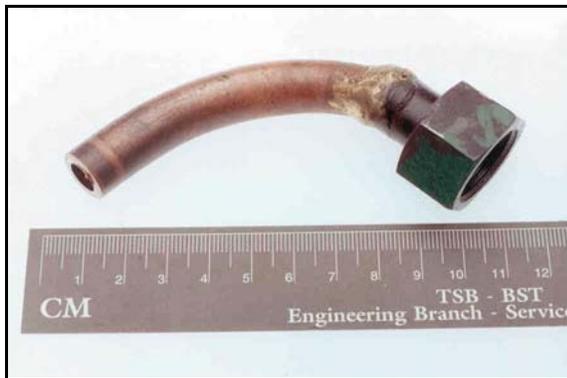
Figure 5

When installed at the shipyard, the connecting piping of the servo power units was copper. The piping connections were installed using direct braising methods and simple butt joints (Figure 5). Joints contained much excess braising material on the exterior, and the one examined in detail during the course of the investigation showed an overflow of braising material into the internal bore (Figure 6). It is estimated that the obstruction would restrict flow to about 70% of the design rate.<sup>8</sup> Bends in the piping were unsymmetrical and flattened at points to the extent that, during repairs subsequent to the grounding, TCMS required all servo power unit piping be replaced with steel piping, properly bent, fitted, and sized.

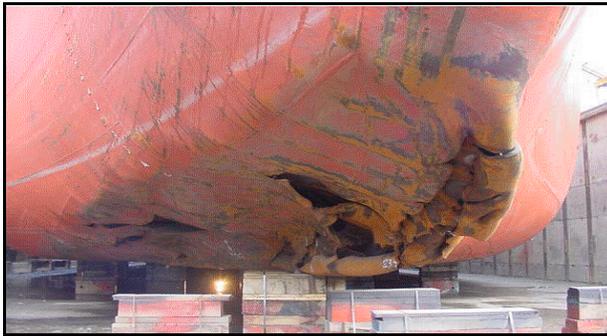
The forepeak and No. 1 starboard double bottom ballast tanks were punctured between frames 216 and 235 (approximately 12 m in length) running from the keel plate to the starboard bilge. The shell plating in way of damage was set in approximately 600 mm. The duct keel plate in way of frames 175 to 185 was also set in. Other bottom plates were set in as far astern as frame 151 and affected tanks 1 P, 2 P&S, 4 P&S, 5 P&S, and 7 S.

**Figure 7.** Forepeak damage

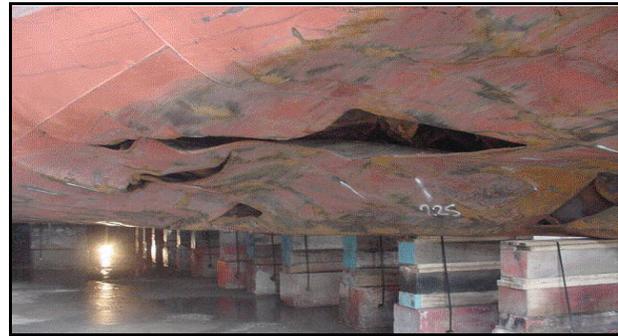
**Figure 8.** No. 1 starboard double bottom ballast damage
