MARINE INVESTIGATION REPORT

M02N0007

FIRE AND SINKING

OF THE SHRIMP FACTORY FREEZER TRAWLER *KATSHESHUK*
BELLE ISLE, NEWFOUNDLAND AND LABRADOR 76 NM ENE

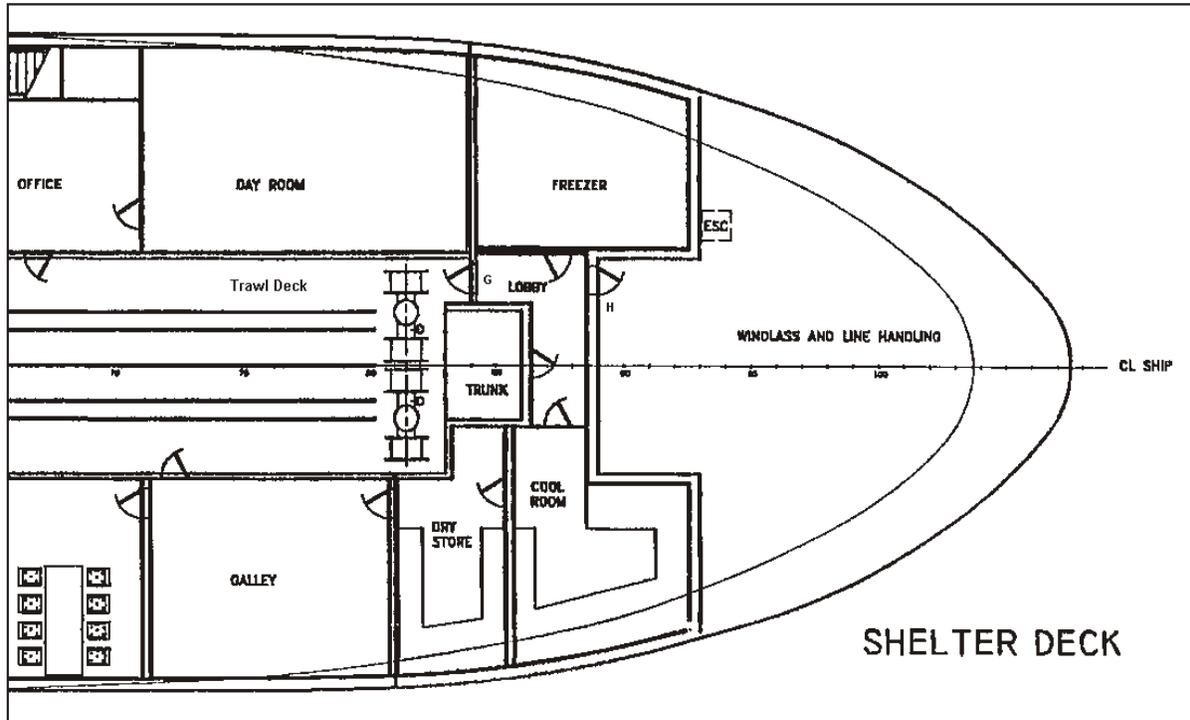
Figure 2. Shelter deck

The door H (see Figure 2) leading from the shelter deck lobby to the forward mooring area was normally left open.

The fire is believed to have started in a relatively small compartment,¹⁰ but quickly breached the compartment and ultimately consumed the entire vessel. The largest obstacle faced by the crew in attempting to fight the fire was the fact that many doors and hatches were open before the fire started, and even more were left open after the internal firefighting attempt was abandoned. In so doing, the fire progressed aft to the 'tween deck accommodation through the open collision bulkhead watertight door. The exact number is not known, but it was determined that several doors in the forward area of the 'tween deck accommodation were left open after the initial fire-fighting attempt failed. The open escape hatch from the forward storage locker allowed smoke to ventilate out to the forward mooring area, while an open door from the forward mooring area to the shelter deck lobby allowed smoke to flow into the lobby.

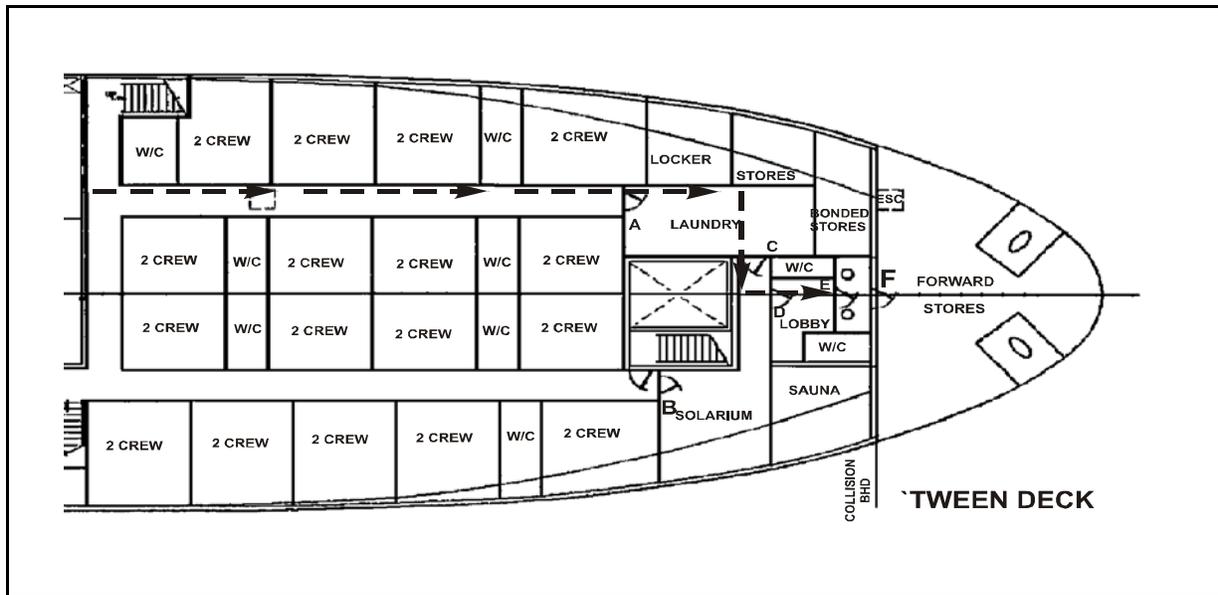
Figure 3a. Route of port fire party

A fire party was assembled in the after cross-alleyway area of the 'tween deck accommodation. The fire party consisted of a fire lead wearing only coveralls and a self-contained breathing apparatus (SCBA) and others without SCBAs as a hose party. After a short delay to charge the fire main, the fire party proceeded up the port side alleyway and through the open door A (see Figure 3a) to the laundry room. Leaving the rest of the hose party in the laundry room, the fire lead proceeded into the solarium through door C, latching it open on the way. The fire lead then opened door D and entered a small foyer where he was met by a wall of smoke. On opening either door E or F⁴, he was met with heat and flame and immediately opened up his hose in a straight stream pattern. He was only able to direct water on the fire for a few seconds before the rest of his fire party (with no SCBA) called for him to pull back. The fire lead, by now running low on air, dropped the hose in the laundry room and retreated to the cross-alleyway area leaving some doors in the open position.

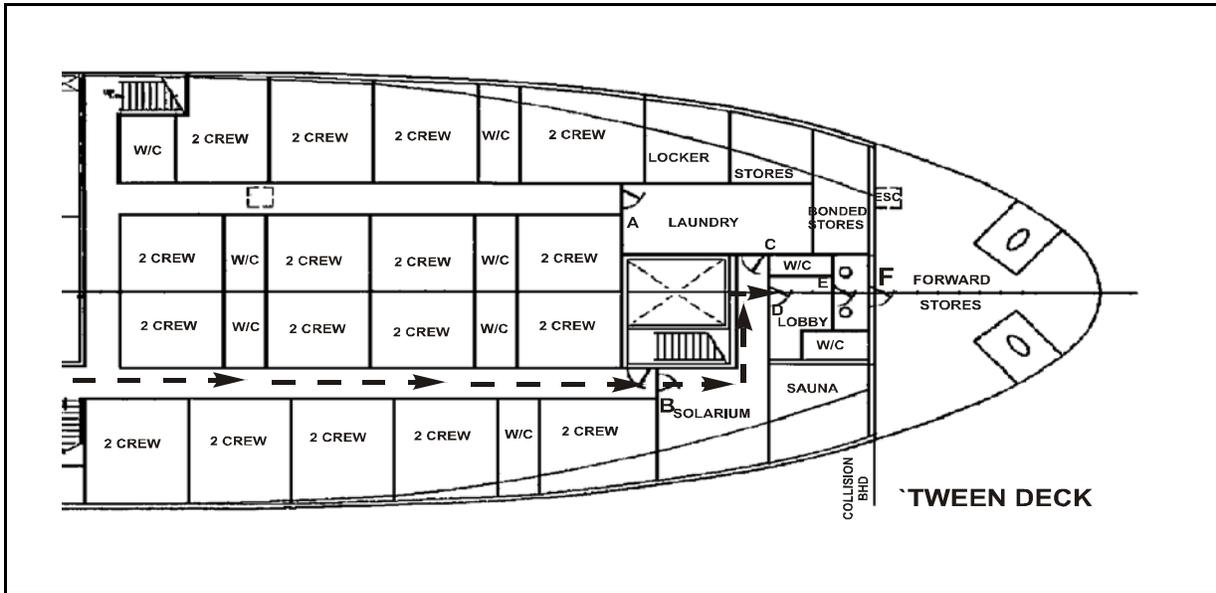
Figure 3b. Route of starboard fire party

While up forward and unknown to the first fire party, a second fire party was being assembled in the starboard alleyway (see Figure 3b). This team consisted of a fire lead wearing jeans, a short sleeve shirt and a SCBA accompanied by a hose party. As the first fire party was pulling back, the second fire party opened door B leading to the solarium and the fire lead felt some heat. He introduced water into the solarium for about a minute before deciding to pull back to get a safety line. On the second trip forward, the fire lead made it to door D and when he opened it, a white flame shot out over his head and hit the deckhead. He opened up his hose at the fire, but was quickly forced back by debris falling from the deckhead. The second fire party then retreated to the after cross-alleyway also leaving some doors in the open position.

Due to reduced visibility, the fire lead could not definitively determine which door he opened, however since weathertight door F was normally left open, it was most likely door E.

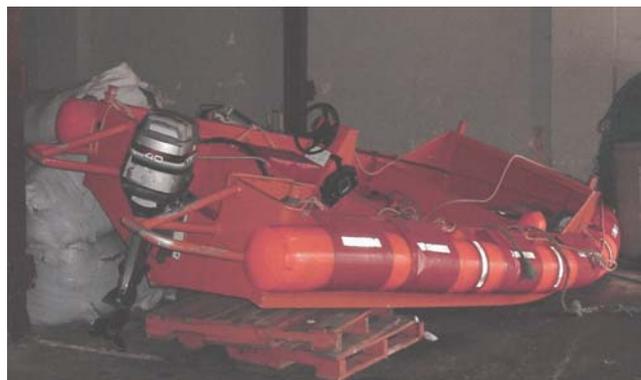
Photo 2. The rescue boat

At approximately the same time and roughly 45 minutes after the fire was discovered, the master decided to evacuate all non-essential personnel to the other fishing vessels in the area. An attempt was made to raise the vessel's rescue boat (see Photo 2) using the port boat davit, but the crew could not get it to operate. As a result, they used the cargo crane on the starboard side. The crew evacuated using the vessel's own rescue boat by boarding the rescue boat on the forecastle deck and then being lowered to the water.

The operational issues with the port boat davit during the evacuation could not be determined.

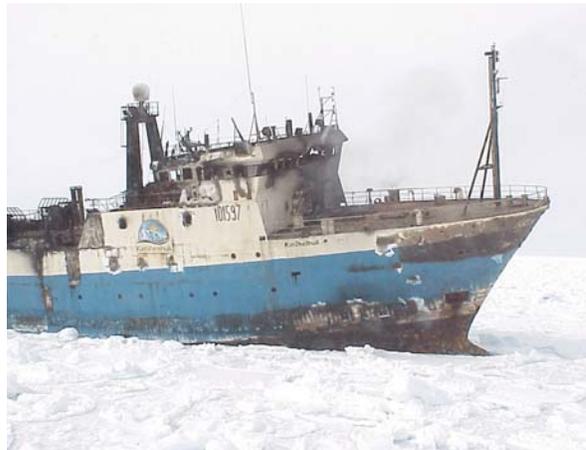
Photo 3. Post fire

Eventually, the wheelhouse began to fill with smoke, and the decision was made by the master for the remaining crew members to leave the vessel. All main and auxiliary power was shut down and the four remaining crew members donned immersion suits and prepared to abandon the vessel. A liferaft was thrown over the side and inflated for use as a temporary shelter. While descending the pilot ladder, at least two crew members fell off. One fell onto the ice and suffered a broken foot while the second fell into the water but was quickly recovered. During the final evacuation, these four crew members were transferred to the *Arctic Endurance*. Approximately 3 hours and 45 minutes after the onset of the fire, the *Newfoundland Otter* made the initial notification of the occurrence to the CCG through the Marine Communications and Traffic Services (MCTS) at St. Anthony, Newfoundland and Labrador.

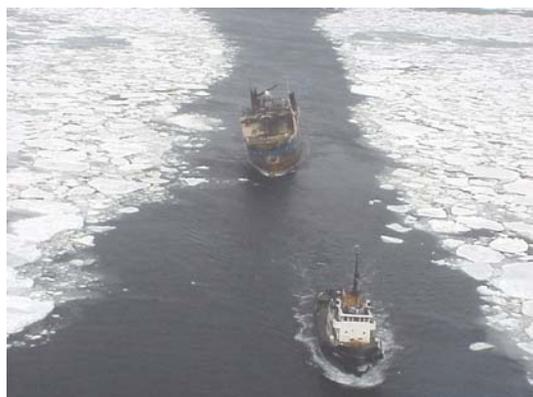
Photo 4. Vessel under tow

The owners of the *Katsheshuk* hired the tug *Atlantic Maple* to tow the vessel to port. By the time the tug arrived on the scene, the now derelict vessel had drifted approximately 168 nautical miles to the south. On the morning of 26 March 2002 (see Photo 4), the *Atlantic Maple* escorted by the CCGS *Henry Larsen*

On the early morning of 30 March 2002, weather conditions were favourable and the *Atlantic Maple*, with the *Katsheshuk* in tow, resumed its passage and headed for St. John's. At approximately 0616, the *Atlantic Maple* noticed the *Katsheshuk* had taken on a pronounced list and appeared to be settling lower in the water. At 0726, the *Katsheshuk* sank in position 47°54.3' N, 052°49.5' W (see Appendix B).

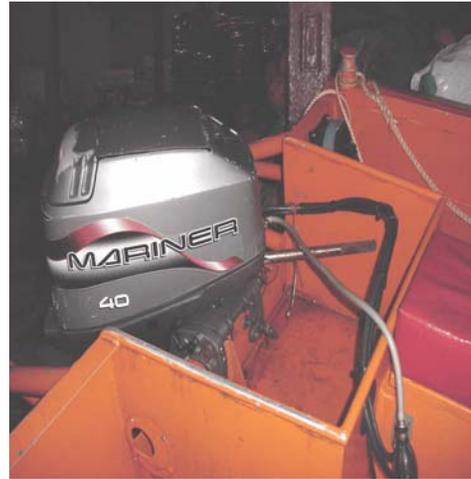
Photo 5. Improvised tiller arm

The *Katsheshuk* had a 5.4 m rescue boat equipped with a 40 HP outboard motor which formed part of the vessel's safety equipment.¹¹ The remote steering control on the rescue boat was reported to have been unserviceable since mid-January 2002. To allow for steerage, an improvised tiller arm (see Photo 5) had been jury-rigged to the outboard motor. This ad-hoc arrangement required the rescue boat to have two operating personnel, one to steer the vessel and a second to operate the throttle.

1. The steering control for the rescue boat had been unserviceable for two months at the time of the occurrence.
