Transportation Safety Board
of Canada

MARINE INVESTIGATION REPORT

M02C0064

COLLISION

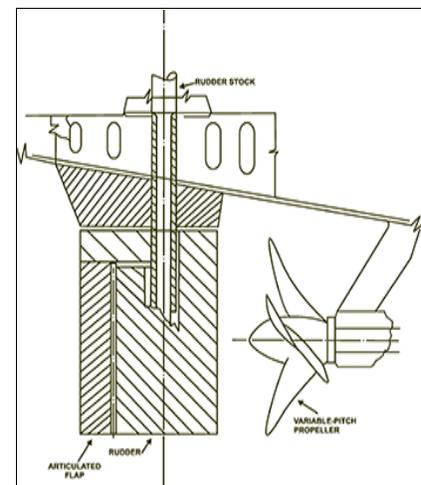
Unlike the rudder and propulsion system on a conventional vessel, the *Stellanova* is equipped with a Becker rudder and a variable-pitch propeller (see Figure 1). To make the vessel more manoeuvrable, the rudder has an articulated flap on its after edge. The helm can be turned up to 35° (at sea) or 45° (in port). The flap deflects automatically in the same direction as the rudder. This increases the helm angle, and the rudder-to-flap ratio can be as high as 2:1. The efficiency of the rudder gives the ship good manoeuvrability in different conditions. However, the investigation revealed that, when the propeller pitch is decreased quickly with the vessel moving forward, the vessel tends to swing unexpectedly to one side or the other, and the helmsman cannot predict to which side it will swing.

Figure 2. Sketch of a Becker rudder

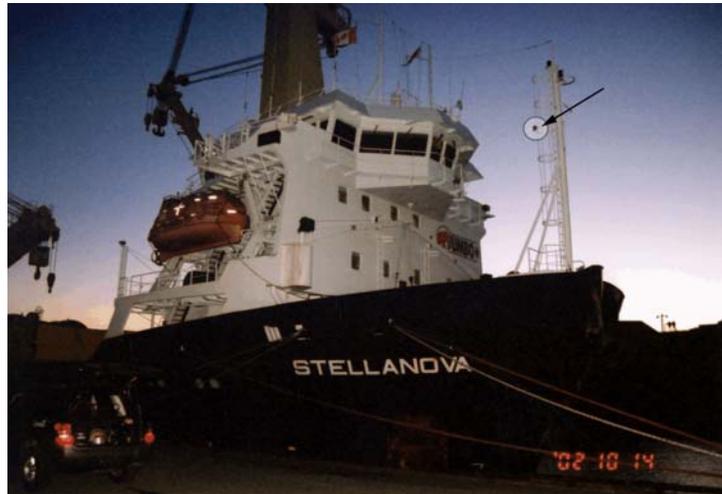
Visibility forward from the bridge is good. The blue steering light is mounted level with the bridge and aft of the foremast (Photo 3 shows the position of the blue light).

Because the distance between the bridge and the forward mast is short, the blue light is not a good visual steering reference.

Photo 3. View forward from the bridge showing position of the blue steering light

In this instance, the vessel's wheelhouse was well forward and the blue (steering) light was not a good visual reference for observing vessel movement. Consequently, a view of the stern was essential to maintain a better appreciation of the vessel's behaviour/response. As the wheelhouse and chart room arrangements restricted view aft, cues necessary to maintain visual reference and situational awareness were not readily available from the conning position. This made navigation from the central conning position more difficult.

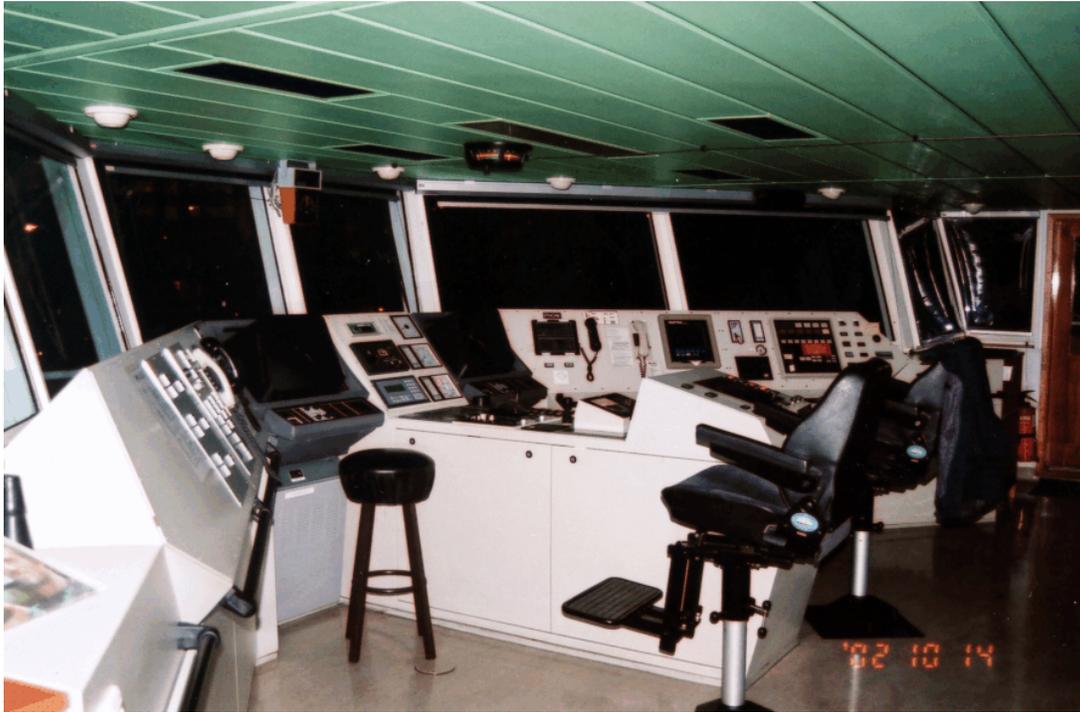
On the *Stellanova*, the wheelhouse is laid out as an integrated bridge. From the conning position, the view over the starboard quarter is limited due to the hutch on the chart table (see photos at Appendix A) and the crane on the starboard side. Visibility directly aft is also reduced due to the access to the lower accommodation decks (see photos at Appendix A). During navigation, to have an aft view, a person has to be stationed either on the port side of the bridge or on one of the wings.

Photo 4. View to starboard from the integrated bridge of the *Stellanova*

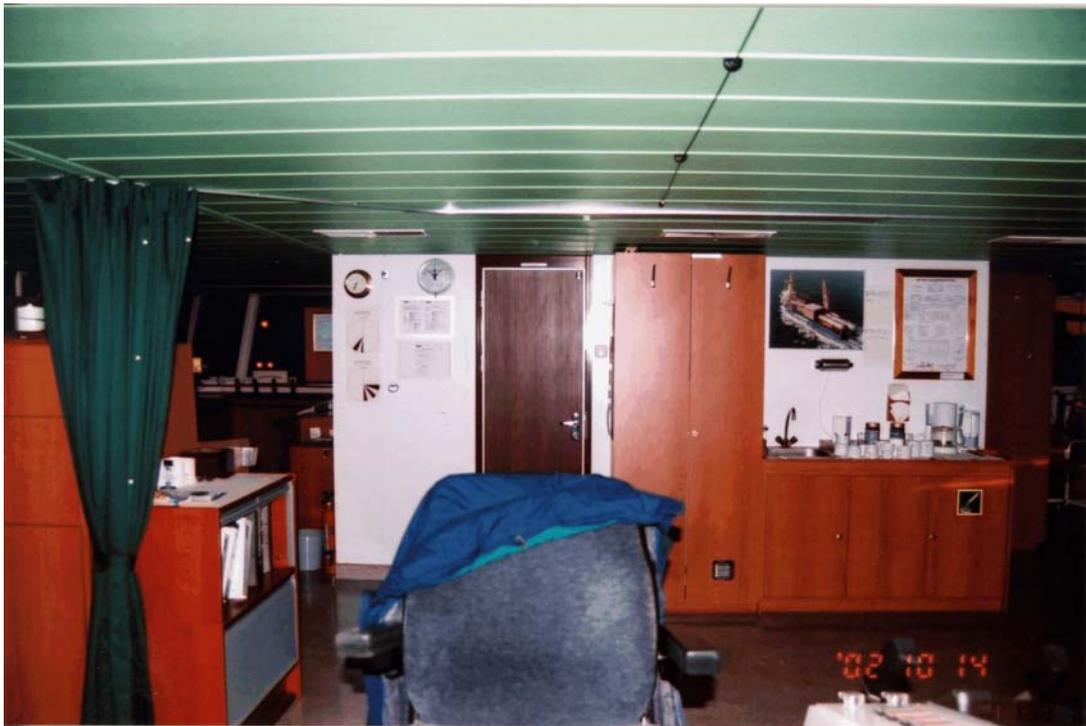
Photo 5. View aft from the conning position

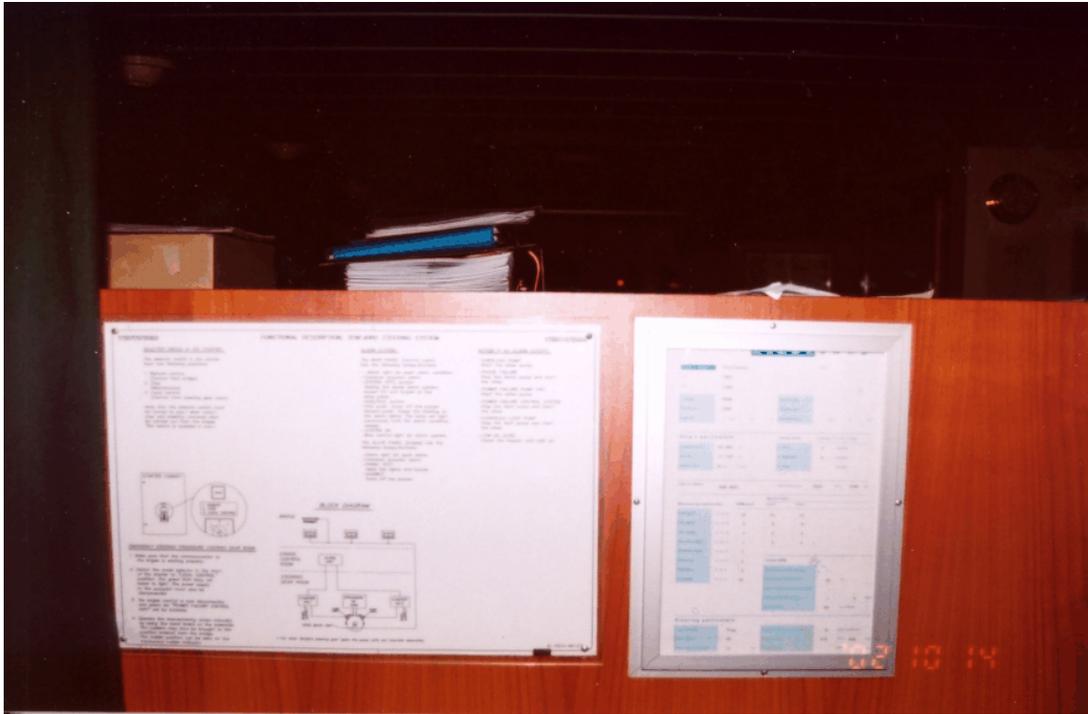
Photo 6. View aft from the starboard radar

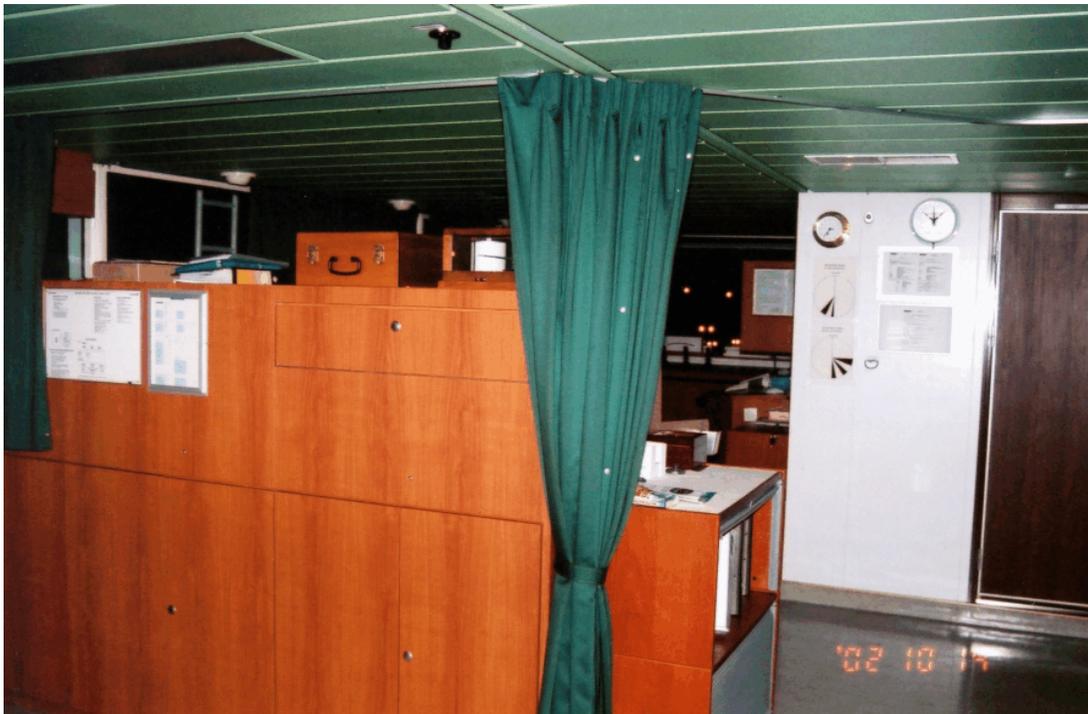
Photo 7. View over the starboard quarter from the helm
