MATING OF THE *MOLIKPAQ* DRILLING RIG

Frank van Hoorn, ARGONAUTICS Marine Engineering – Sausalito, Ca, USA
In-Tae Kim, Daewoo Heavy Industries Ltd. – Okpo Yard, Korea

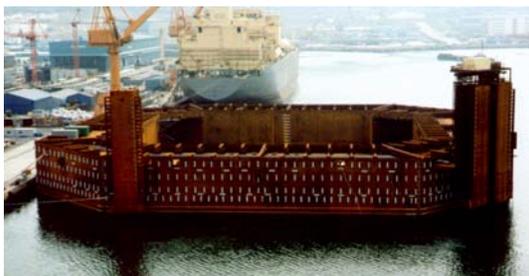
Since the rig's new location in the Sea of Okhotsk is in deeper waters, a 50.5 ft high steel structure was designed by Sandwell Engineering Inc.¹ and Rubin Central Design Bureau for Marine Engineering, to increase the rig's hull depth. This "Spacer" was built in sections at the Amur Shipbuilding Plant and assembled in Bolshoi Kamen. The octagonal, donut shaped 15,000 t Spacer measured 361 x 361 ft and was outfitted with 3 stability towers. A 3.5 ft deep skirt protruded below the base line. On the top, a total of sixty four pedestals, each 6.5 ft in height, were to ensure that the support loads of the *Molikpaq* were guided from its transverse bulkheads into the Spacer frames. The maximum allowed misalignment between the Spacer pedestals and the *Molikpaq* bulkheads was 4 inch. Because of the uncertainties in the "as built" surveys of both structures, the lateral mating tolerance was specified to be half of this, i.e. 2 inch. Three steel stoppers were installed to assist with the alignment of the structures during mating.

The Spacer hull was subdivided into 8 main ballast tanks and 8 corner tanks. A hydraulic operated valve system was installed for gravity ballasting. Deballasting was effected by compressed air, provided by a bank of rental compressors, mounted onto a barge. The compressed air was forced through the vent pipes via a manifold. The Ballast Control Container was mounted on the center buoyancy tower, where the valves for the vent pipes and air manifold were also located.

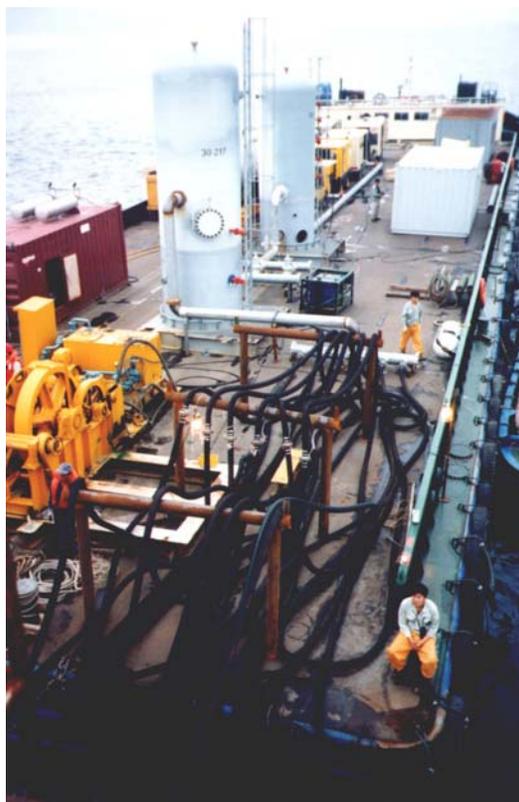
The compressor barge consisted of a total of 12 trailer mounted rental compressors, hooked up to a central pipe line, feeding a high pressure air receiver which in turn fed a low pressure storage vessel. A set of 6 flexible air hoses connected the low pressure manifold on the barge with the air flow control manifold on top of the center buoyancy tower of the Spacer. This barge was also outfitted with a generator set (to run the compressors), portable office space and a mooring winch.

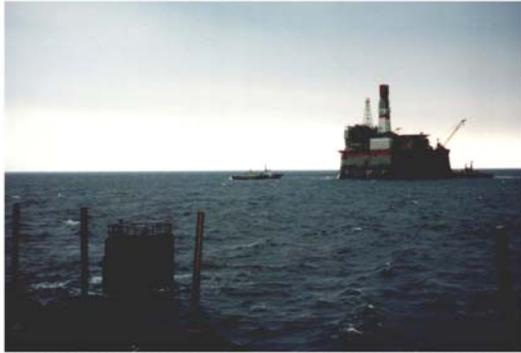
On May 25, the *Molikpaq* arrived at the mating site. The Spacer was ballasted further down to mating draft. Weather conditions initially looked favorable, but during final maneuvering towards the submersed Spacer, the horizon started to darken and a wind started to blow. The operation was temporarily aborted to see if this unreported front would blow over. White caps started to appear and wind speeds exceeding 20 knots were measured. The *Molikpaq* became harder to control by the attending tug boats and it was decided to tow her back to the yard and postpone the mating operation with one day (next day's weather forecast looked good). The Spacer was deballasted approx. 5 ft to bring it into survival mode. Later in the day, heavy seas caused the compressor barge to break loose, ripping 3 of the 6 flexible air hoses.
