## MARINE INVESTIGATION REPORT

M09C0029

EXPLOSION

TANKER *ALGOCANADA*

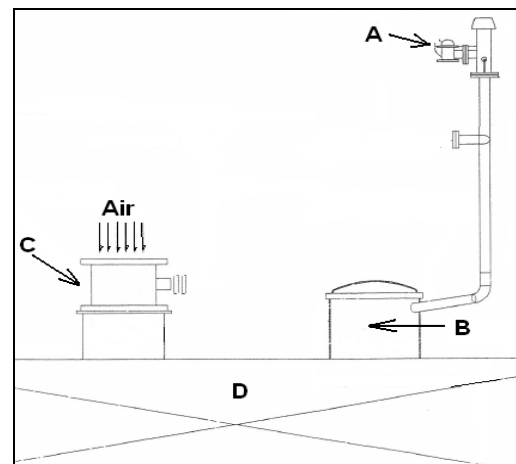
**Figure 2.** Normal venting arrangement

The *AlgoNova* P&A Manual states that tank ventilation is to be performed using portable water-driven air fans placed at the tank-cleaning hatches (see Figure 2). The practice of using the fixed tank-drying system for ventilation had been carried over from another company vessel, the *AlgoScotia*.
