MARINE INVESTIGATION REPORT

M17A0004

Grounding

Bunkering tanker *Arca 1*
Little Pond, Nova Scotia
08 January 2017

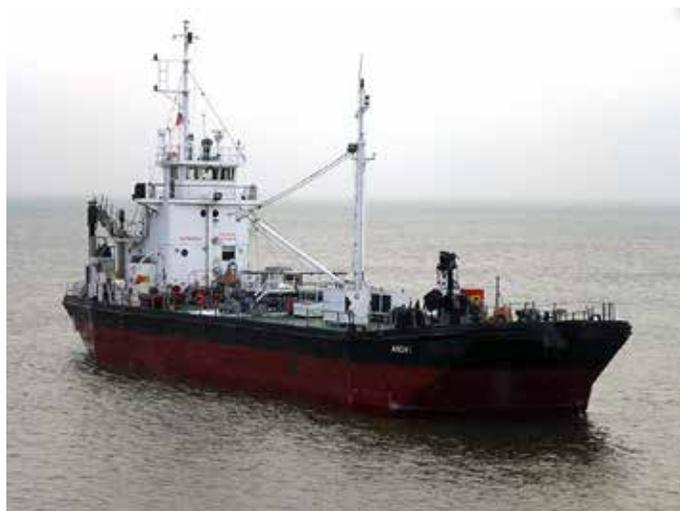
Figure 1. *Arca 1*

The *Arca 1* is a bunkering tanker with a capacity of 1527 m³, designed for the transportation of oil to vessels at a maximum speed of 8 knots (Figure 1). The vessel was built in St. Catharines, Ontario, in 1963 and had operated in the ports of both Montreal and Sorel, Quebec. The vessel was restricted to minor waters voyages, Class II.¹ In 2004, a second hull was installed over the internal oil storage tanks, providing a double hull (Appendix A). The construction of the second hull provided a 750
