Marine Accident Investigation Branch (MAIB) - Safety Digest 02/1999

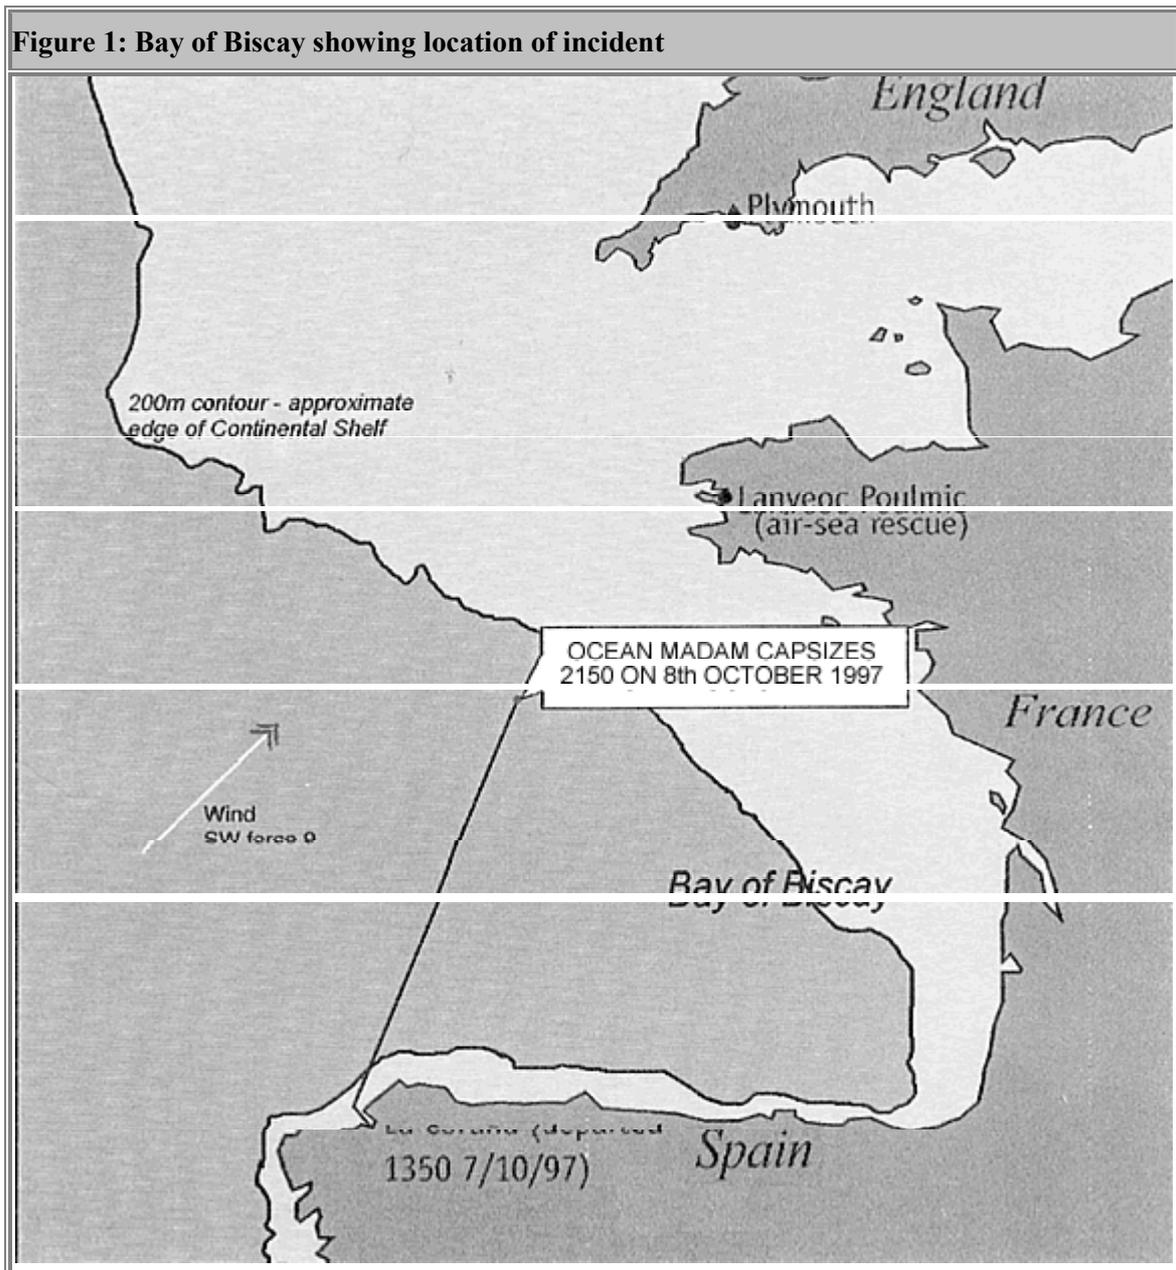
After an indeterminate period the yacht righted herself and this enabled the skipper to climb back on board. On regaining the cockpit he discovered that the yacht had been dismasted and that he was alone. There was no sign of the crewman who had been on watch with him. When last seen he been wearing a lifejacket and safety harness and had been clipped on. There was no indication of harness failure so it is assumed he had unclipped himself when trapped under water.

The missing crewman was never found.

- 1. The ability to survive in heavy weather is dependent on three factors; a suitable boat, thorough preparation and an experienced and well worked up crew. Providing all three criteria can be met, there are no overwhelming reasons why sailors should not confront these conditions. But as soon as any one of these requirements is ignored, overlooked or underestimated, the risks escalate. If all three are disregarded then the attempt becomes dangerous and the consequences potentially tragic.**

- 2. In deciding whether a boat is capable of standing up to bad weather, there is little to replace practical experience of the actual craft and a sensible appraisal of what it is capable of. This must be supported by an understanding and knowledge of equipment carried and the boats handling characteristics. Once the shelter of the land is left behind, a skipper is placing great trust in the boats design, her rigging, maintenance and watertight integrity. Any small boat is subjected to immense forces in heavy weather and if anything unexpected gives, disaster can follow.**

- 3. *Ocean Madams* skipper knew the boat and had already sailed several hundred miles in varying weather conditions on this voyage without cause for concern. He did not, however, know enough about her stability to predict her performance in the heavy weather likely to be encountered in an autumn gale in the Bay of Biscay. Yachts are designed for particular conditions and should not be deliberately placed in situations for which they are unsuitable. There is a world of difference between a craft suitable for summer cruising and one designed to cross oceans in all weathers.**
