**SAFETY STUDY 1/2001**

**REVIEW OF  
LIFEBOAT AND LAUNCHING SYSTEMS'  
ACCIDENTS**

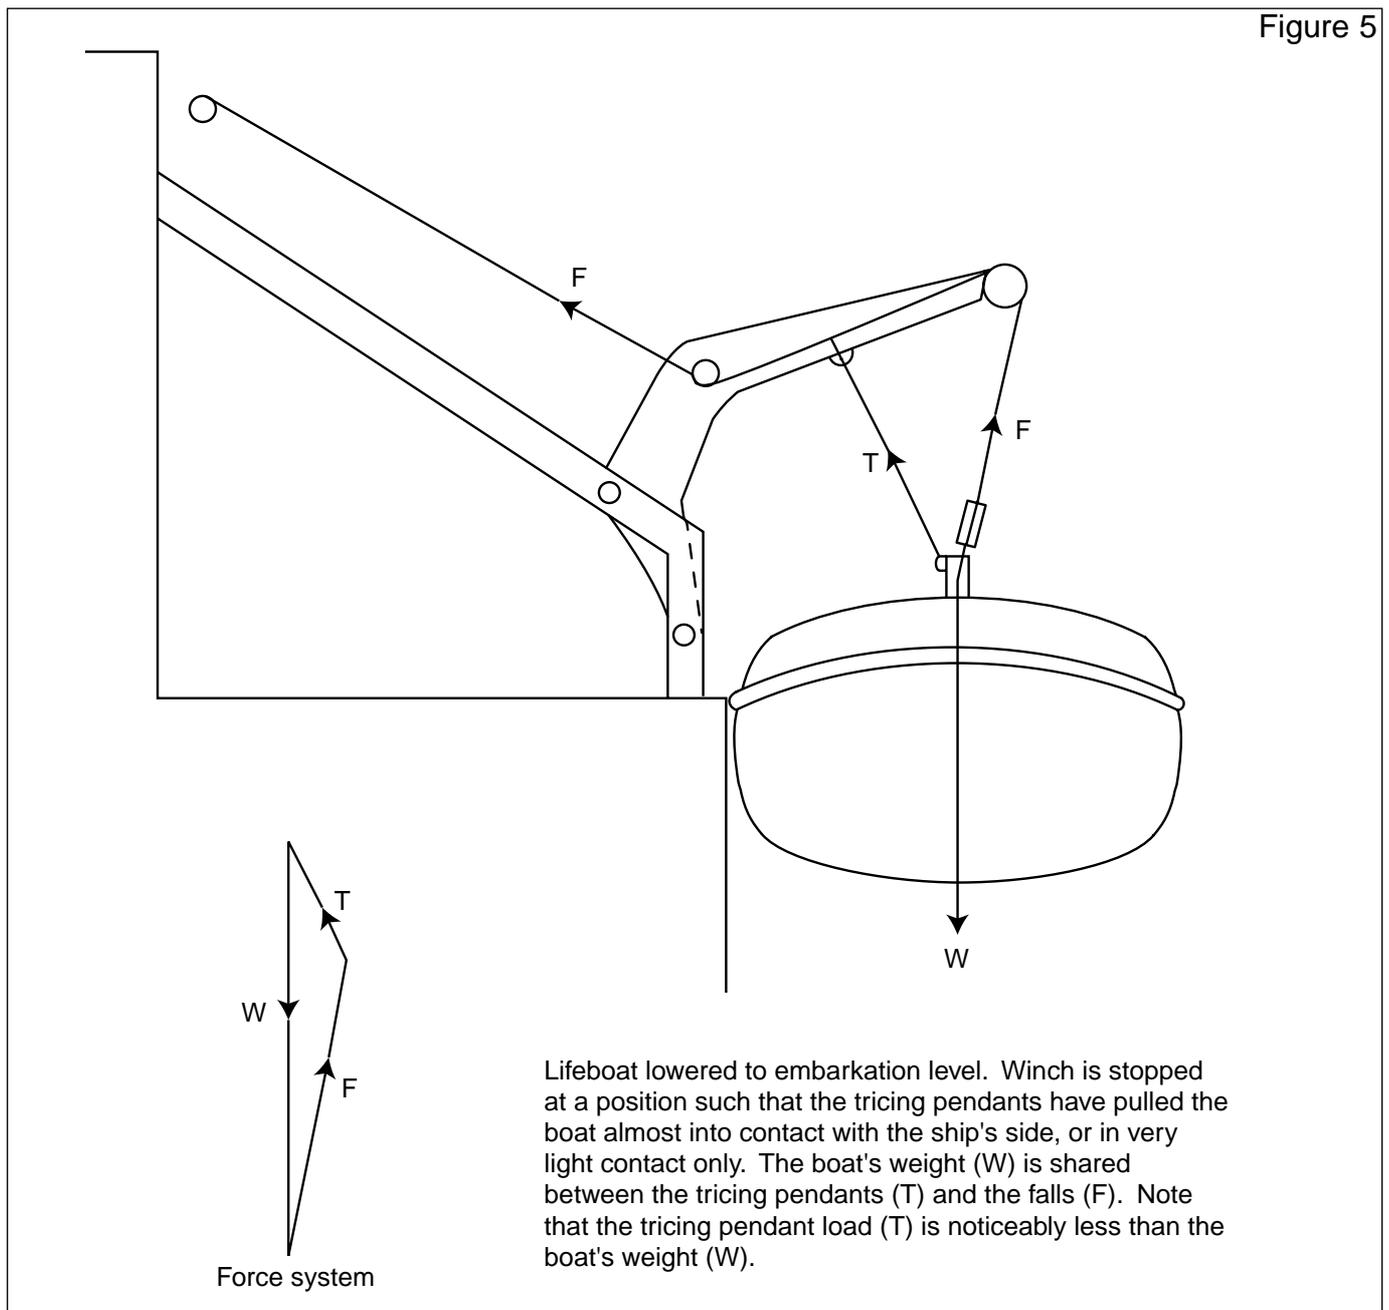
Figure 6

Launching procedures call for the lifeboat to be lowered to embarkation level while the tricing pennants pull it into the side of the vessel (see Figure 5). Once at the correct level, bousing tackles are secured between the forward and aft lower blocks and the ship (see Figure 6). When tightened they take over the function of the tricing pennants, which are then disconnected.

Above diagram shows the forces acting on a davit arm with the boat properly bowsed in with the bousing tackle horizontal. This is the condition shown in Figure 6. The forces in the lower and back falls have been added to give the resultant wire load. The only other significant forces acting on the arm are the top and bottom roller forces.
