**MARINE INVESTIGATION REPORT**  
**M05W0111**

**LOSS OF PROPULSION, SUBSEQUENT STRIKING OF BERTHED  
PLEASURE CRAFT AND GROUNDING**

**ROLL-ON/ROLL-OFF FERRY *QUEEN OF OAK BAY*  
HORSESHOE BAY, BRITISH COLUMBIA  
30 JUNE 2005**

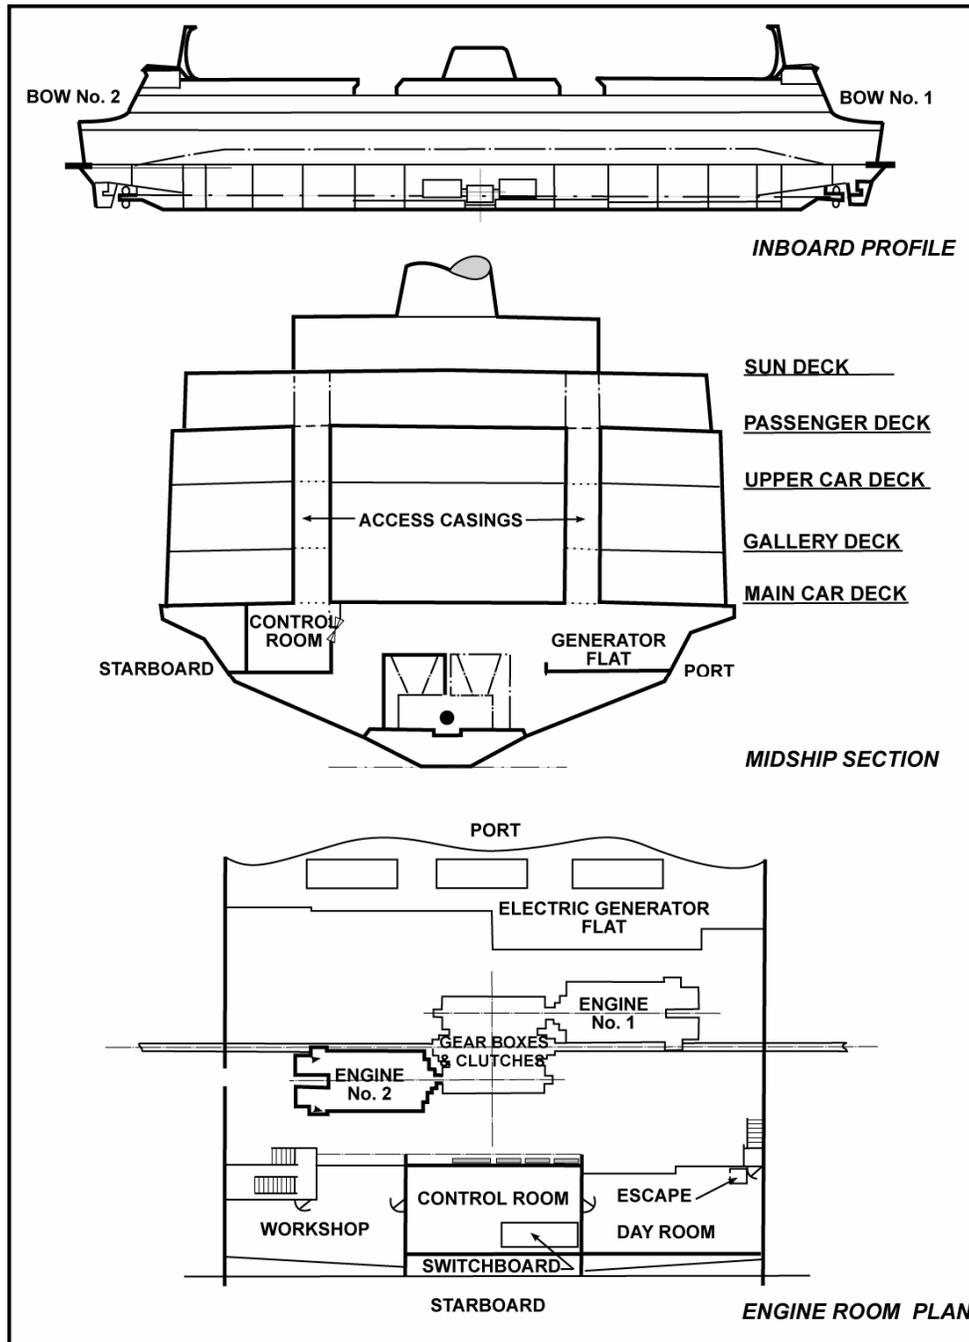
Figure 1. General arrangement of compartments at midships

The *Queen of Oak Bay* is a double-ended vessel having a wheelhouse, a controllable-pitch propeller and a rudder at each end, and the engine room at midships. The two ends are almost identical and, for the purposes of identification, are numbered 1 and 2. This establishes the port and starboard sides of the vessel and the numbering system of the machinery in the engine room (see Figure 1).

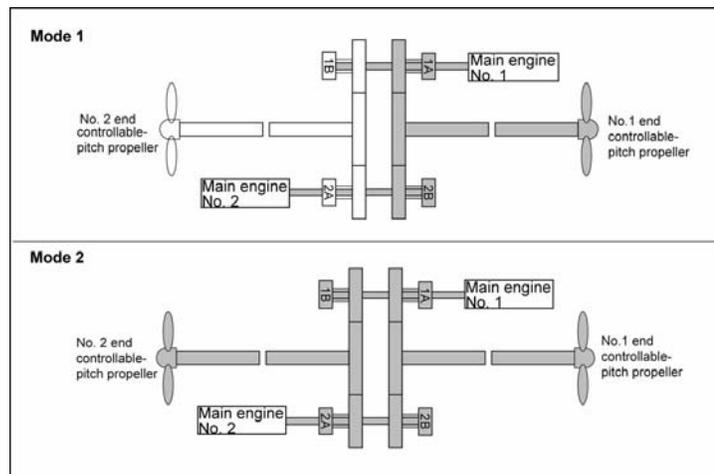
**Figure 2.** Mode 1 and Mode 2

#### Mode 2

All four clutches are engaged, providing power to both propellers. This mode is primarily used during berthing and unberthing. The amount of power absorbed by each propeller can be varied by adjusting the blade pitch, but the default is a ratio of 70:30 or 60:40, with the forward propeller taking the lesser amount, because it is used to slow the vessel.

In both modes, the two main engines are mechanically coupled, effectively behaving as a single unit. There is no automatic means to isolate them in the event of a fault in one; any change in the operating condition of one is automatically, and instantaneously, reflected in the other.<sup>5</sup>

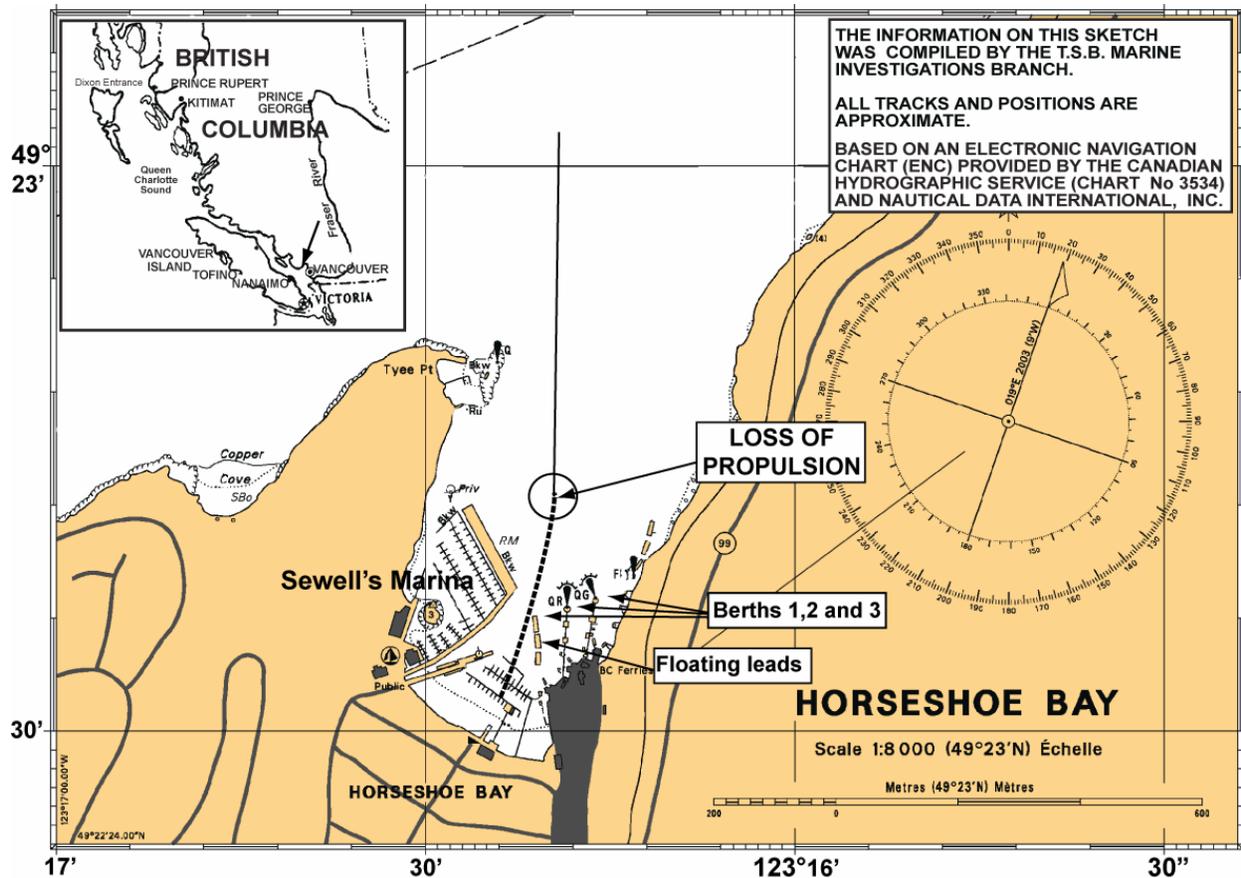
Figure 3. Aerial view of Horseshoe Bay (courtesy of BC Ferries)

At 1002, the master placed the engine room on “standby” for arrival at Horseshoe Bay and at 1005 changed over to Mode 2, engaging all four clutches. The vessel was lined up for the centre of the No. 1 berth, but at 1008, while about 200 m away from the floating leads, all propulsive power was lost. Seeing that the propellers had stopped turning, the master telephoned the engine room, informed them of the power loss, and ordered the engines to be restarted and power restored.
