London Offshore Consultants Pte. Ltd.

Our Ref: 4076/C4/R001/JMW/LOCS

“HEBEI SPIRIT”
COMMENTS ON THE INCHEON MARITIME
SAFETY TRIBUNAL (SPECAIL TRIBUNAL)
DECISION - 4TH SEPTEMBER 2008

Date: 21 November 2008

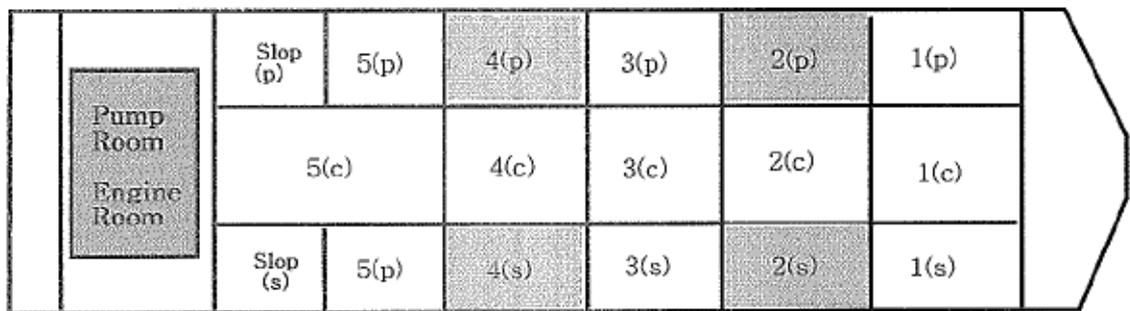
[Picture 16] Arrangement of cargo tanks and ballast water tanks

“Hebei Spirit” has 13 cargo tanks and 4 ballast water tanks. ([Picture 16], [Table 7])

As can be seen from the ships drawing the vessel actually has eight water ballast tanks, not four as the IMST have erroneously stated. The other ballast tanks are the fore peak, engine room side tanks (2) and the aft peak.

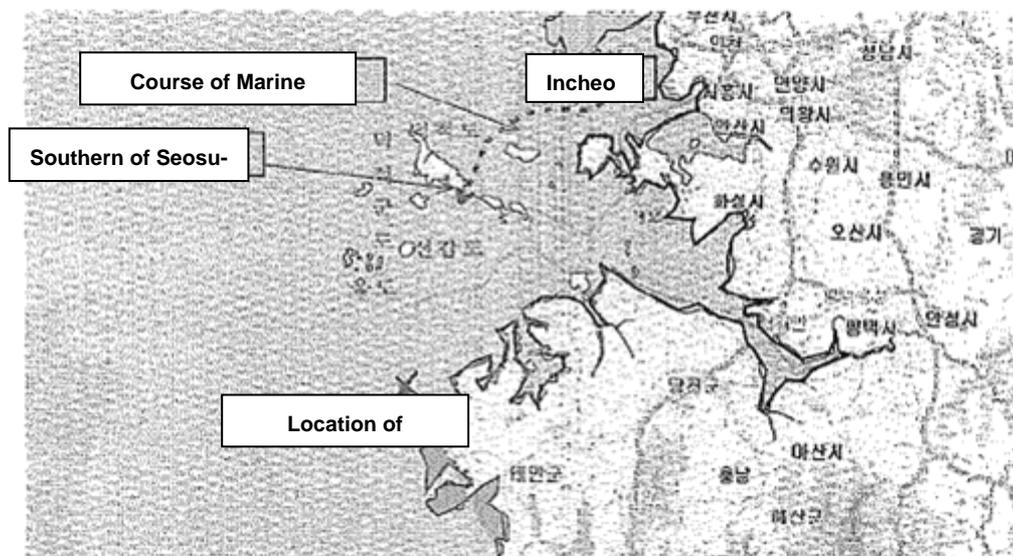
[Picture 17] Track of Marine Spread's voyage to south of Seosu-do after departure from Incheon Port

After departure, when “Samsung T-5” was passing by Palmi-do while maintaining manual steering at a speed of 4 knots at around 1600 hours on the same day, the master Seung Min Cho made a report to the Vessel Traffic Service Center (“VTS”) of Incheon Port. Thereafter, the Marine Spread proceeded south along Seosu-do, located in a special area of Incheon Port, and passed by Seosu-do at around 2030 hours on the same day. For sailing along the coast, “Samsung T-5” and “Samho T-3” each increased the length of their towing lines by 420 m and 400 m, respectively, and set their course to 206 degrees at a speed of 4.2 knots around the time of 2040 hours. At that time, the tugboats had switched on three towing lights, including the head light, the side light as a streaming light, and the white light. [Picture 17]

I assume that the length of the tow lines were increased to 400m and 420m, not by those lengths. In addition, the description of the navigation lights displayed shows that the tug masters did not consider the tow was in any way restricted in its ability to manouever.

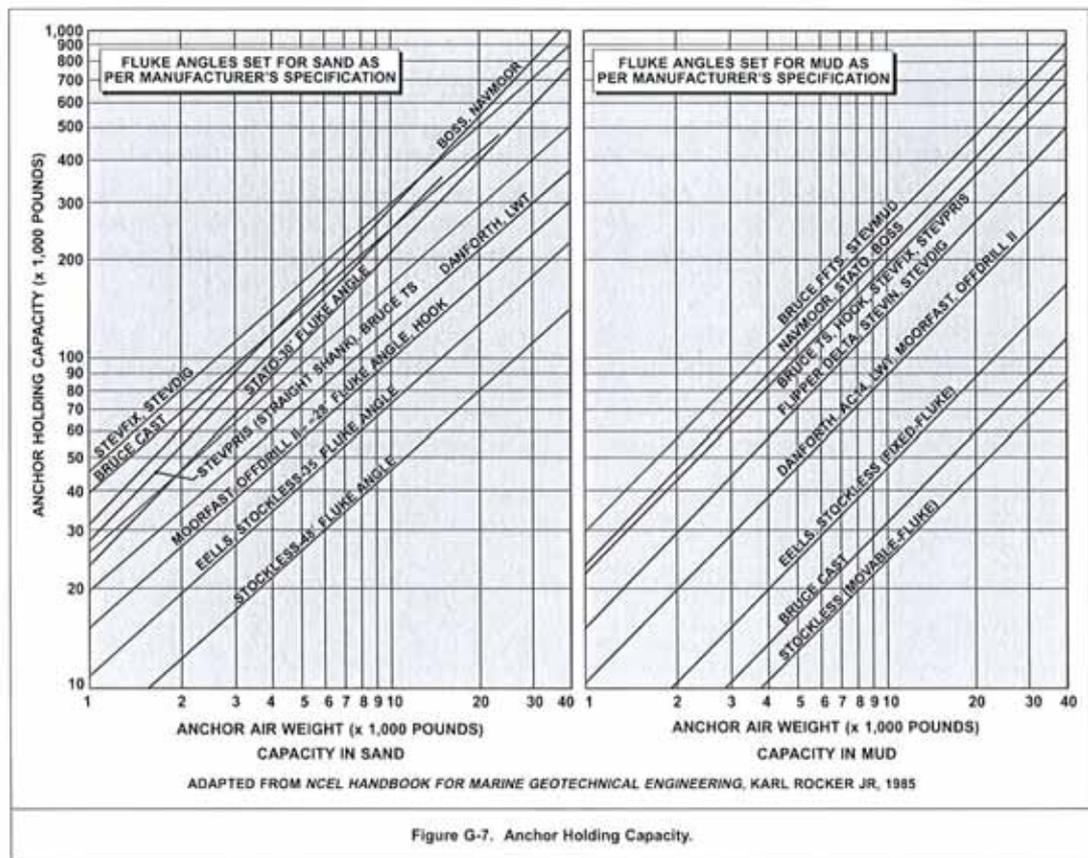
If the Master of “SAMSUNG T-5” really believed that the marine spread was in trouble and uncontrollable, he could have deployed the free-fall anchor on the “SAMSUNG NO.1”, to arrest any uncontrollable movement, which could then have been assisted by the tow tugs to maintain its anchored position as the IMST later include themselves. If he discounted the possibility of anchoring because of the nature of the seabed, sand, this again shows his lack of understanding of marine matters and a lack of knowledge of the capabilities of the equipment available on the barge. A high holding power anchor with up to fifteen shackles of cable would hold extremely well in sand, particularly when supplemented by the pull generated by the tow tugs. Please see the following extract from the US Navy Salvage handbook.

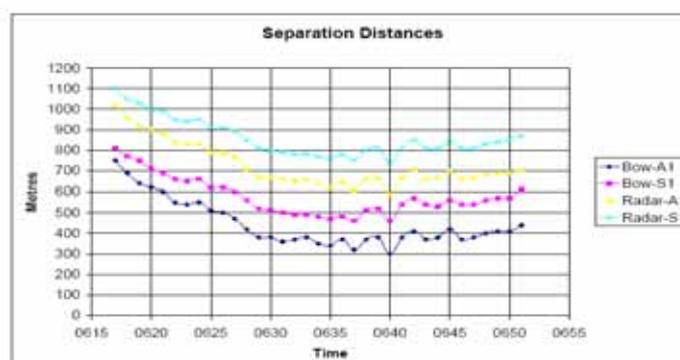
This particular paragraph places emphasis on the request by VTS for “HEBEI SPIRIT” to heave anchor. At the time of this request the marine spread had passed the closest point of approach and was moving away, contrary to the claim in this paragraph that the distance was not increasing as can be seen from the attached diagram below.

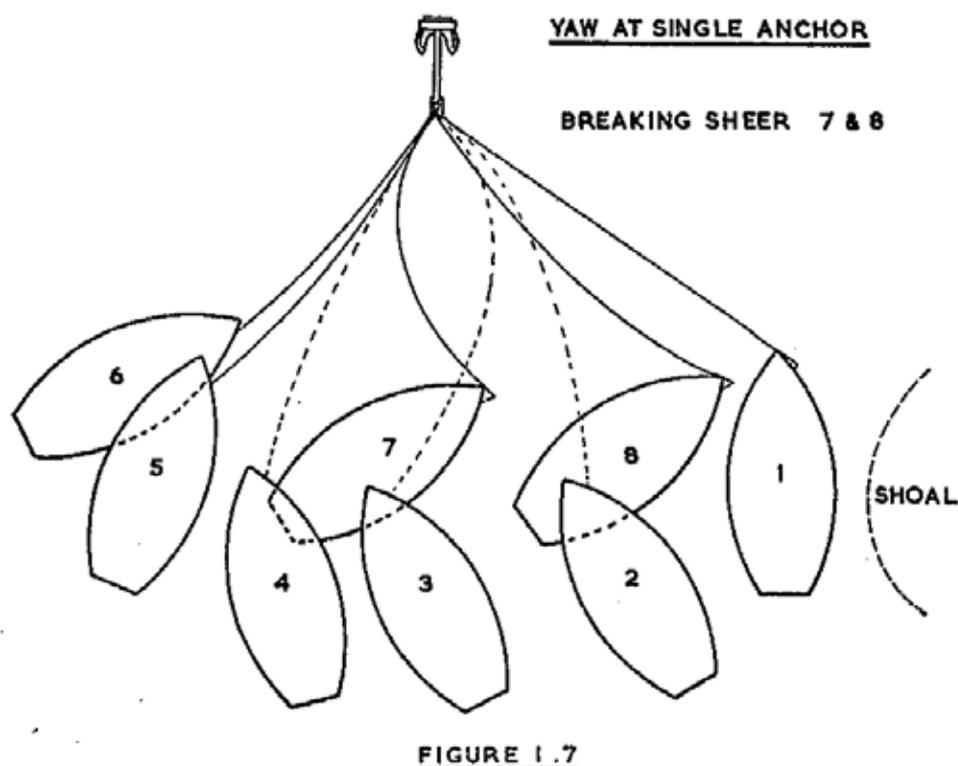
This is factually misleading. The cause recorder trace shows that from 0400 to 0430 hours the bow of “HEBEI SPIRIT” only changed from 293° to 305° and from 0430 to 0500 from 305° to 315°. Yawing is a term that describes rapid and substantial changes of heading whilst at anchor. I have attached an extract from Danton’s Theory and Practice of Seamanship to illustrate such a movement.

It can be seen that the yawing illustrates substantial and rapid changes in the ships head. The course recorder trace shows the head of “HEBEI SPIRIT” never yawed like this throughout the time it was anchored.

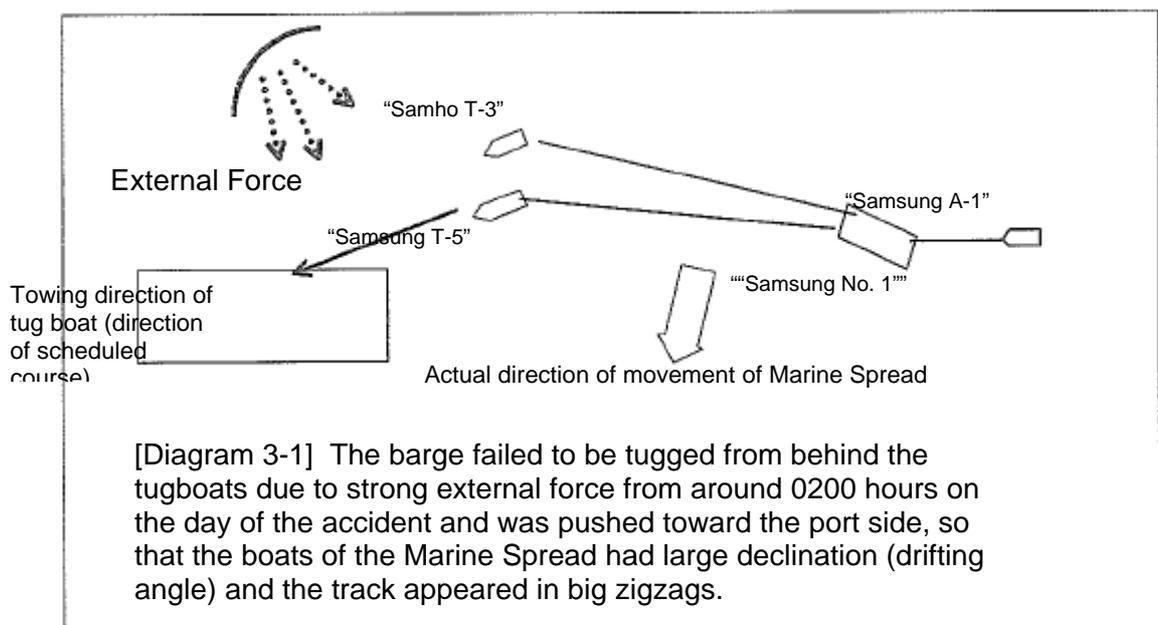
[Diagram 3-1]

At around 0400 hours of the same day, when the decision to seek shelter was made, external forces on the barge “Samsung No. 1” was greater than the bollard pull of “Samsung T-5” and “Samho T-3” combined. “Samsung No. 1” therefore did not move in the direction it was towed but was pushed in the direction of the combined forces of the towing force and the external forces, and started pulling the tugboats. This resulted in almost a 90-degree angle drift between the towing direction and the route on which the Marine Spread actually moved (Diagram 18, Diagram 19 and Diagram 3-1).

Such result means that the towing vessel lost its control over its navigating direction or positioning ability, making it impossible for the master to normally navigate the vessel, resulting in a loss in towing ability. The fact that the master of “Samsung T-5” had estimated at around 0400 hours on the day of the accident that normal navigation was impossible and therefore decided to seek shelter is evidence that towing ability was lost.
