Report on the investigation of  
a main engine room fire on board

***Pride of Canterbury***

while berthing in Calais

on 29 September 2014

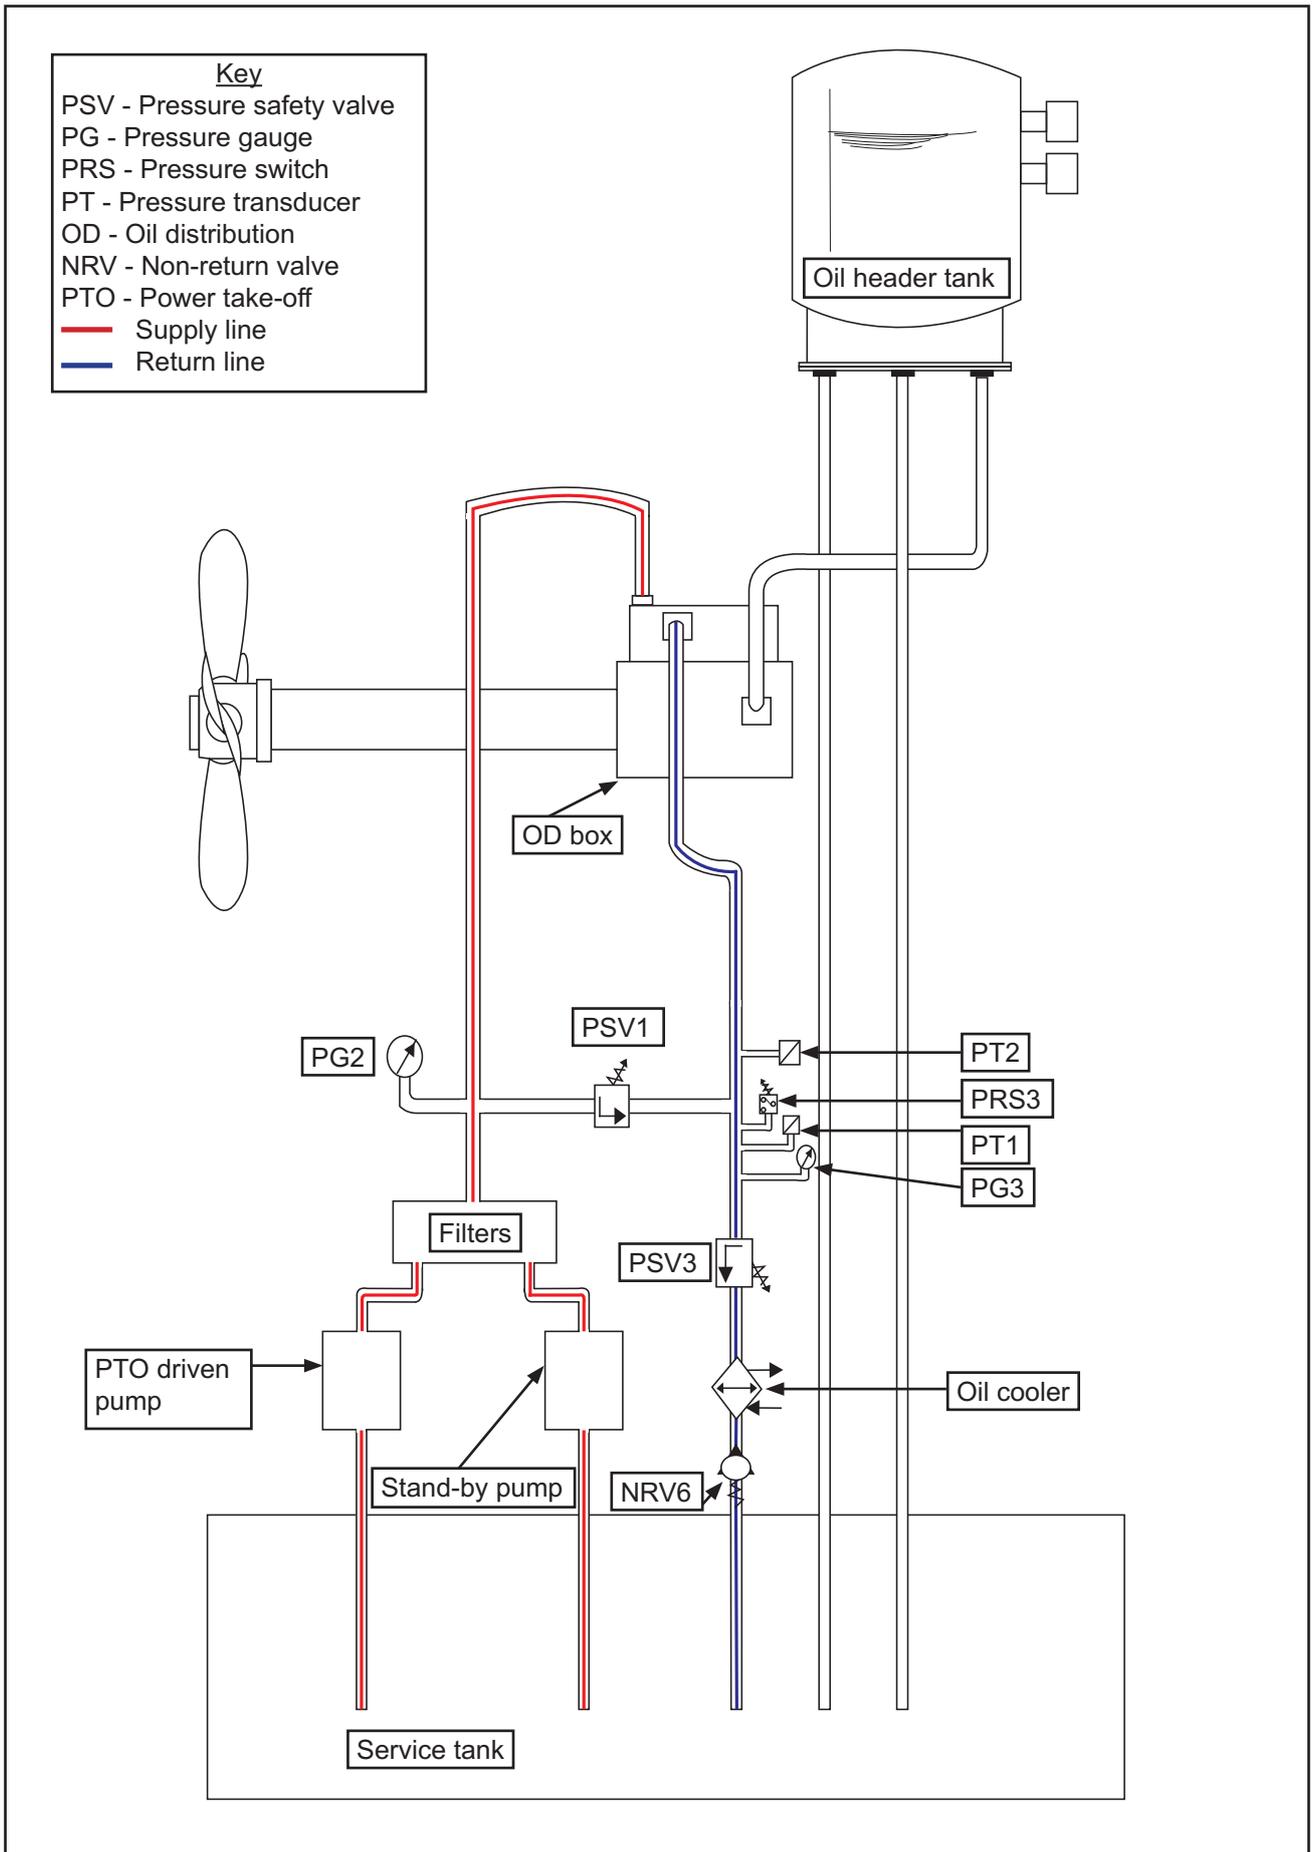
**Figure 12:** Controllable pitch propeller system simplified schematic

**Figure 12** provides a simplified schematic of one of the CPP systems. The main components of the system were the propeller hub, oil distribution (OD) box (**Figure 13**), power take-off (PTO) driven pump (**Figure 14**), hydraulic module (**Figure 15**) and oil header tank. The hydraulic module housed the CPP system's reservoir, filters, pressure safety valves (PSV), oil cooler, stand-by pump, pressure gauges and sensors. The OD box was situated between its respective diesel engines on deck 1, while the hydraulic modules were positioned outboard on deck 2 in the engine room.

The system oil pressure was regulated by maintaining the return line from the OD box at 8 bar utilising a pressure safety valve (PSV3) termed a back pressure valve (**Figure 16**). A further pressure safety valve (PSV1) was fitted in the supply line to the OD box to enable pressure to be dissipated into the return line if it exceeded 145 bar. **Figure 17** shows the fire-damaged starboard hydraulic module with the relevant components highlighted. An oil cooler was situated after the back pressure valve and a non-return valve (NRV6) was positioned immediately before the return into the reservoir.

The return line from the OD box also contained a pressure switch (PRS3), which automatically started the electrically-driven stand-by pump if the pressure reduced below 6 bar, and two system pressure transducers (PT1 and PT2), which were set to alarm when the pressure dropped to 4 bar. When the shafts were not turning, engaging the automatic stand-by pump ensured that a positive pressure remained in the CPP hydraulic system, preventing potential sea water contamination at the propeller hub and ensuring circulation of the oil. The stand-by pump could also be started manually in the ECR if for some reason it failed to start automatically. The system was also provided with a temperature sensor on the OD box, which was set to alarm at 69°C.
