DANISH MARITIME ACCIDENT INVESTIGATION BOARD

# MÆRSK BATTLER

Marine accident report on MAERSK BATTLER's loss of tow and the foundering of MÆRSK SEARCHER and MÆRSK SHIPPER on 21 and 22 December 2016

The report is issued on 30 August 2017

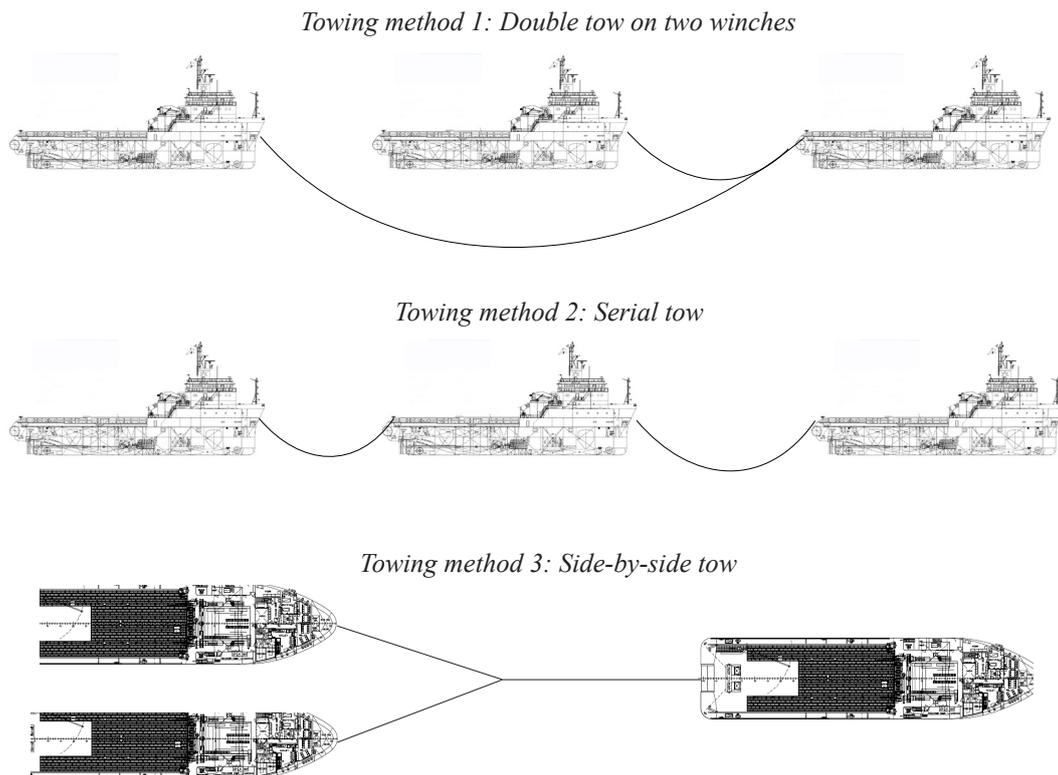
The first setup, the double-tow, was recommended by an external towing company, but required a specific winch setup, which was not available on MAERSK CHANCELLOR, and therefore not possible. The second towing setup with the ships connected in series required the middle ship to be manned and operational in order to control the winches with the connecting wire to the last ship. A third towing setup with the S-type ships being towed side by side was also discussed, but was discarded due to some identified risks of the superstructures making contact during tow (figure 2).

Figure 2: The three towing methods considered for the towage of MÆRSK SEARCHER and MÆRSK SHIPPER  
Source: DMAIB

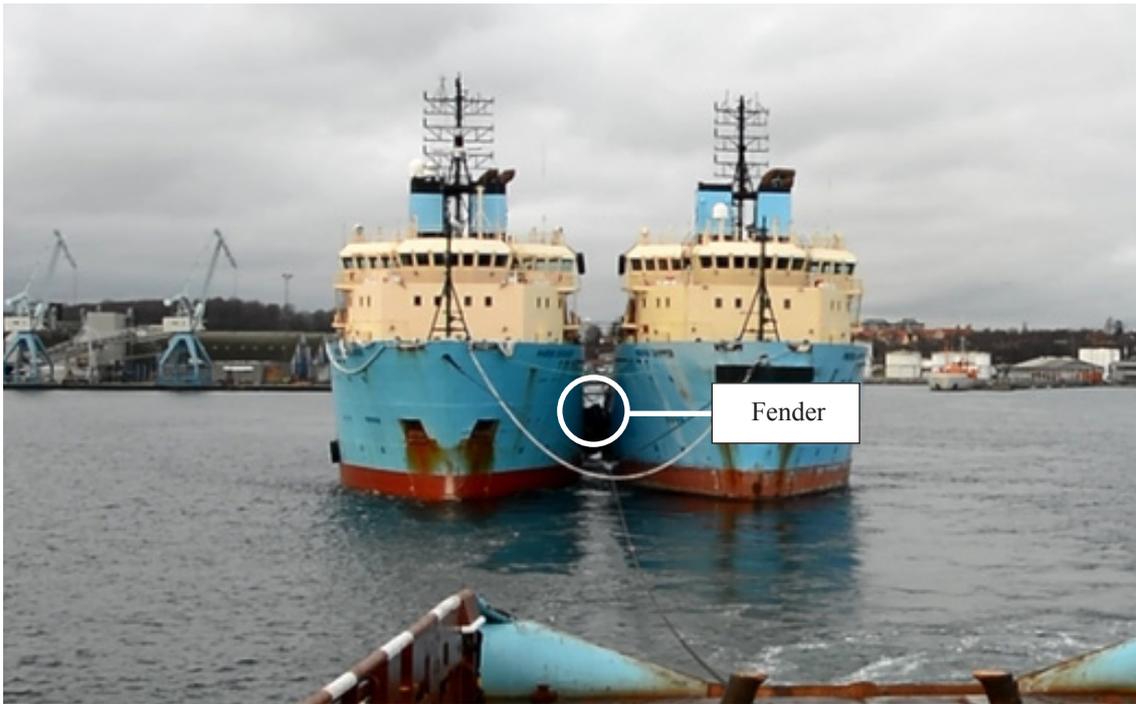
Figure 4: Towage at departure from Fredericia on 12 December 2016  
Source: Private photo

MÆRSK BATTLER departed Fredericia on 12 December 2016 at approx. 1130 (figure 4), and the towage exited the port area and proceeded to the Skaw Roads, where MÆRSK BATTLER was to take stores. The weather was clear and the two ships under tow were lying steady in the water next to each other. MÆRSK BATTLER took stores on 14 December and proceeded south through the North Sea. The crew continued to experience problems with receiving emails and updating the SPOS<sup>2</sup>, and they therefore relied on the master retrieving weather forecasts on his personal mobile phone when the ships were within reception reach of a mobile signal.

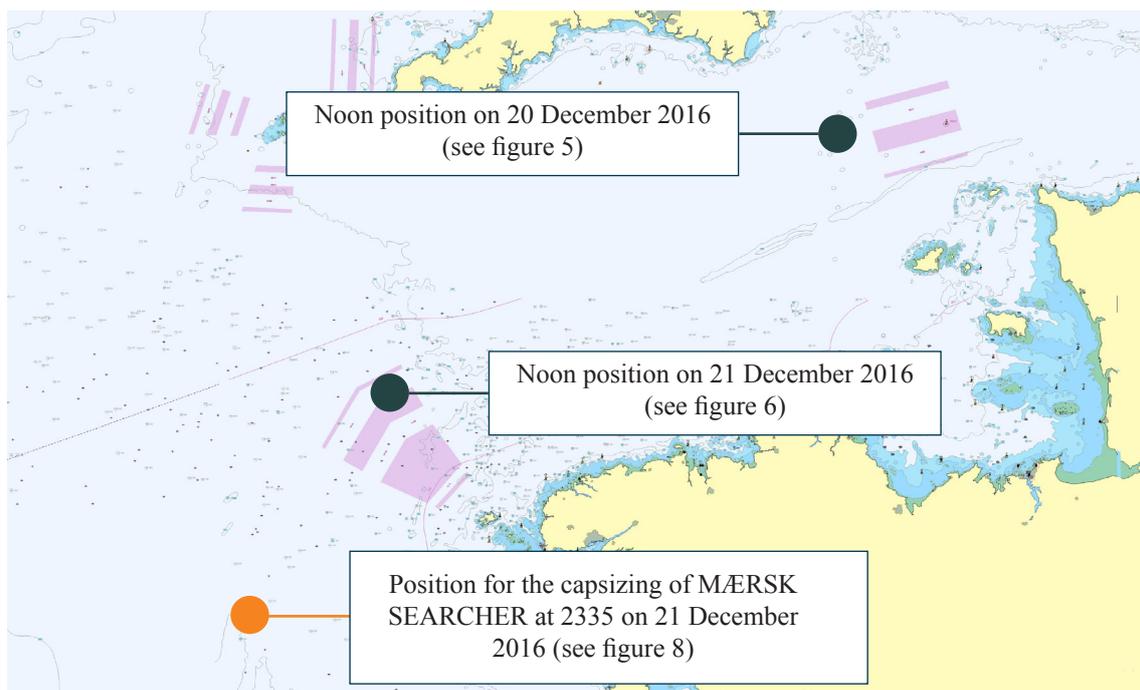
On the night of 21 December, the master was on duty on the bridge along with a watch-keeping AB. The ships were acting as they had done all day, rolling and colliding with each other and having a slight list towards each other. At 2325, the AB suddenly noticed that MÆRSK SEARCHER was lying deeper in the water than before and was listing heavily. He communicated this observation to the master, who immediately realized that MÆRSK SEARCHER was about to capsize. However, the crew on MÆRSK BATTLEL had no means to recover this situation. Ten minutes after the AB made this observation, MÆRSK SEARCHER capsized (figure 7).

Figure 7: Position for the capsizing of MÆRSK SEARCHER.  
Source: DMAIB
