Sinking of the US Cargo Vessel *El Faro*

Illustrated Digest

This digest of the National Transportation Safety Board's (NTSB's) Marine Accident Report **NTSB/MAR-17/01** contains a description of the accident and safety issues, and summarizes some of the safety recommendations intended to prevent such an accident from happening again. The full report and docket can be found at www.nts.gov.

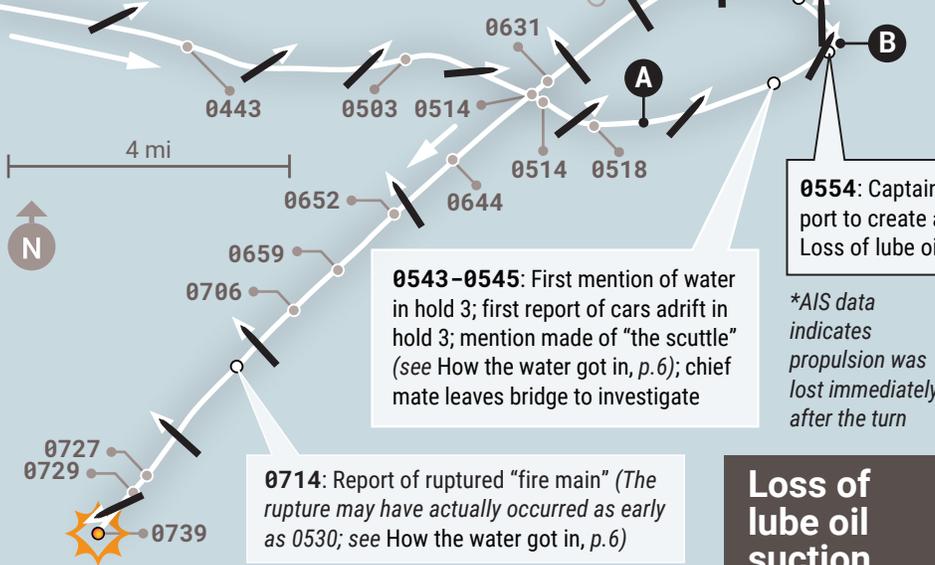
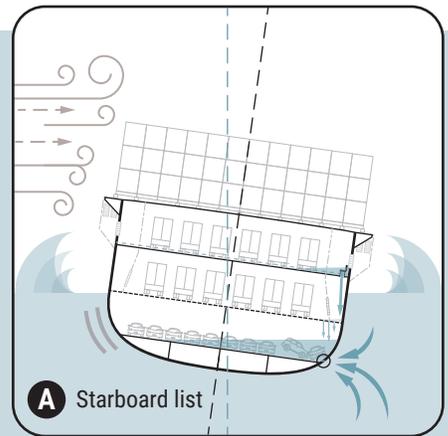
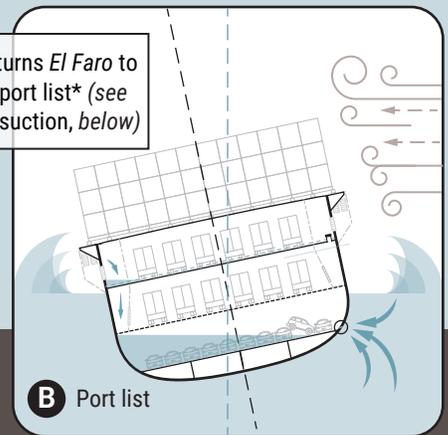
El Faro's final maneuvers

El Faro's captain and crew turned the vessel's bow into the wind several times. Then, at 0554, the captain ordered a turn to port to get the wind on the ship's starboard side, generating a port list. A few minutes later, El Faro lost propulsion (see Loss of lube oil suction, below).

Because the bellmouth (intake) for the main propulsion engine lube oil pump was located toward the starboard side, it mattered whether the ship was listing to port or starboard. (The trim of the ship also affected the oil suction; forward trim was worse). It also mattered how much lube oil was in the sump.

At **0616**, the engine room called. Although the conversation from the engine room was not recorded on the VDR, the captain asked, “so . . . is there any chance of gettin’ it back online?” It is likely that a suction pipe leading to the lube oil service pump had taken in air instead of oil (see Loss of lube oil suction, p. 7). The port list, coupled with the vessel’s motion, resulted in a loss of oil pressure that caused the main engine to shut down.¹⁰ Once propulsion was permanently lost, *El Faro* was pushed sideways by the wind and waves.

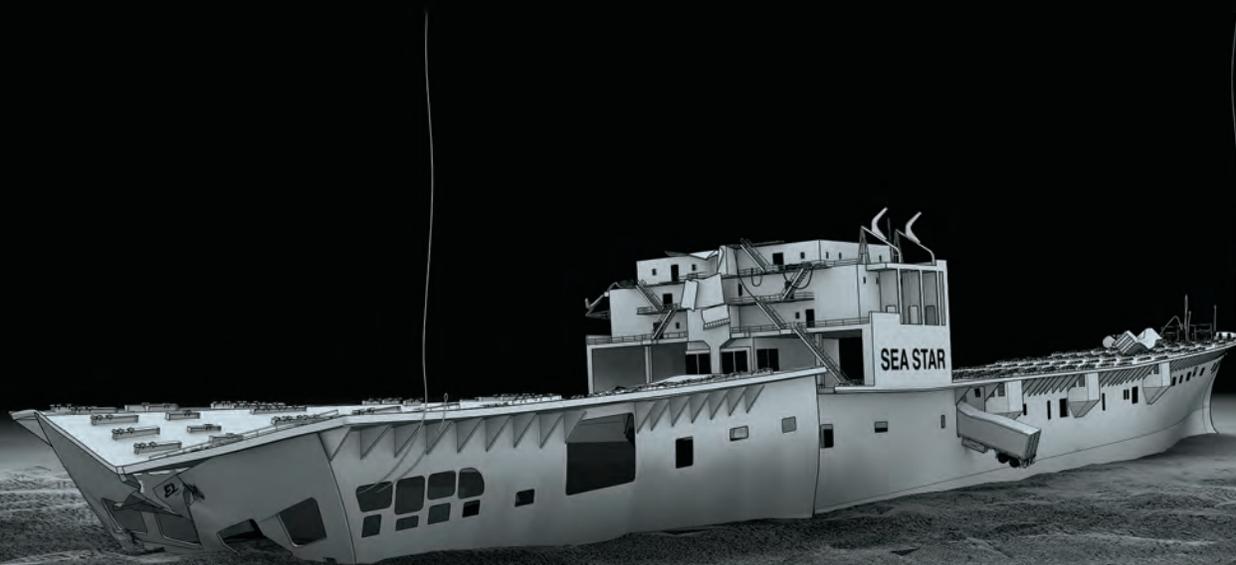
Artist's rendering of *El Faro* at final rest
based on data collected during search and recovery missions

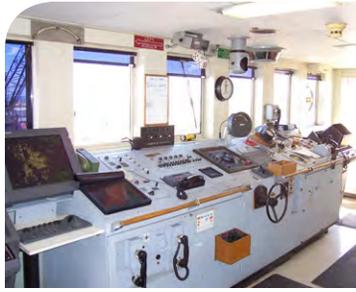
Two members of the bridge team suggested or hinted that they disagreed with the captain’s decisions, but the captain disregarded their concerns. For their part, the bridge crew deferred to the captain’s authority and experience, rather than acting more assertively. Regardless, when the crew did voice concerns, the captain chose not to listen. The suggestions of not only one but two of his officers should have prompted him to at least return to the bridge and review the weather information.

Although bridge resource management (BRM) stresses assertiveness, traditional maritime culture emphasizes the captain’s authority onboard and responsibility for the vessel. TOTE had not effectively implemented BRM, which involves modernizing centuries-old roles and including the bridge team in discussions pertaining to the safe navigation of the vessel.

El Faro's bridge
