MARINE INVESTIGATION REPORT

M02N0007

FIRE AND SINKING

OF THE SHRIMP FACTORY FREEZER TRAWLER *KATSHESHUK*
BELLE ISLE, NEWFOUNDLAND AND LABRADOR 76 NM ENE

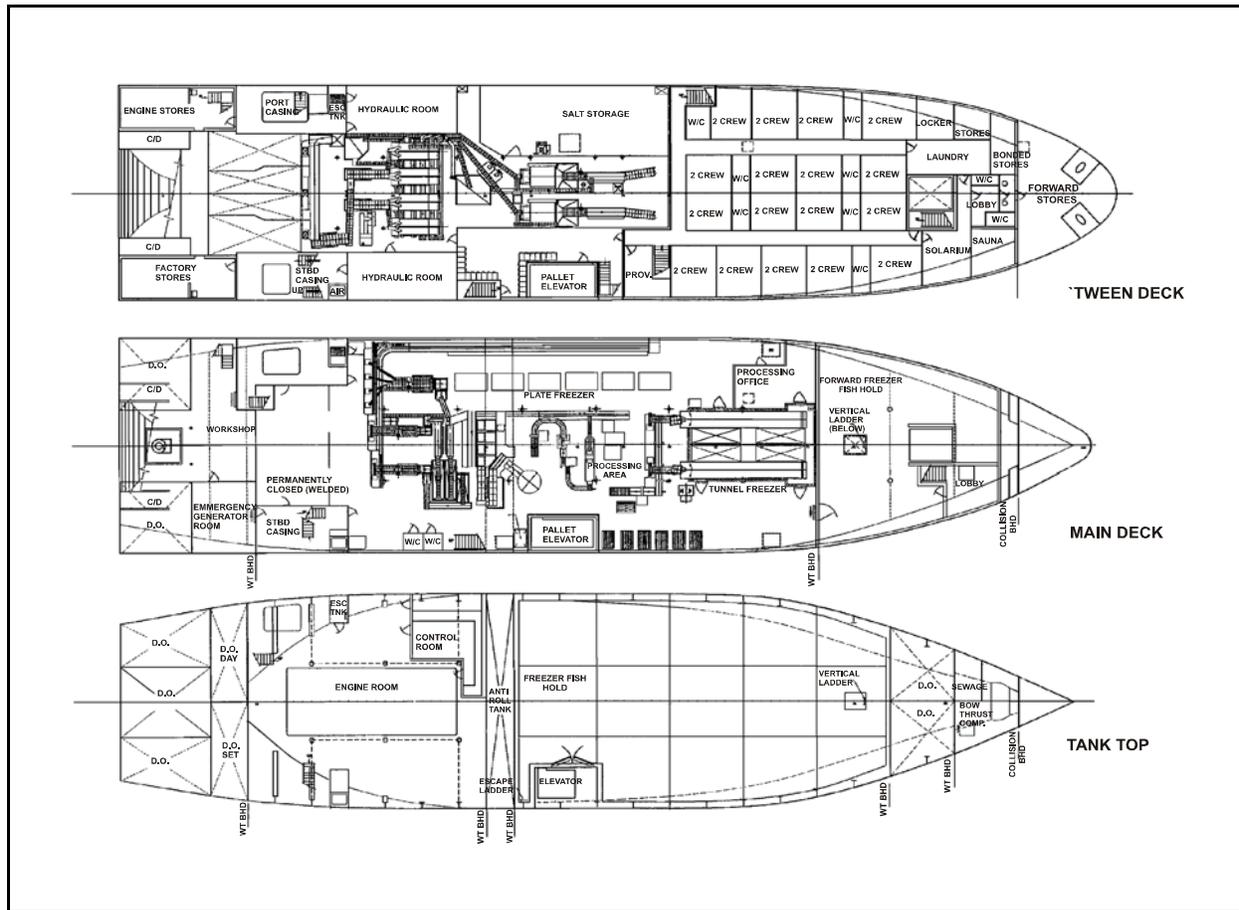
Figure 1 (cont'd)

While up forward and unknown to the first fire party, a second fire party was being assembled in the starboard alleyway (see Figure 3b). This team consisted of a fire lead wearing jeans, a short sleeve shirt and a SCBA accompanied by a hose party. As the first fire party was pulling back, the second fire party opened door B leading to the solarium and the fire lead felt some heat. He introduced water into the solarium for about a minute before deciding to pull back to get a safety line. On the second trip forward, the fire lead made it to door D and when he opened it, a white flame shot out over his head and hit the deckhead. He opened up his hose at the fire, but was quickly forced back by debris falling from the deckhead. The second fire party then retreated to the after cross-alleyway also leaving some doors in the open position.

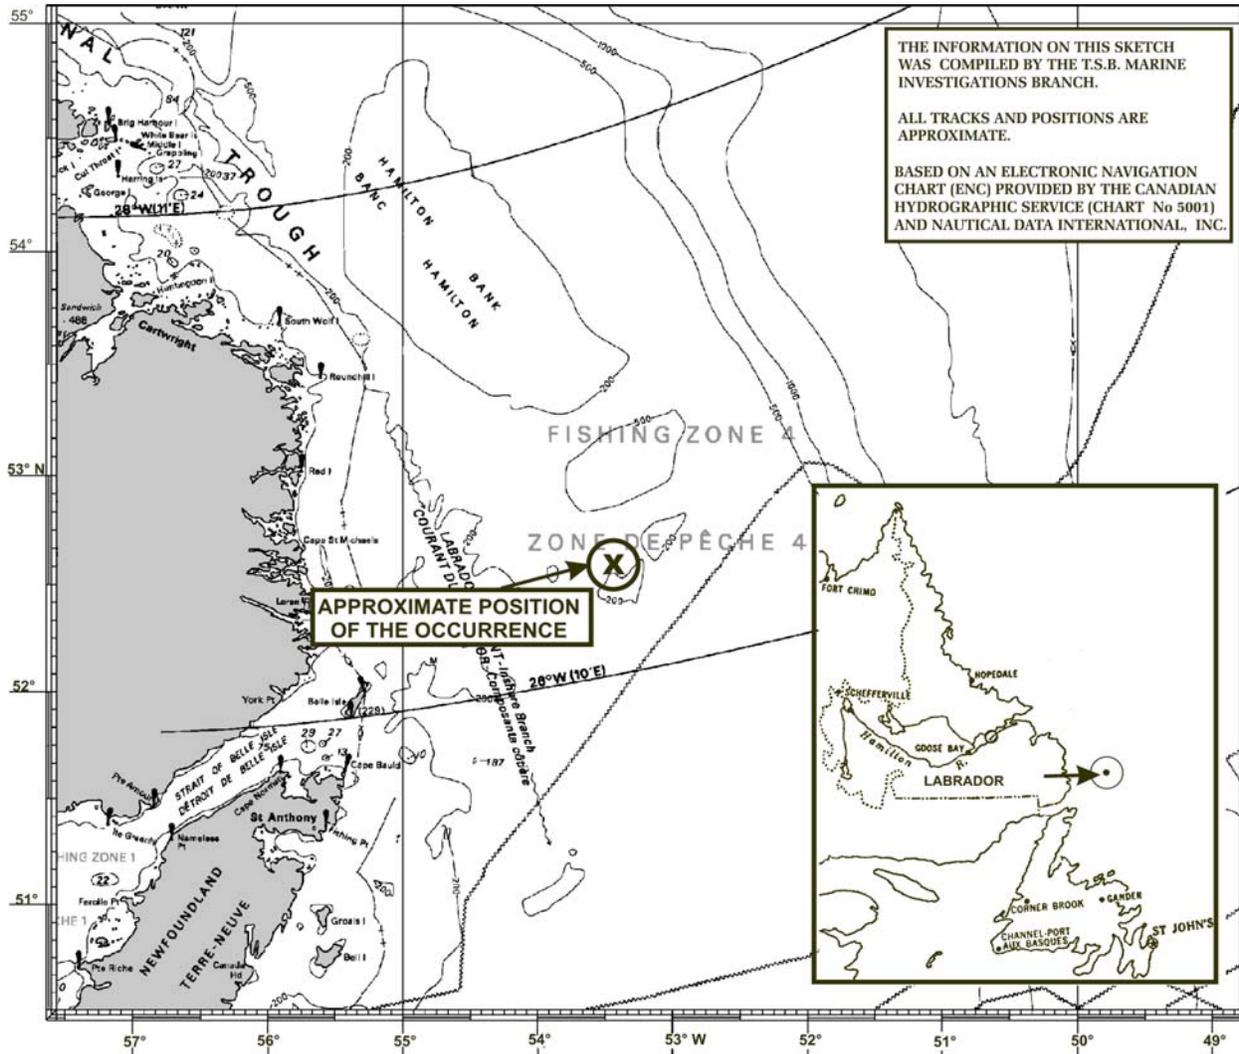
Appendix A – Sketch of the Occurrence Area

On 11 March 2002 at 2400,³ the *Katsheshuk* with a crew of 30 sailed from Harbour Grace, Newfoundland and Labrador, bound for the shrimp fishing grounds off eastern Labrador (see Appendix A). On arrival at the destination, the vessel started fishing, but had to move around from area to area to find the shrimp. On the morning of 17 March 2002, poor weather conditions prevented the vessel from fishing, so it steamed on a west-south-west course into the ice pack. At 1200, the vessel stopped in the ice to await better conditions. At approximately 1545, two crew members working on deck saw smoke coming from door G (see Figure 2) in the trawl deck superstructure providing access to the lobby. One crew member immediately went to inform the officer of the watch (OOB) while the other entered the lower accommodation to warn the crew.

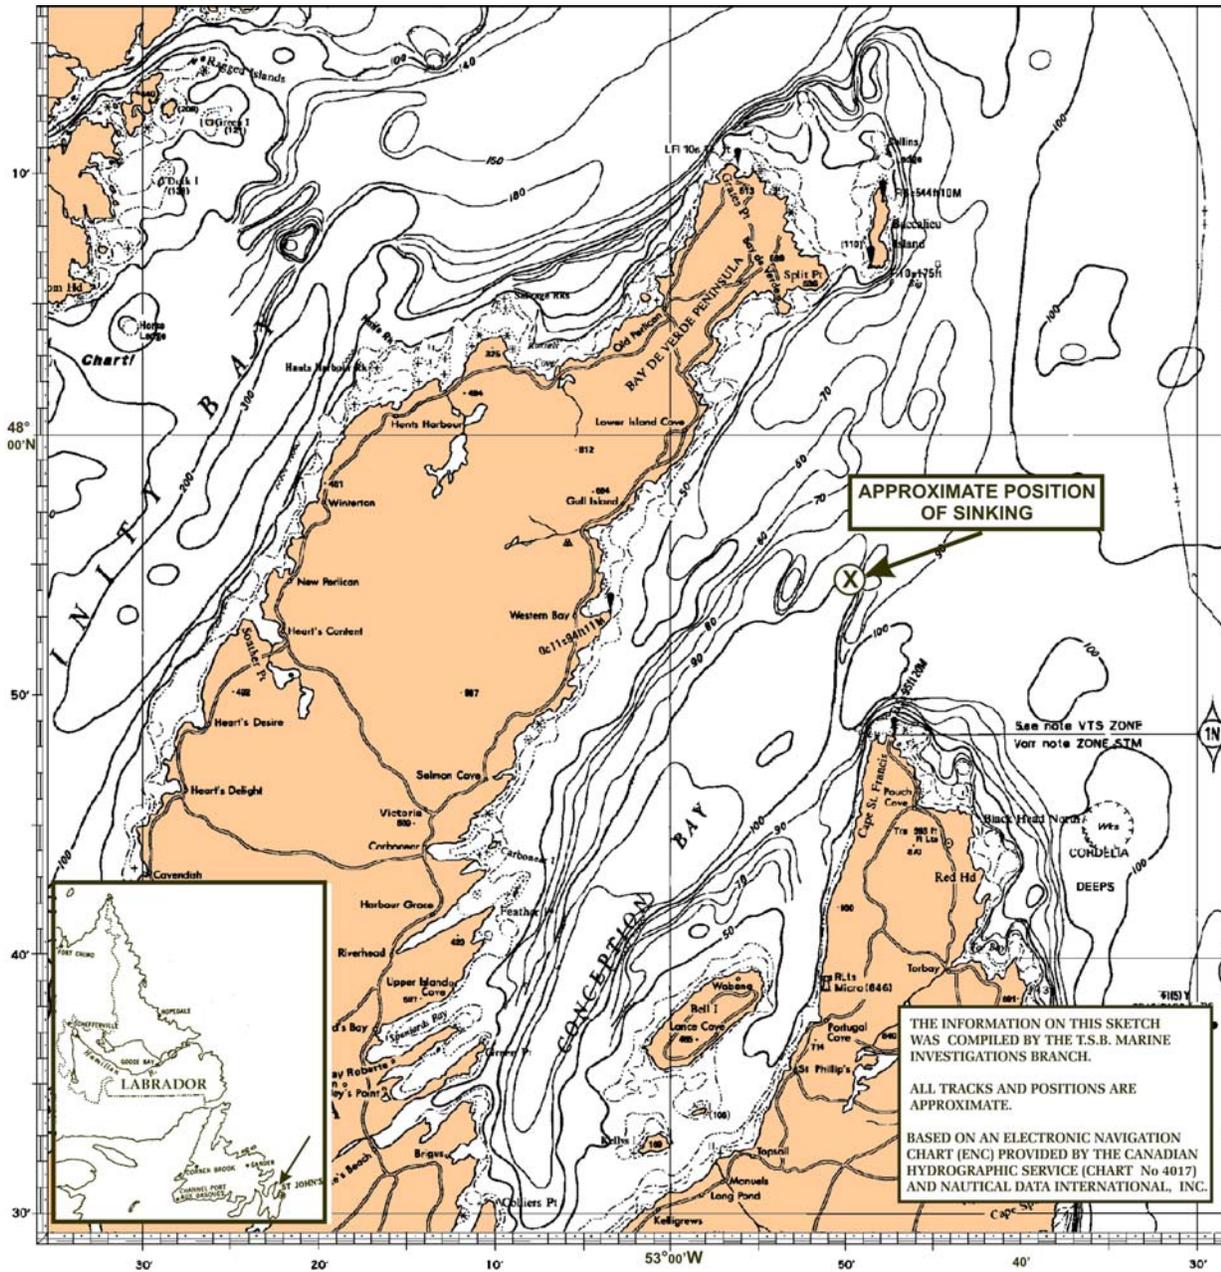
Appendix B – Sketch of the Sinking Area

On the early morning of 30 March 2002, weather conditions were favourable and the *Atlantic Maple*, with the *Katsheshuk* in tow, resumed its passage and headed for St. John's. At approximately 0616, the *Atlantic Maple* noticed the *Katsheshuk* had taken on a pronounced list and appeared to be settling lower in the water. At 0726, the *Katsheshuk* sank in position 47°54.3' N, 052°49.5' W (see Appendix B).
