# Typical wear mechanism of 2-stroke exhaust valves

Marine Propulsion Conference 2004

*Dr. Ing. Holger Fellmann, Head of 2-stroke department & service; Märkisches Werk GmbH*

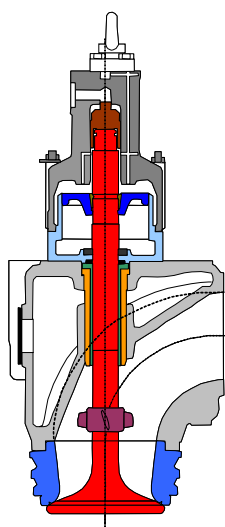
- Valve drive or hydraulic actuator
- Air cylinder
- Valve housing
- Valve guide
- Valve spindle
- Bottom piece or seat ring

*Figure 01:  
Main components of an exhaust valve*

The design of the exhaust valves of all three engine builders are different in details, but the general function is the same, see figure-01. The main components of MC, RTA and UEC are:

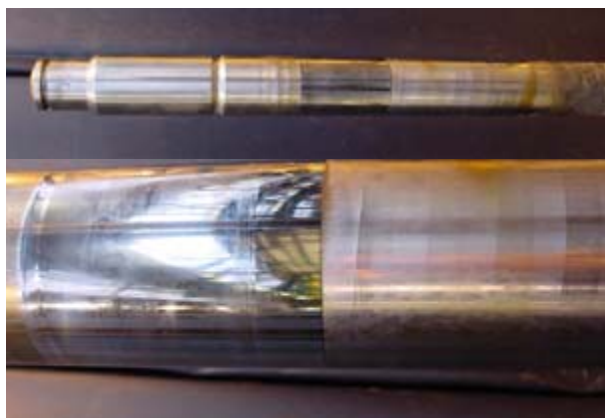
Figure 02:  
*Physical adhesion and abrasive wear of a hard-chromed valve spindle (MC-type after 15,000 hrs)*

Adhesion and abrasive wear is very often found in the stem sealing area of hard chromed, MC valve spindles (see figure 02). Usually the limit of this stem diameter is reached after 12,000 - 18,000 hrs. MC valve spindles with HVOF-stem coating, as well as RTA- and UEC valve spindles with hard-chromed stems, reach a TBO (time between overhaul) of 24,000 - 36,000 hrs.

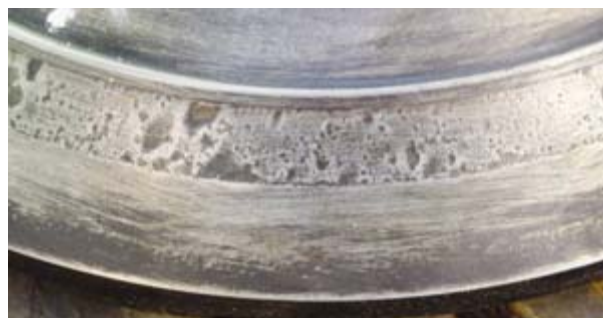
Figure 03:  
*Typical dent marks of the seat of a valve spindle (MC60-type Nimonic after 8,300 hrs)*

The probability and intensity of dent marks is directly related to the material combination of valve spindle seat and bottom piece. The hardness of the seat material of RTA- and UEC-type is about 400 HV for valve spindle and bottom piece, the hardness of the MC-types is about 400 HV for seat of valve spindle and about 500 HV for the seat of bottom piece.

Seating pressure and sealing velocity are also relevant factors for dent marks. The MC-type has a higher seating pressure (>700 bar) than the UEC- and RTA-type (about 550 bar). Typically, 550 bar gives good sealing and low wear. (KINGSTON-JONES, THOMAS, RADCLIFF 1990)

Together with high seat pressure and a higher seat hardness of the bottom piece, the MC-type shows the highest probability and intensity of dent marks with TBOs of 6,000-18,000 hrs (see figure 03). The seats of RTA- and UEC-types require overhauls after 12,000 - 36,000 hrs.

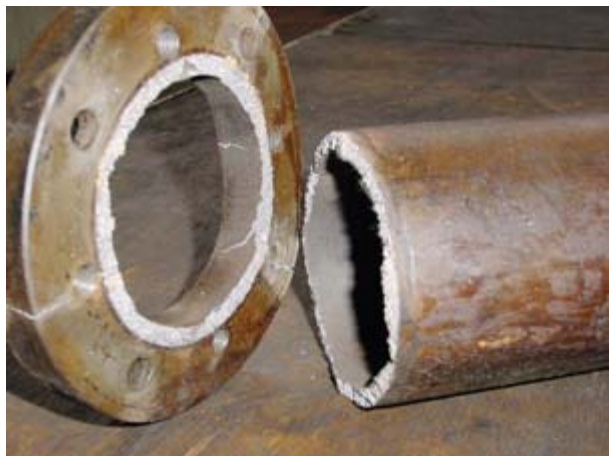
*Figure 04a: Breakage of the valve guide during valve spindle disassembling*

To disassemble exhaust valves, hydraulic power is usually necessary to remove the valve spindle from the valve guide. In some cases the sticking of the valve spindle is so extreme that the valve guide breaks during the operation (see figure 04a and 04b).

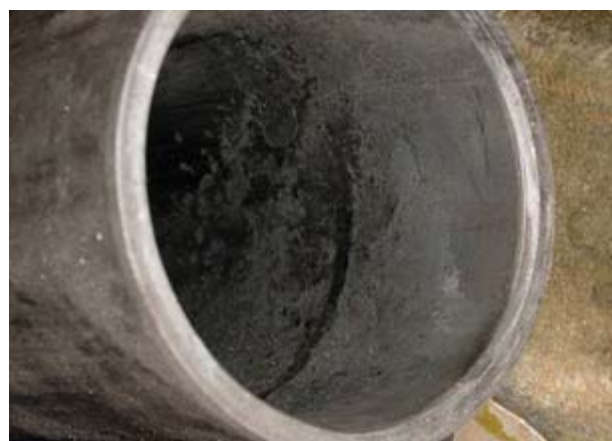
*Figure 04b: Typical deposits of inner diameter of valve guide (MC70-type after 8,200 hrs)*

Depending on the design of the valve guide, its inner diameter will display more or less deposit buildup. Exhaust gas enters into the clearance between valve spindle stem and the inner diameter of the valve guide, which allows deposits inside the guide (see figure 04). Due to this, MC-types need a replacement of the valve guide between 6,000 - 8,000 hrs to minimize the risk of the valve spindle sticking in the guide.

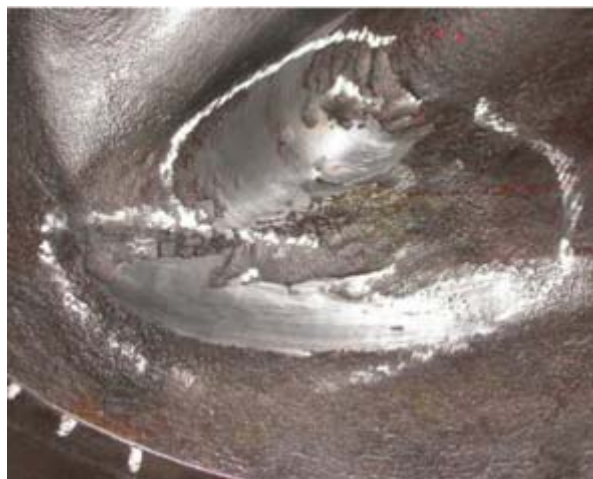
*Figure 05:  
Low temperature corrosion of valve housing  
(MC-type 43,700 hrs)*

Heavy fuel contains high amounts of sulfur (up to 5%). If there is an exposed surface where the temperature is below the dew point of sulfurous acid, the acid condenses into liquid and can attack the metal surfaces. If a large amount of concentrated sulfuric acid condenses, it can attack the valve housing, bottom piece, valve guide and valve spindle stem. Sulfur acid has an extremely corrosive effect on cast iron (BEHRENS, GROTH 1990).

Nearly all components of the exhaust gas channel show some low-temperature corrosion (see figure 05-07).

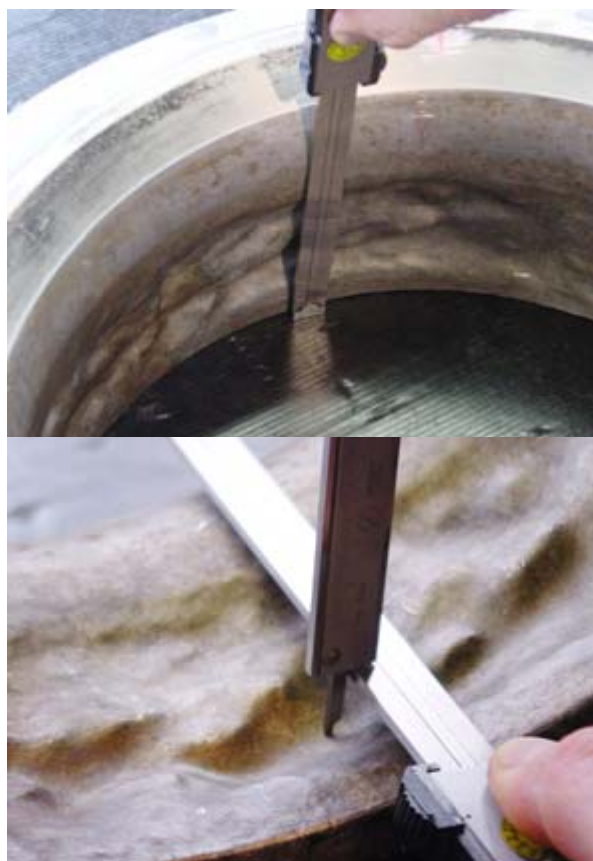
*Figure 06:  
Low temperature corrosion of bottom piece  
(RTA-type after 28,420 hrs)*

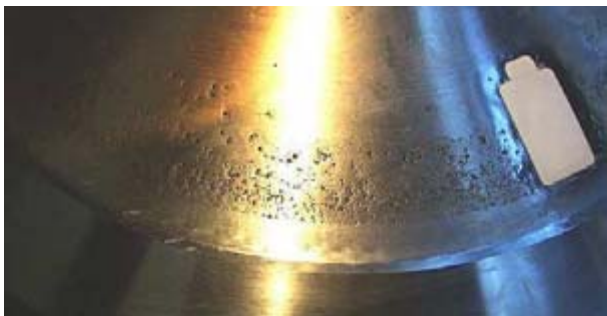
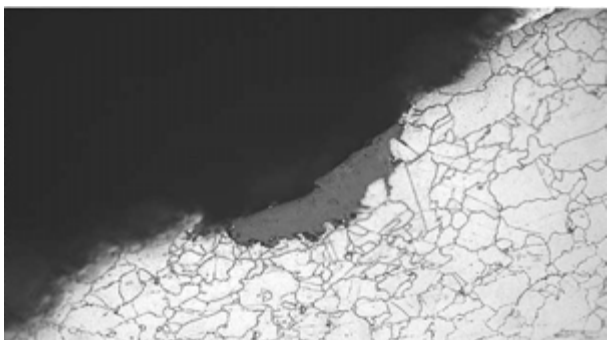
Figure 07: Low temperature corrosion (pitting corrosion attack) of under head radius of valve spindle (MC60-standard / 22,700 hrs)

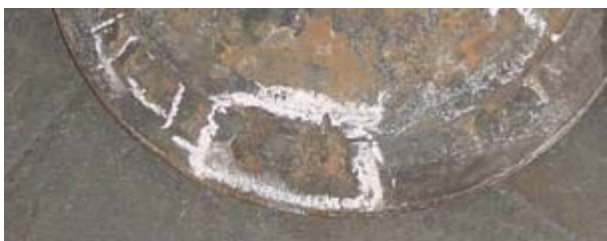
Figure 08: “Cobble stone corrosion” appearance of valve spindle failure through high-temperature corrosion (MC60 Standard-type)

As a result of the above-mentioned physical process, the following wear mechanism can be described. Hard salt deposits on the seat surfaces of the valve spindle lead to dent marks caused by each closing stroke of the valve spindle. This can lead to crucial micro gas channels, which will grow over the time (NANDA, 2003). Because of the high temperature, the salt deposits reach their melting point, then the “cobble stone corrosion” starts (see figure 08) at the seat and finally leads to blow-byes (UMLAND 1975, RITZKOPF 1975). Result: The whole exhaust valve has to be replaced.

The bottom of the valve spindle is mostly operating in the critical area of the high-temperature corrosion seen as “cobble stone corrosion”. The wear rate is between 0,2 - 1,0 mm / 1,000 hrs. depending on valve material and type of engine. The limit for remanufacturing is only reached after 12 mm. This leads to a TBO of about 12,000 - 60,000 hrs. Figure 09 shows micro cuts of Nimonic with high-temperature corrosion.

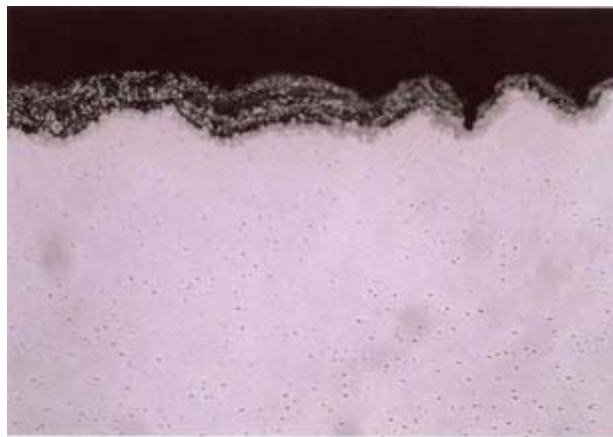
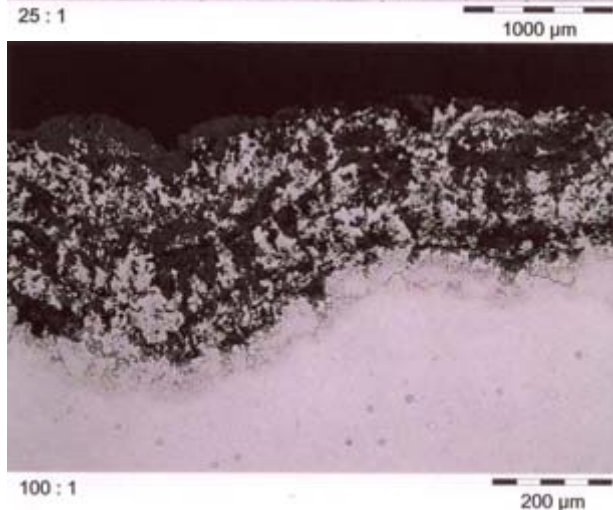
Figure 09: Micro cuts of Nimonic with high-temperature corrosion.

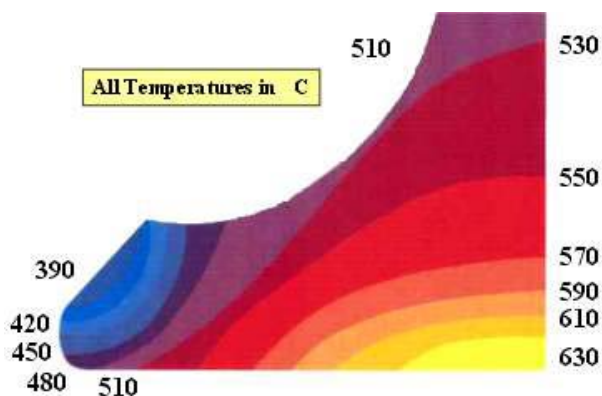
Figure 10:  
Typical temperature distribution of a Nimonic exhaust valve head

The valve spindle is the component with the maximum thermal stress. Most of fatigue problems are documented at the valve spindles. Figure 10 demonstrates a typical heat distribution across a Nimonic valve head.

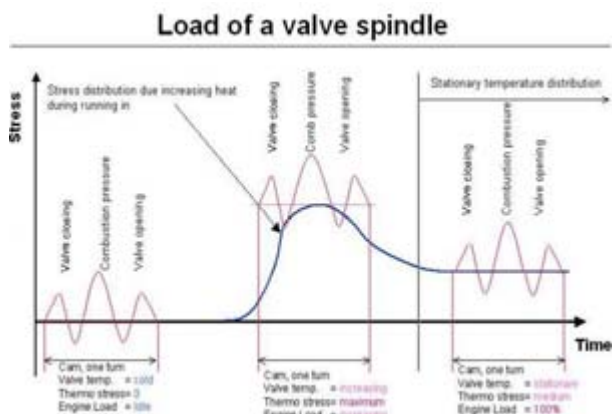
Figure 11:  
Mechanical and thermal load as function of running in and stationary operation

The maximum thermal stress takes place during the warm-up period. During this period the temperature at the center of the valve bottom and the seat reaches the maximum difference. Under regular operating conditions the temperature distribution is much lower. The mechanical load of a valve spindle is nearly constant between warm-up and regular operating, see figure 11.

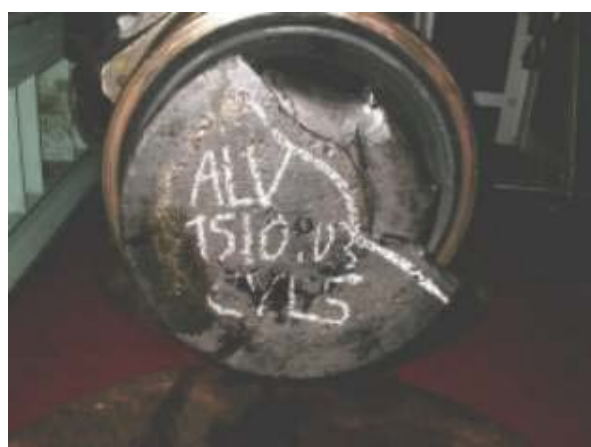
Figure 12:  
Catastrophic failure of a repaired valve spindle (RTA72 Nimonic-type 740 hrs after repair)

There are two typical failure reasons. One is a crack that starts in the under head radius. After the micro cracks get to a critical length, the speed of the crack growth increases. A catastrophic failure follows, with parts of the spindle dropping down into the combustion chamber (see figure 12 and 13).

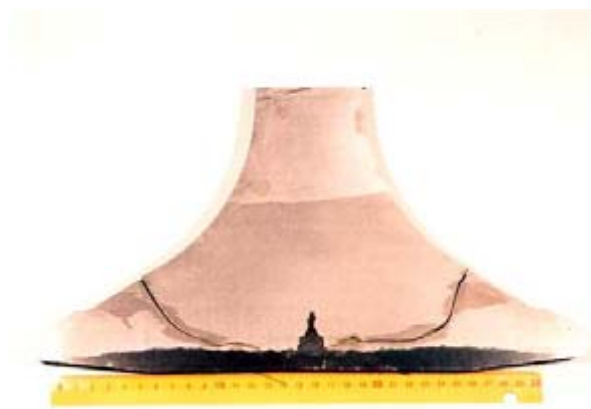
Figure 13:  
Macro cut through the center of a valve head (RTA62 Nimonic-type 6,430 hrs after repair)

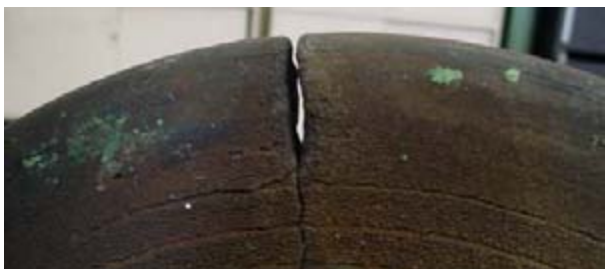
Figure 14:  
Failure of a valve spindle  
(RTA84 Nimonic type 5, 270 hrs after repair).

The second failure reason is: Micro cracks starting in the outer diameter of the valve bottom. After reaching the seat area blow-byes are created and the valve spindle is destroyed (see figure 14).

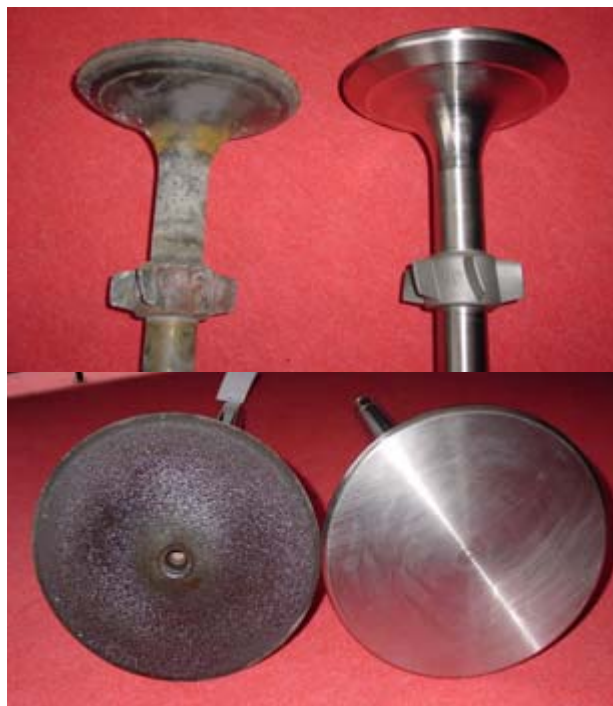
Figure 15 a/b:  
Nimalike spindle before and after remanufacturing

Nimalike is used in two ways: To extend the lifetime of a standard valve spindle to a lifetime similar to Nimonic, or to remanufacture Nimonic valve spindles in a way that leads to “close to new” conditions after the process (see figures 15 a/b).

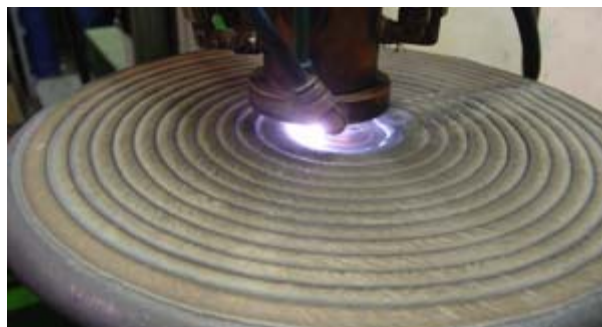
Figure 16: PTA-welding

The competence to perform this remanufacturing method is a combination of long-time experience in the field and manufacturing technology. The experience is coupled with continuous improvement of manufacturing processes and intensive R&D in the fields of metallurgy and welding processes (see figure 16).

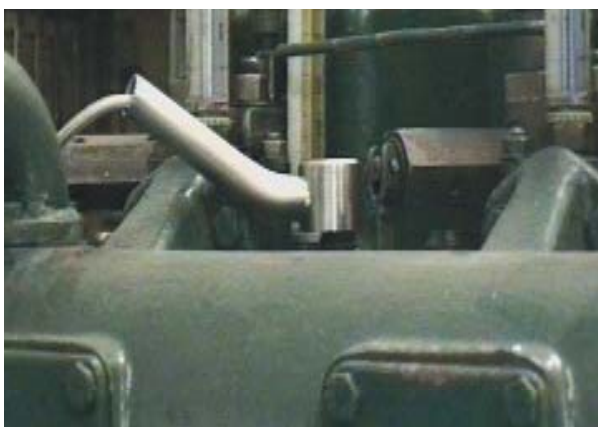
Figure 17:  
Leakage Measure System onboard in use

For this reason MWH provides the “Leakage Measure System”, a mobile diagnostic system which is able to detect leakages at the cylinderhead to prevent fatal failures of a running engine. The principle is based on measurement of ultrasonic sound by using one simple and robust sensor (WEHNER, ALBERT 2001).

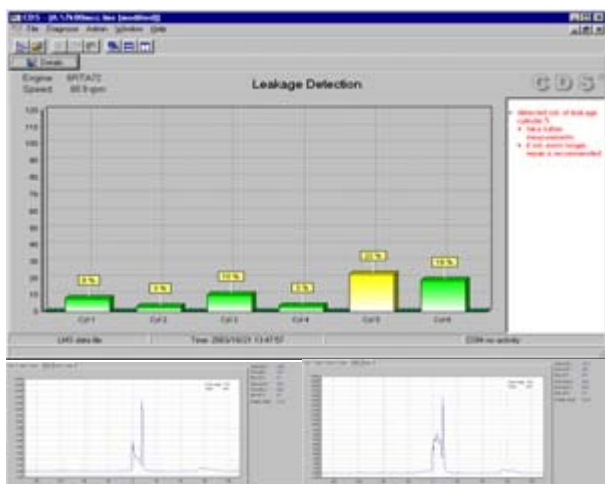
Figure 18:  
Documentation of the result of leakage detection and valvetiming/ignition

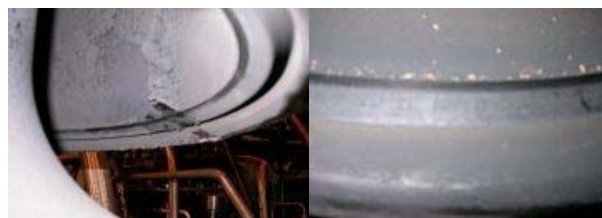
Figure 19:  
Seat ring and valve spindle show no dent marks after app. 1,000 hours.

The valve rotator forces an accurate, reliable valve turning during valve closing. The Turnomat® principle is simple and surprisingly effective: The forced rotational movement causes a defined rotational energy for the valve at the instance of seating. This brings about the desired polishing effect, removing combustion deposits between valve spindle and valve seat and, at the same time, optimizing the heat exchange to the cooler valve seat.

First field tests are ongoing with a MC70 engine. Inspections have proven that the Turnomat® works as designed (see figure 19).
